Re: Rhinelander Hydroelectric Project, FERC Project No. 2161 - 035  
Invasive Species Survey Report

**2006  
INVASIVE SPECIES REPORT  
FOR THE  
RHINELANDER HYDROELECTRIC PROJECT  
ONEIDA COUNTY, WISCONSIN  
FERC Project No. 2161**

**2006 Invasive Species Report**

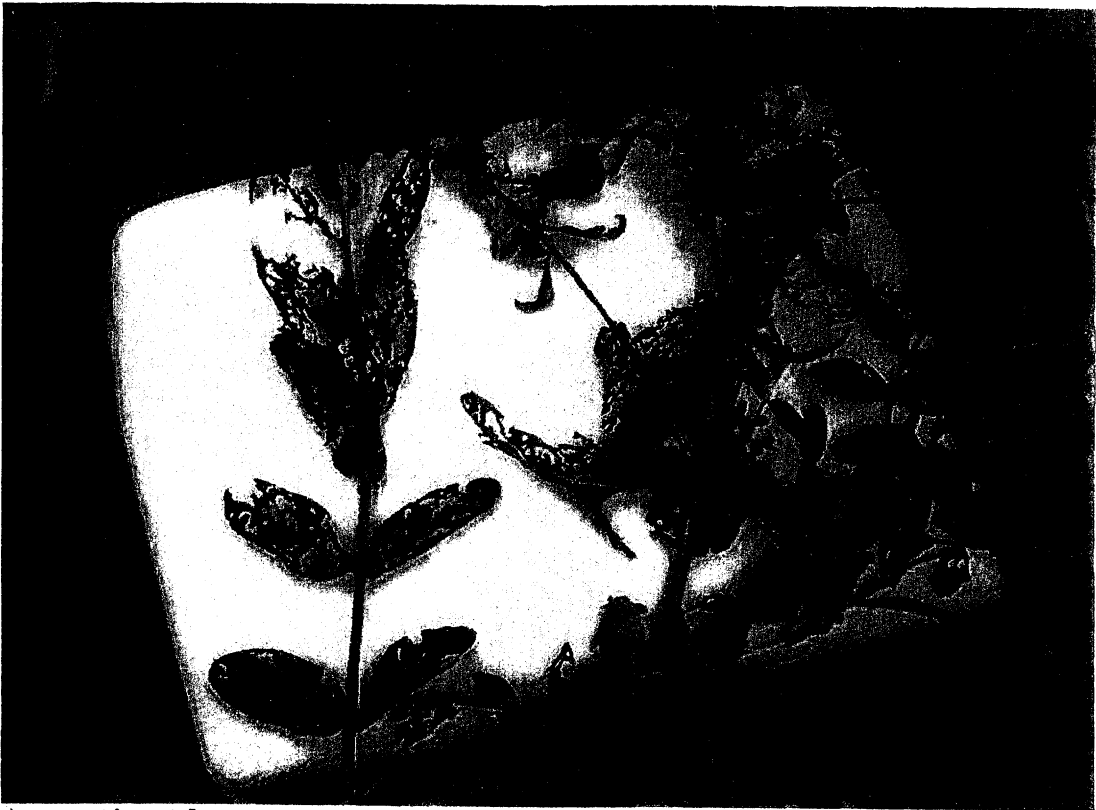
One other occurrence appeared to have a large amount of insect damage. That was labeled as RLND PL004, was located on the left side of the bypass reach approximately 175' upstream from the Davenport Street bridge, and was comprised of 1 plant. When PL information was acquired prior to performing the survey, the WIDNR indicated that bio-control methods (beetle release) had been performed on a site on an island a short distance downstream from the Project. Beetle migration from that site may explain the damage to the plants at PL002 and PL004.

**Apparent insect damage at RLND PL004**
