The 1979 effects of the Hilbert Wastewater Treatment Facility
on the Hilbert Tributary to the North Branch
of the Manitowoc River
(Pre-operational Study)

By: Dennis C. Weisensel

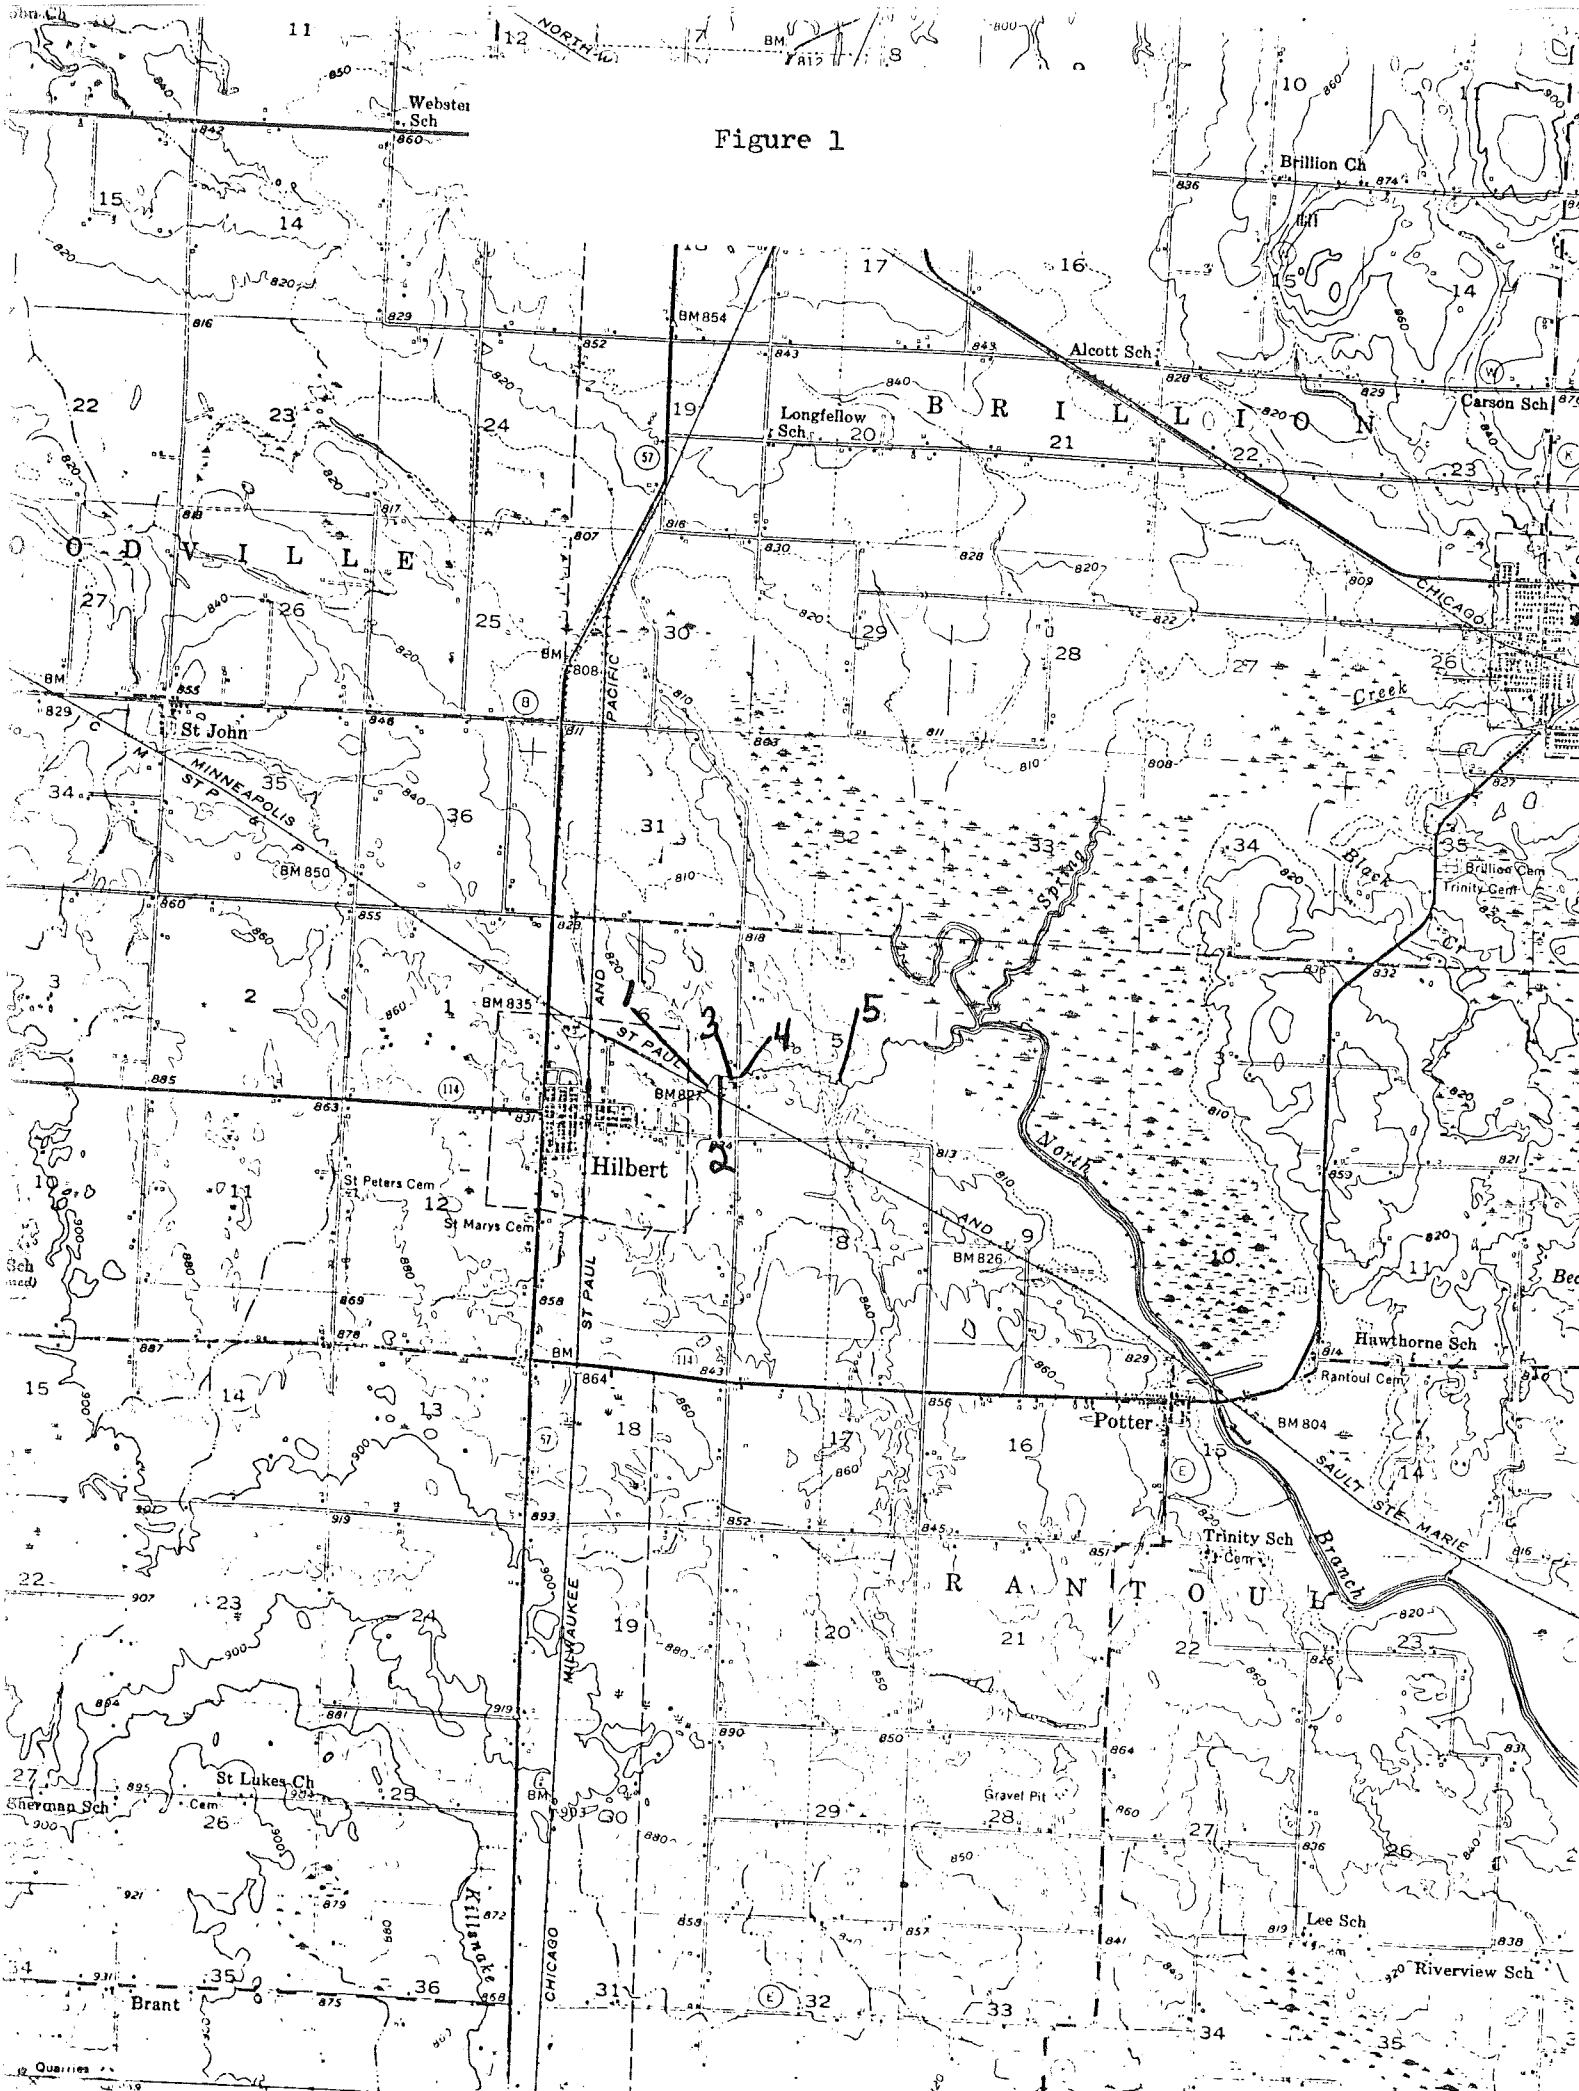
Figure 1

Chemical parameters, periphyton, macro-invertebrate population and flows were conducted on the Hilbert tributary in conjunction with the Hilbert Wastewater Treatment Facility. Five stations (Figure 1) were established on the river. Station #1 was located 150 feet above the outfall. Station #2 is the Wastewater Treatment Facility outfall. Station #3 is the mixing zone 100 feet below the outfall. Station #4 is at Irish Road. Station #5 is 1/2 mile below Irish Road.
