Wisconsin Valley Improvement Company
2016 Purple Loosestrife Annual Monitoring Report

2016 Field Monitoring Results

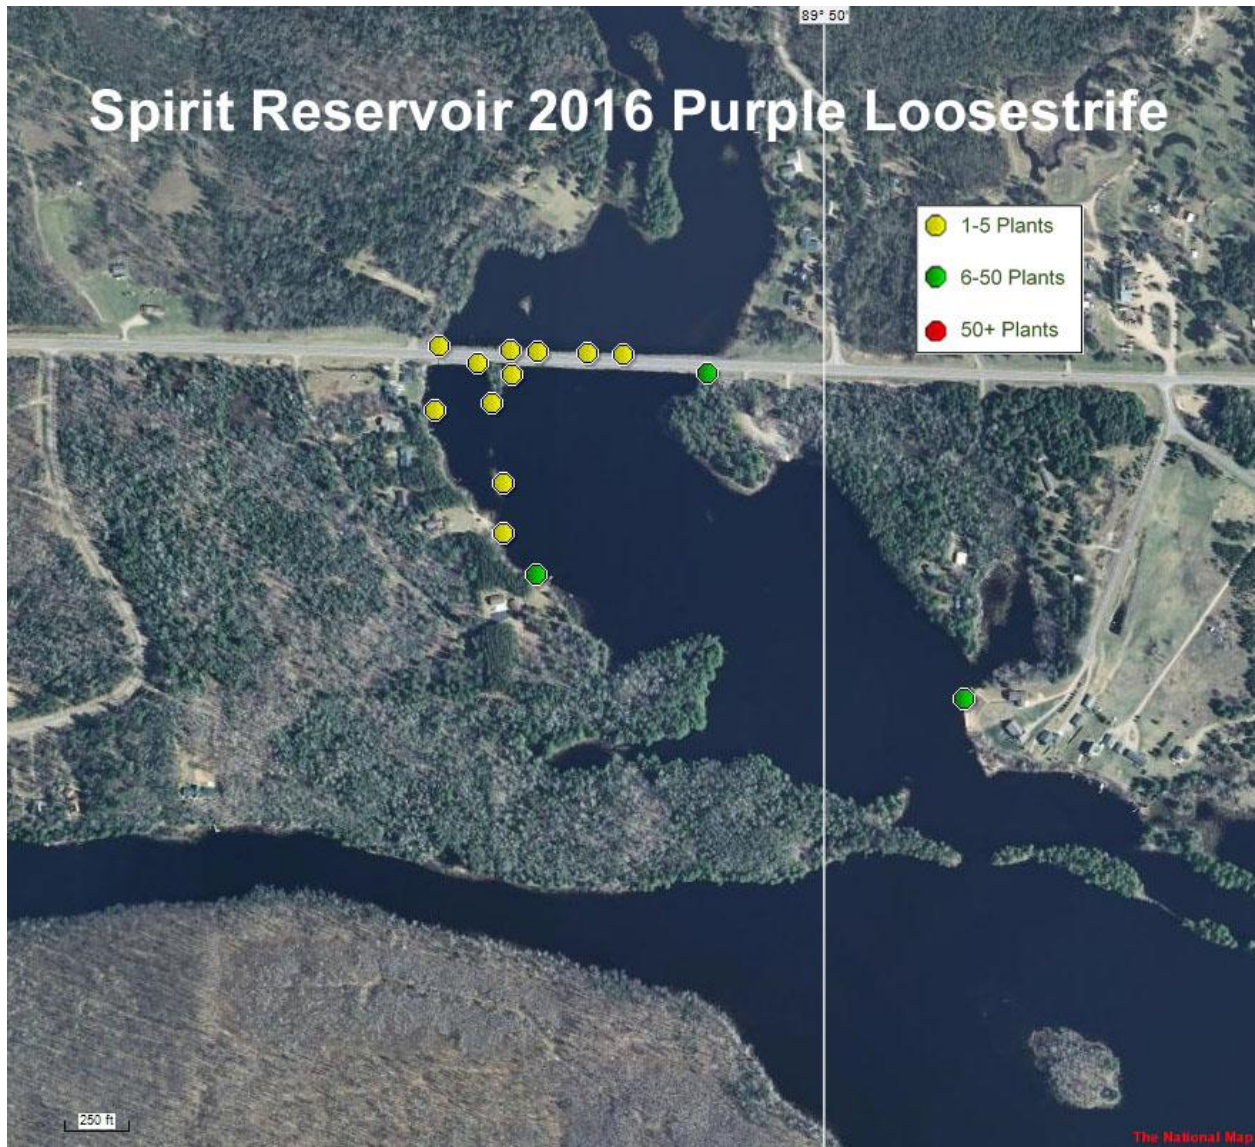
Spirit Reservoir – On August 18, 2016 WVIC and the WDNR AIS LTE monitored the portion of Spirit Reservoir where PL has historically occurred. Reservoir elevation was 1431.64 ft. NGVD (6.24 ft. below full). Figure 3 is a distribution and relative abundance map of recorded PL locations in 2016 and Table 3 lists GPS coordinates for each observation. There were 11 sites of 1-5 plants, 3 sites of 6-50 plants, and no sites of 50+ plants identified in 2016. PL was not identified outside the historic range at Spirit. *Galerucella sp.* beetle activity has not been observed since 2011.

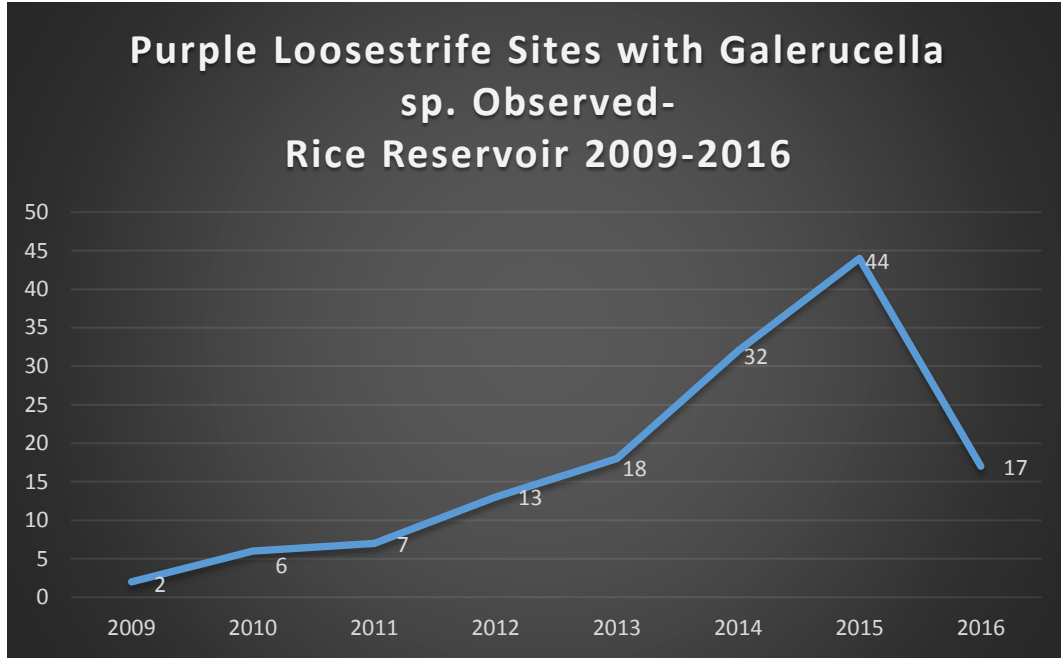
Figure 4

Galerucella sp. beetle activity and leaf damage was identified at 17 sites in 2016 marking a decline from 2015 (Figure 4). The decline in beetle activity is likely related to above average water levels throughout the season which also reduced the number of PL sites with 50+ plants. Beetle activity was found at 0 of 2 sites with 50+ plants, 12 of 34 sites with 6-50 plants, and 5 of 75 sites with 1-5 plants. 2016 was the third season in which vegetative damage assessments were conducted at each site where beetle activity was identified. Table 2 provides the percent range of plants damaged at each site and leaf tissue removed per plant within the site. Figure 5 displays the average damage scores (1-4 scale) for each of the PL relative abundance categories. The highest level of beetle activity was found at sites with 6-50 plants where more damage was observed throughout the site and within individual plants as compared to sites with only 1-5 plants.
