East Alaska Lake

Kewaunee County, Wisconsin

Alum Treatment Feasibility Study

April 2005

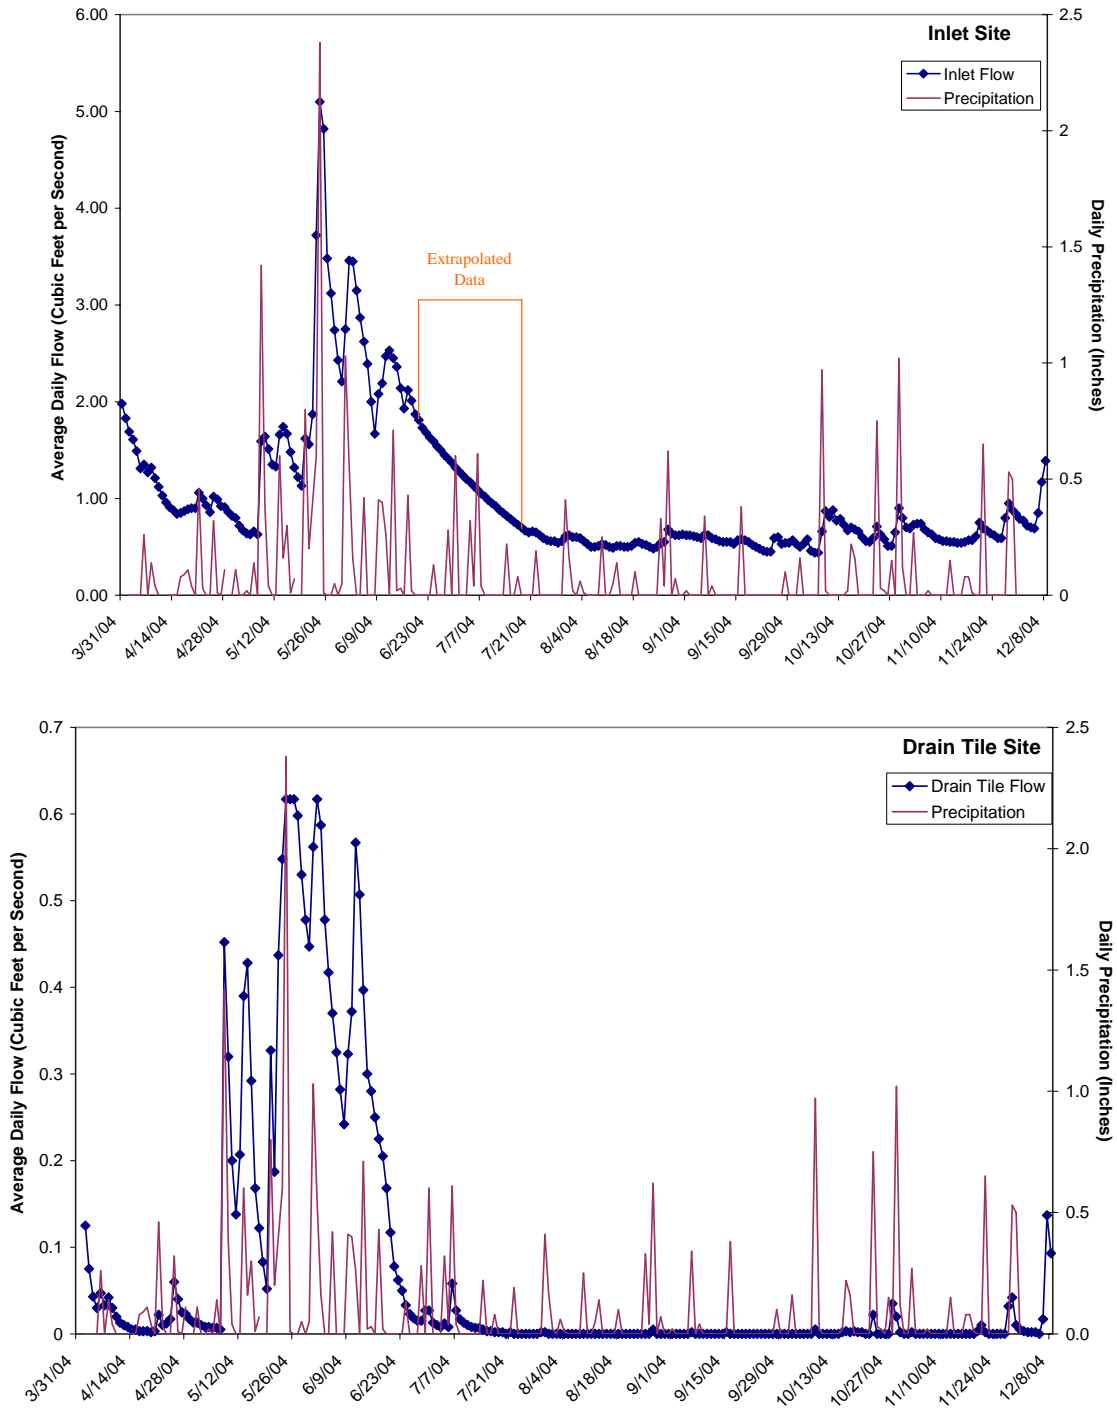
Figure 1. Inlet and Drain Tile average daily flows and daily precipitation. Note that the primary Y-axes on each graph pertaining to flow rate are different while the secondary axes indicating precipitation are identical.

Flows from the Drain Tile and Inlet sites (Map 1) were monitored during the spring, summer, and fall of 2004. The Inlet site flowed during the entire study period, while the Drain Tile site was reduced to nothing more than a trickle after mid July (Figure 1). As displayed in Figure 1, the affect of precipitation on the flow rates of both sites diminished as the monitoring period progressed and the ground dried as a result of below average precipitation during July, August and September (Figure 2).

Unfortunately, the monitoring unit located at the Inlet site malfunctioned and was in for repair from June 19 to July 18. As a result, the data used in FLUX and displayed in Figure 1 were extrapolated. It is believed that these data are relatively accurate as no more than a half-inch of rain fell during any one day while the unit was being repaired and the flow pattern follows that of the Drain Tile site.

Phosphorus loadings for the Drain Tile and Inlet sites (Figure 1) were estimated using FLUX, a model developed by William Walker of the US Army Corps of Engineers Waterways

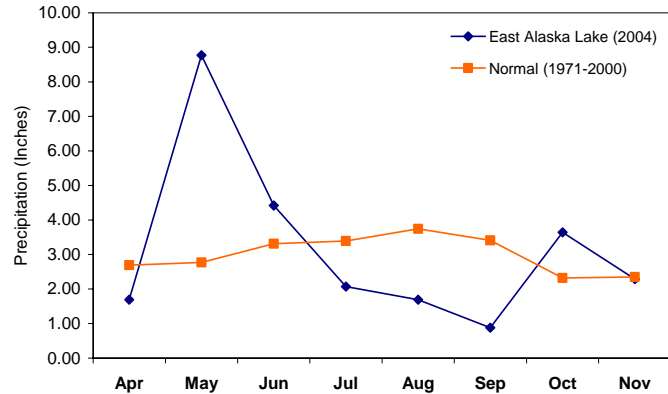
Figure 2. Normal and observed precipitation values. Normal values are from Kewaunee, Wisconsin while the observed values were recorded at the lake by Mr. Alan Stangel.

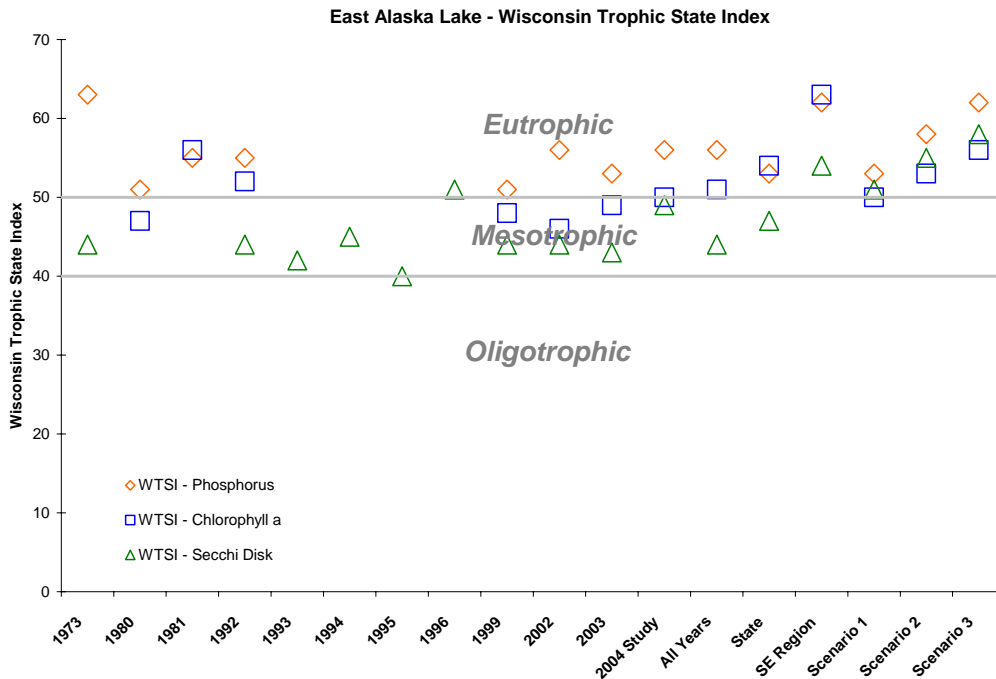
Figure 3. Wisconsin Trophic State Index results for East Alaska Lake, state, and region. Scenario 1 – Inlet as sole source. Scenario 2- Drain Tile as sole source. Scenario 3 – Internal loads as single phosphorus source.

Utilizing the WTSI (Figure 3) for the Inlet (Scenario 1), the lake would be considered moderately eutrophic (much as it is now). The WTSI for the Drain Tile (Scenario 2) calculations indicates that the lake would be much more eutrophic, especially considering the phosphorus value.

Because the load is internally generated, there would be no associated water inputs with the 131 kg addition. WiLMS requires some sort of water input to generate its estimates; therefore, a false watershed was created to mimic the water entering the lake through the runoff. The false watershed was set to 61.9-acres, corresponding to the area of the actual East Alaska Lake watershed (not including West Alaska Lake's watershed). Unlike a normal watershed, there is no phosphorus load associated with its runoff. The model estimated the average surface water phosphorus value to be approximately .081 mg/l, a "Poor" level according to the AWQI. Predictive chlorophyll-*a* and Secchi disk values were also considered "Poor" at 16.5 µg/l and 3.8 feet, respectively. These results correspond to a highly eutrophic state based upon the WTSI (Scenario 3, Figure 3).

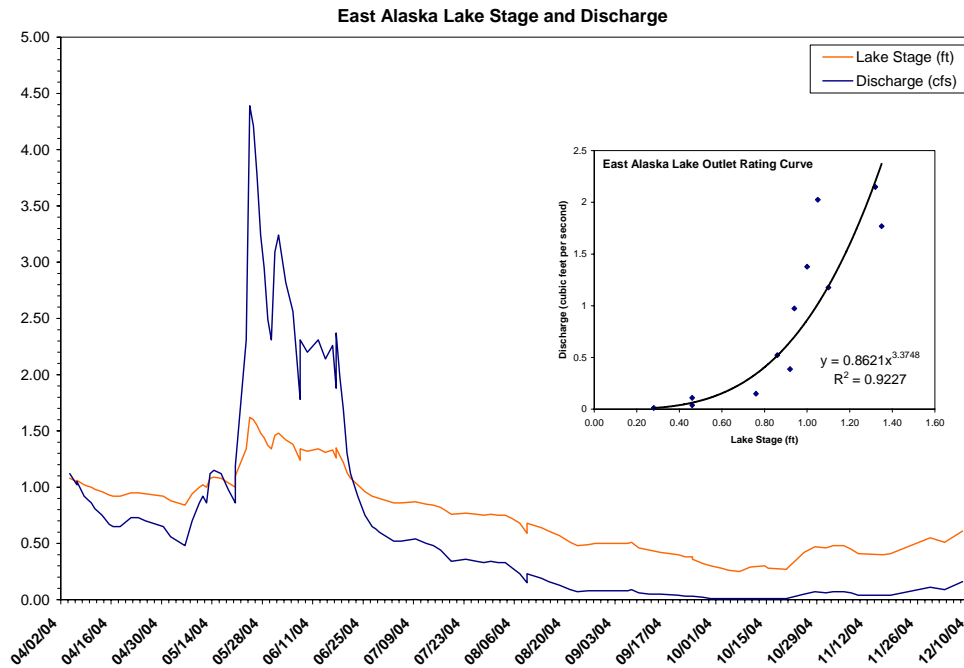
Figure 4. Lake stage and outlet flows for study period. The discharge values were calculated using the rating curve relationship displayed in the inset chart.

Mr. Alan Stangel graciously measured lake stage on nearly a daily basis throughout most of the study. Mr. Stangel's measurements were coupled with the measured flows exiting the lake to produce a rating curve allowing outflows to be determined using lake stage (Figure 4). These data indicate that the outflow discharges throughout the majority of the year. Calculations using time-weighted flow determined that approximately 356,000 m³ of water exited the lake during the study. Comparing this volume to the volume that entered the lake through the Inlet and Drain Tile sites (approximately 680,000 m³) demonstrates that much of the lake's inflow discharges through groundwater.

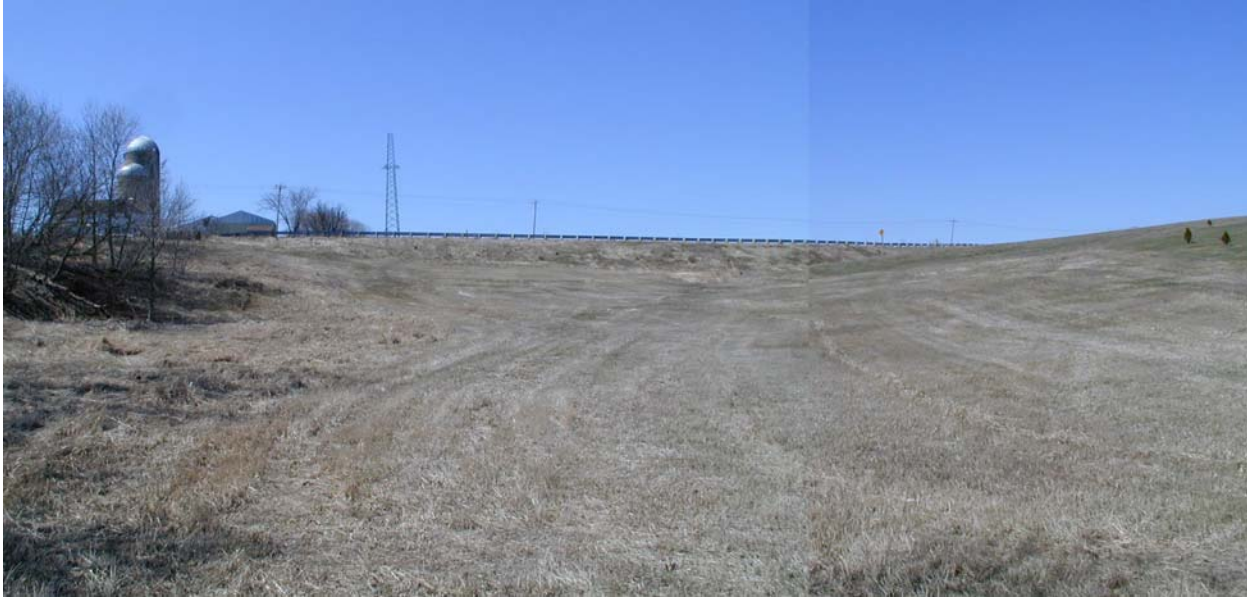
Photo 1. Potential detention basin site to treat Drain Tile discharge. Photo taken facing northwest at the Drain Tile site. It is likely that the tileline follows this valley as it slopes towards East Alaska Lake.

Minimizing the impact of the Drain Tile could be accomplished through the creation of a sedimentation basin to intercept and treat the discharges before they enter the lake. A study completed at English Lake, Manitowoc County, Wisconsin determined that over 60% of inflowing phosphorus was removed before it entered the lake by a newly constructed wetland detention basin (NES 2001). If a basin could be constructed at East Alaska Lake that would remove 50% of the phosphorus from the Drain Tile, it would be a significant reduction in loading. A secondary benefit to the construction of the basin would be enhanced wildlife habitat.

A suitable location for such a detention basin is located just inland from the Drain Tile outfall (Figure 1 and Photo 1). If the Tri-Lakes Association intends to pursue the construction of the basin, it is recommended that they enlist the assistance of a professional engineering firm

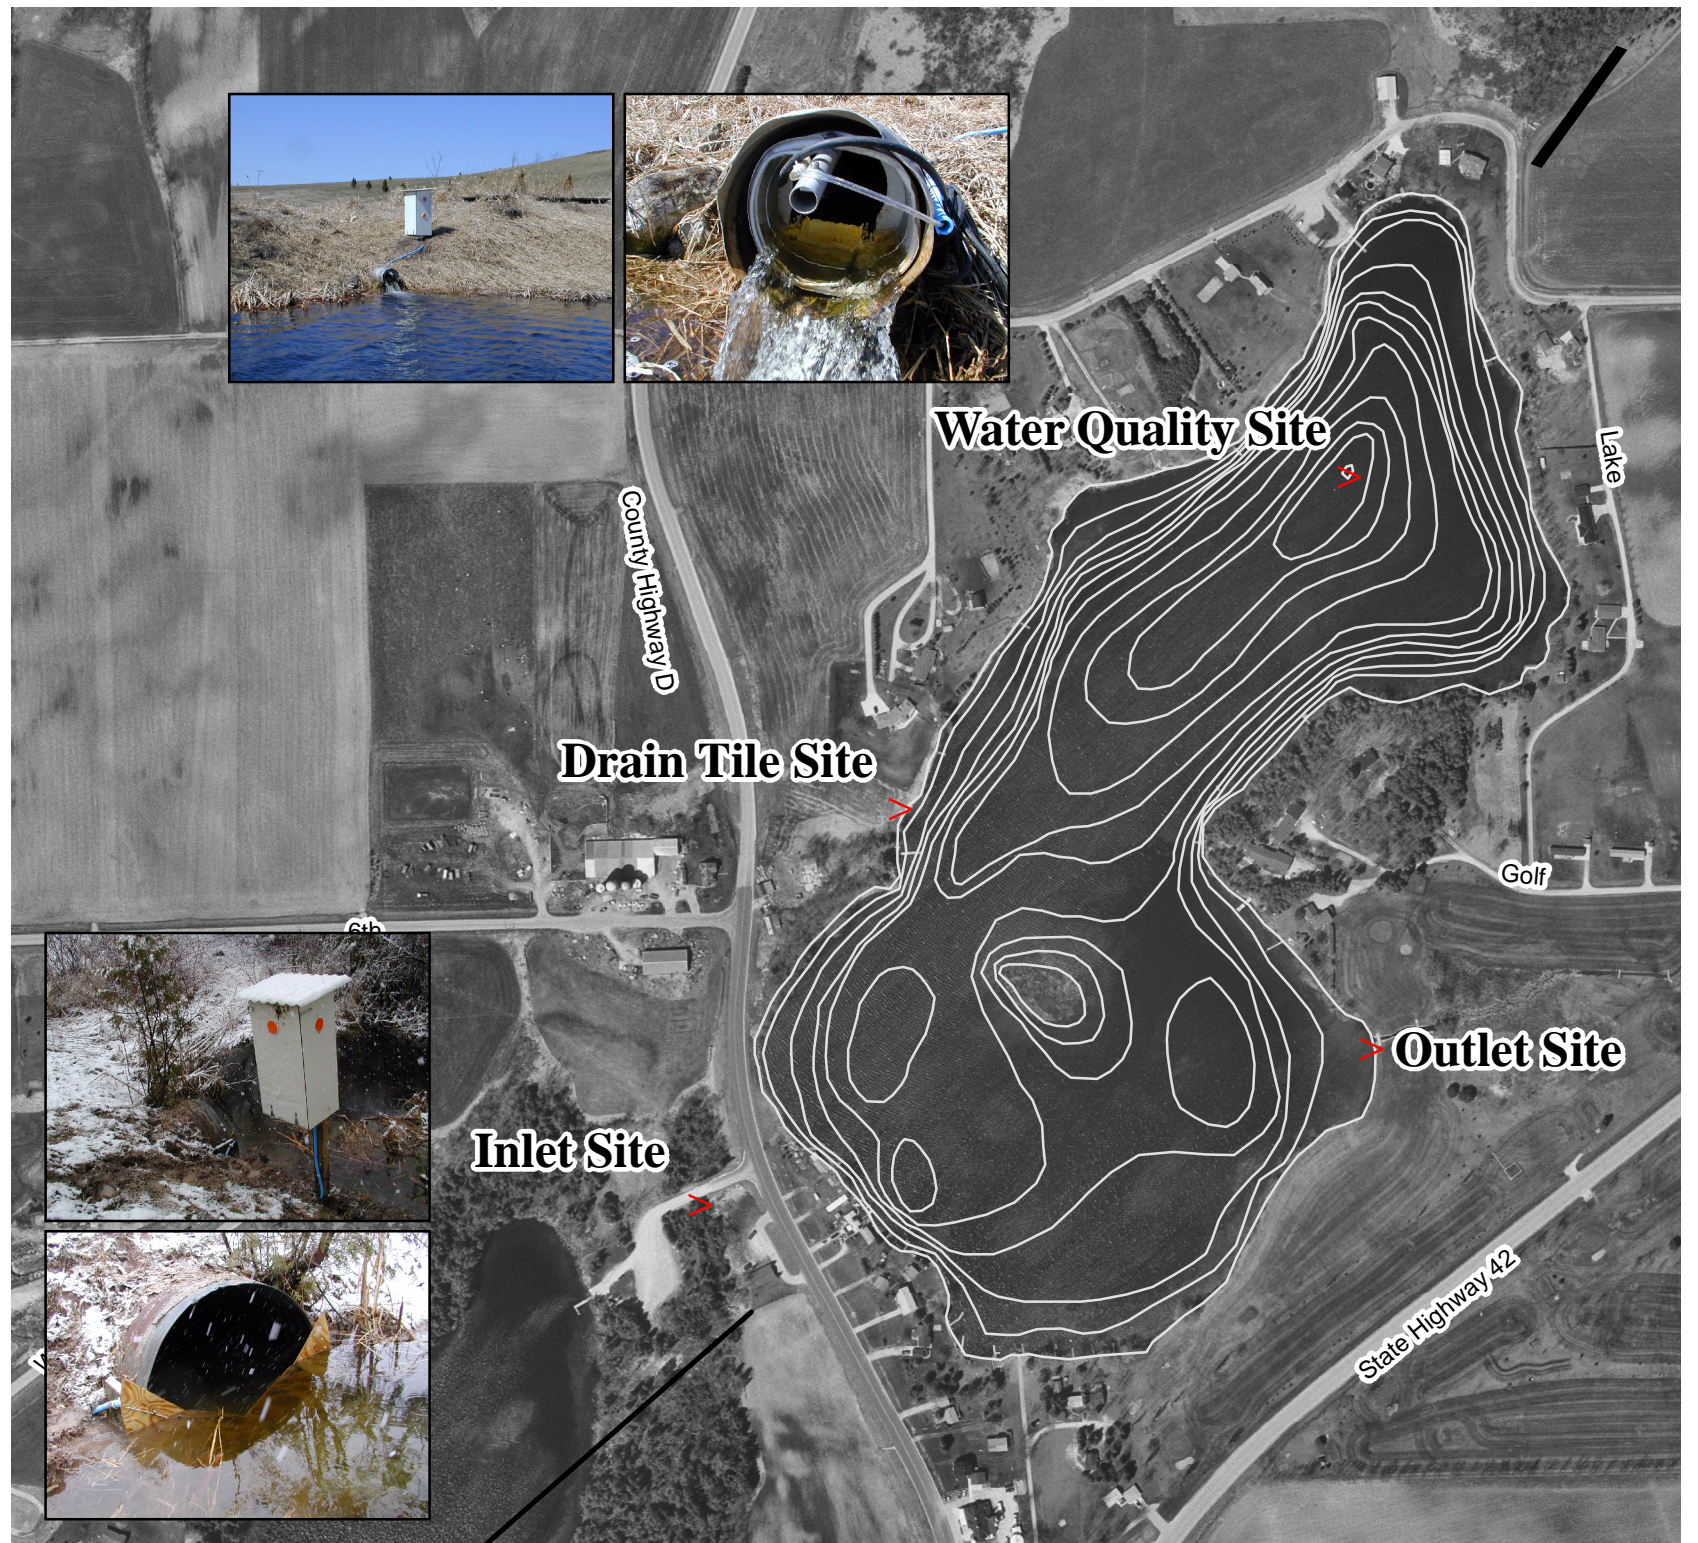
Map 1
East Alaska Lake
Kewaunee County, Wisconsin
Project and Monitoring Site Locations
