FOX LAKE LONG-RANGE AQUATIC PLANT MANAGEMENT PLAN UPDATE (2014-2018)

***THE FOX LAKE INLAND LAKE PROTECTION AND REHABILITATION
DISTRICT AND THE WISCONSIN DEPARTMENT OF NATURAL RESOURCES***

JUNE 15, 2014

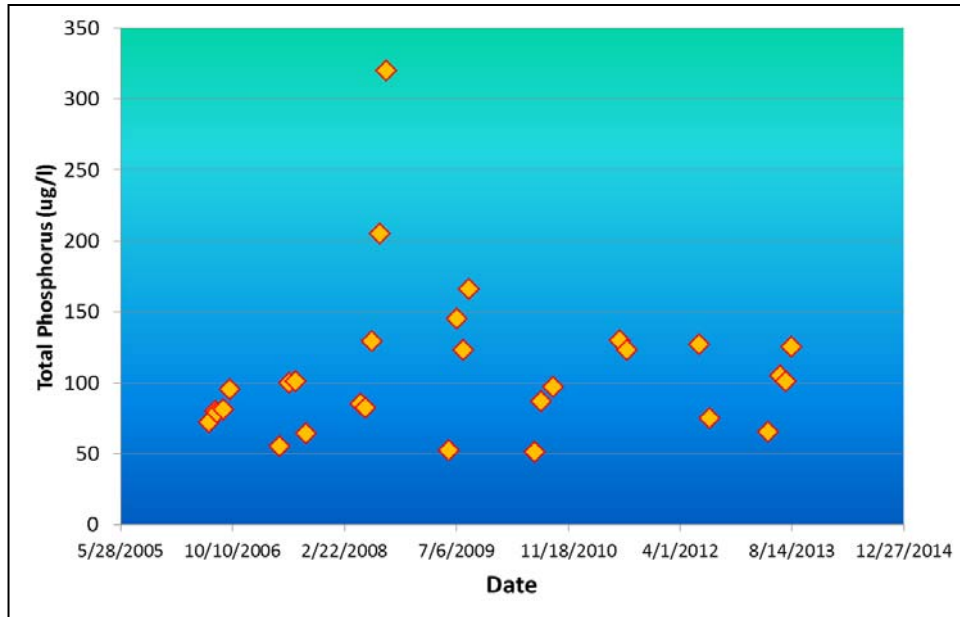
Figure 2-4
 Fox Lake Total Phosphorus
 Source: WDNR

The steady decline of Fox Lake's water quality has been the focus of a number of studies. The studies indicate that Fox Lake is eutrophic to hyper-eutrophic and capable of a rapid transition from a clear water macrophyte dominated ecosystem into a turbid algal dominated system. Typical goals to manage a shallow eutrophic lake in the clear water state require total phosphorus <100ug/l (Scheffer et al. 1993 and Hosper and Meijer 1992). In-lake phosphorus concentrations range from 100 ug/l to greater than 300 ug/l during the summer months from 2006-2013 (Figure 2-4).

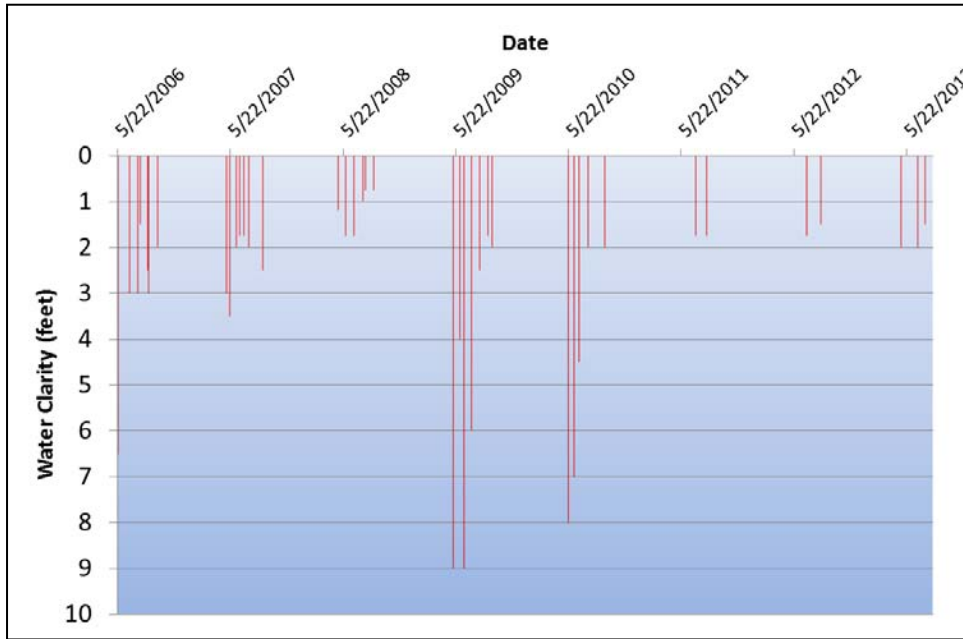
Figure 2-6
Fox Lake Secchi Depth
Source: WDNR

Secchi disk readings from 2006-2013 were generally poor, less than two feet in mid-summer (Figure 2-6). Spring values in 2009 and 2010 did reach as much as 8 and 9 feet, however the lake did not stay clear for the entire summer.

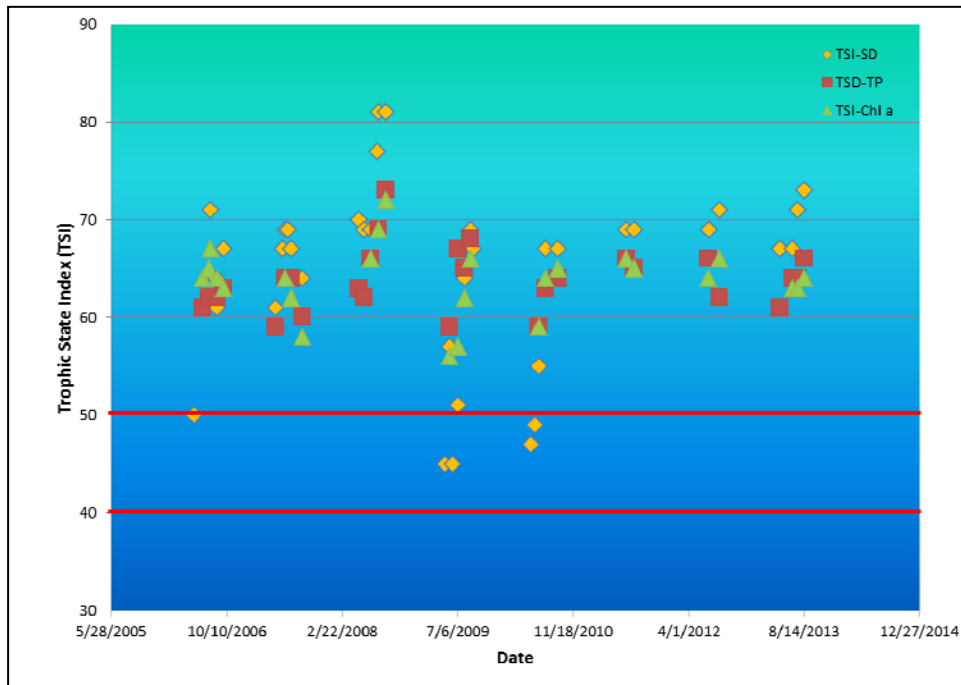
Figure 2-7
Trophic State Index Values 2006 to 2013 Fox Lake
Source: WDNR

Analysis of Trophic State Index values for chlorophyll-a, Secchi disk, and total phosphorus indicate that Fox Lake is eutrophic and that lake turbidity may be due to more than just high algal populations, but may be augmented by suspended sediment from nonpoint source pollution and re-suspension of bottom sediment by wind and bottom feeding fish activity (Figure 2-7).

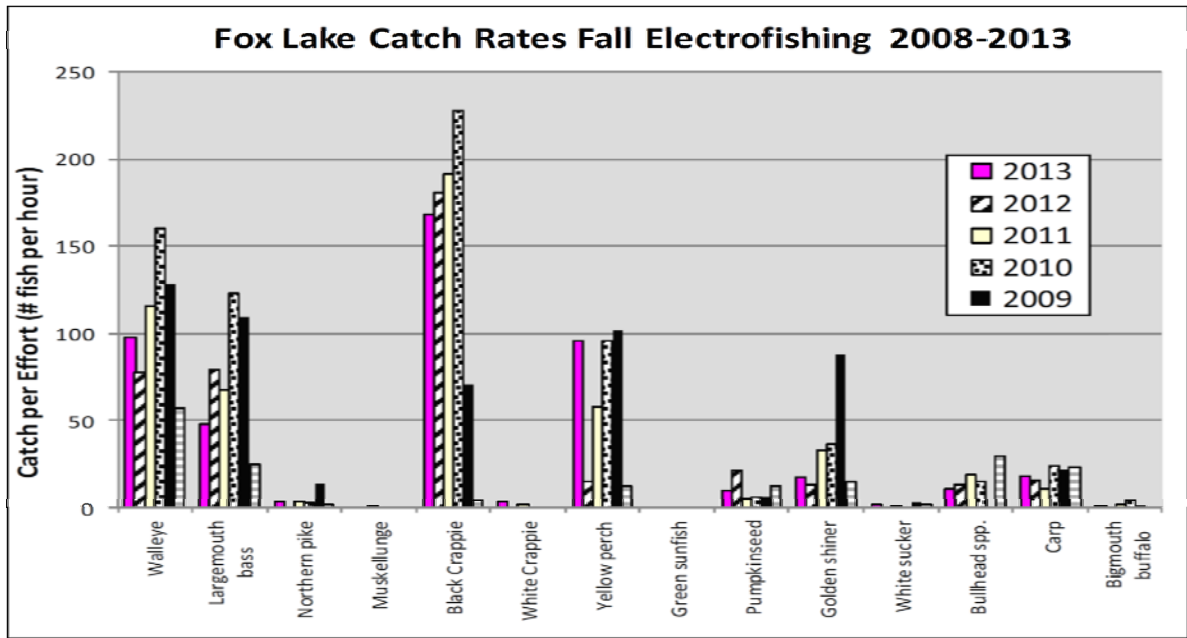
Figure 2-10
 Results of Annual Electrofishing Surveys Fox Lake 2008-2013
 Source: WDNR

The fishery of Fox Lake is samples annually by the WDNR staff from the Horicon area office. The results of monitoring from 2008 through 2013 are illustrated in Figure 2-10. Results for key fish species are summarized in Table 2-7 for 2010 through 2013. The results show a general decline in walleye, largemouth bass and black crappie numbers from 2010 to 2013, a large increase in yellow perch numbers in 2013, and generally low numbers of bullhead and carp.

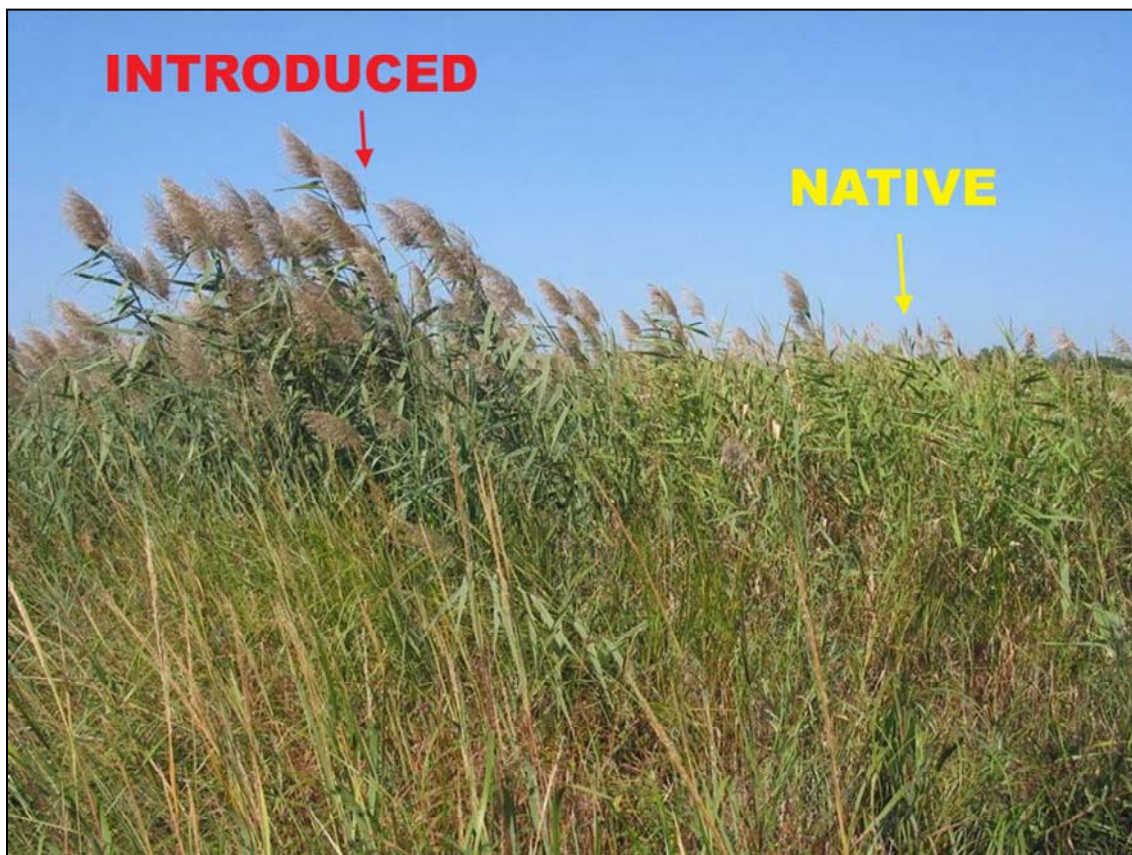
Figure 4-8
Native and Introduced Phragmites

Although it is uncommon, native phragmites can be found in some areas. Before attempting to control phragmites, it is important to identify the native phragmites versus the non-native, invasive variety. Figure 4-8 shows the difference in seed heads between the native and introduced phragmites.
