RE: WVIC Project 2113; 2015 Purple Loosestrife Annual Monitoring Report

**2015 Purple Loosestrife Annual
Monitoring Report**

Wisconsin Valley Improvement Company
2015 Purple Loosestrife Annual Monitoring Report

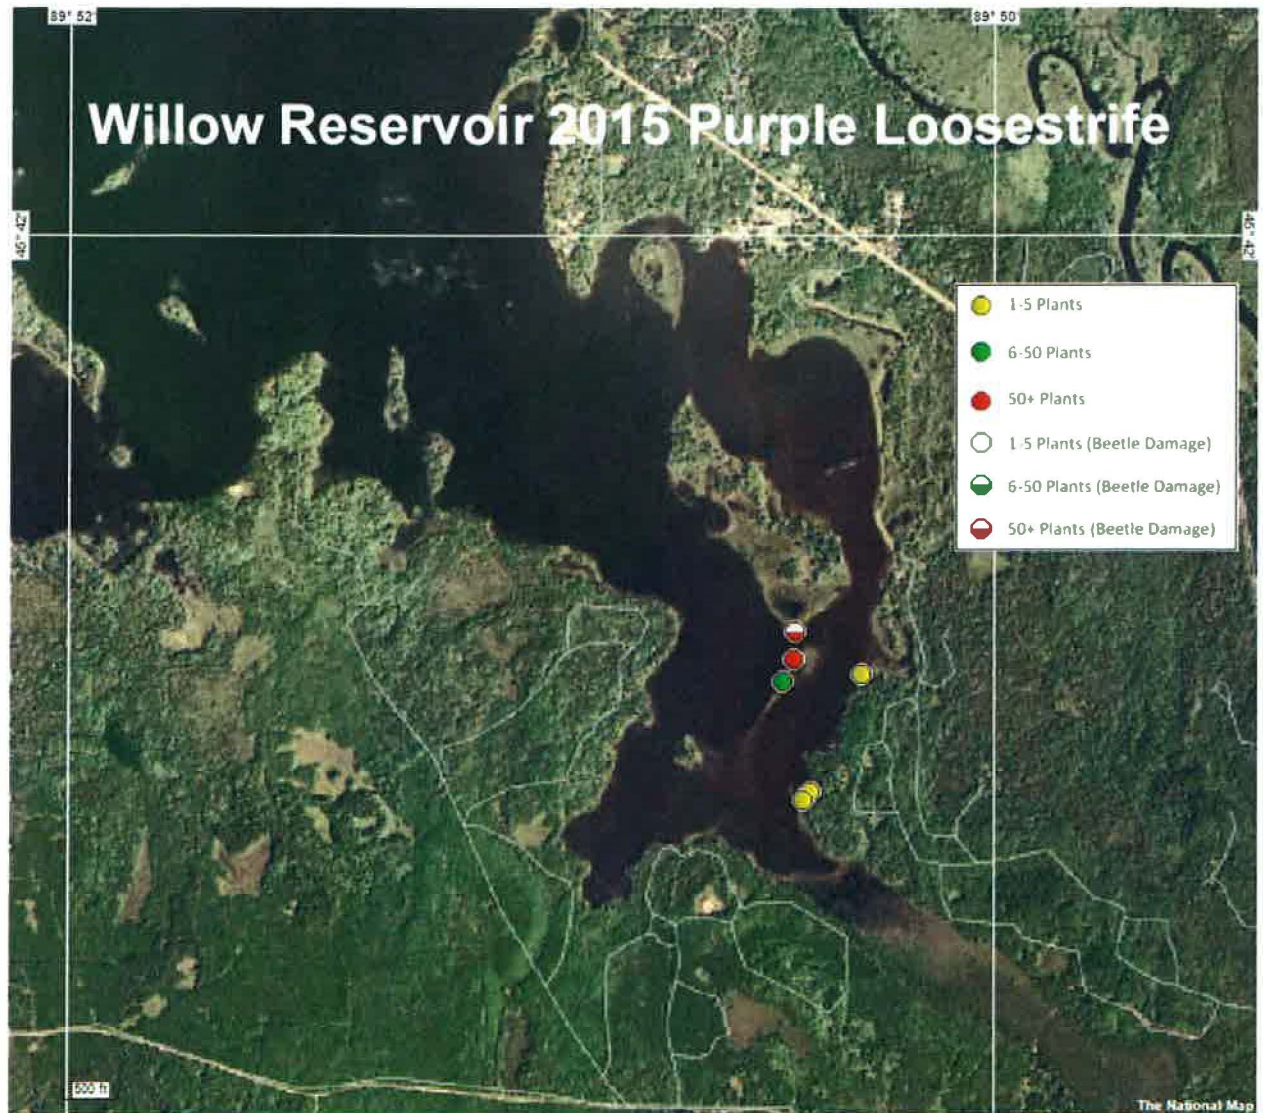
Willow Reservoir – On August 5, 2015 WVIC monitored the area of Willow Reservoir where purple loosestrife (PL) has historically occurred. Reservoir elevation was 1524.66 ft. NGVD (4.69 ft. below full). The area was accessed by boat and then surveyed by walking the islands and exposed shoreline and counting both immature and mature plants. GPS readings were taken every 100 ft. where plants were observed. The relative abundance of PL was recorded as A (1-5 plants), B (6-50 plants), or C (50+ plants). Figure 1 is a distribution and relative abundance map of recorded locations in 2015 and Table 1 lists GPS coordinates for each observation. There were 3 sites of 1-5 plants, 1 site of 6-50 plants, and 2 sites of 50+ plants identified in 2015. PL was not identified outside the historic range at Willow.

Galerucella sp. beetle activity and leaf damage was identified at 1 site with 50+ plants in 2015. Beetle activity had not been observed on the Willow Reservoir in the past although established populations are present in the Tripoli area to the southwest, Rice Reservoir to the southeast and the Minocqua Reservoir system to the northeast, all within 10-12 miles of the site. The percent of plants within the site exhibiting damage from beetle feeding was recorded using a 1-4 scale with the following representative values: 1 (1-25%), 2 (26-50%), 3 (51-75%), or 4 (76-100%). Using the same scale and values, the average level of leaf tissue area removed by beetle feeding per plant within each site was also recorded. Table 1 provides the percent range of plants damaged at the site and leaf tissue removed per plant within the site.
