Lake Management Plan for the Pike Chain of Lakes Price and Vilas Counties, Wisconsin

[Pike Lake Chain includes Pike Lake, Round Lake,
Amik Lake, and Turner Lake]

2003

Prepared by **Steve McComas, Blue Water Science**
with significant contributions from the Pike Lake Chain of Lakes
Association, and Wisconsin Department of Natural Resources

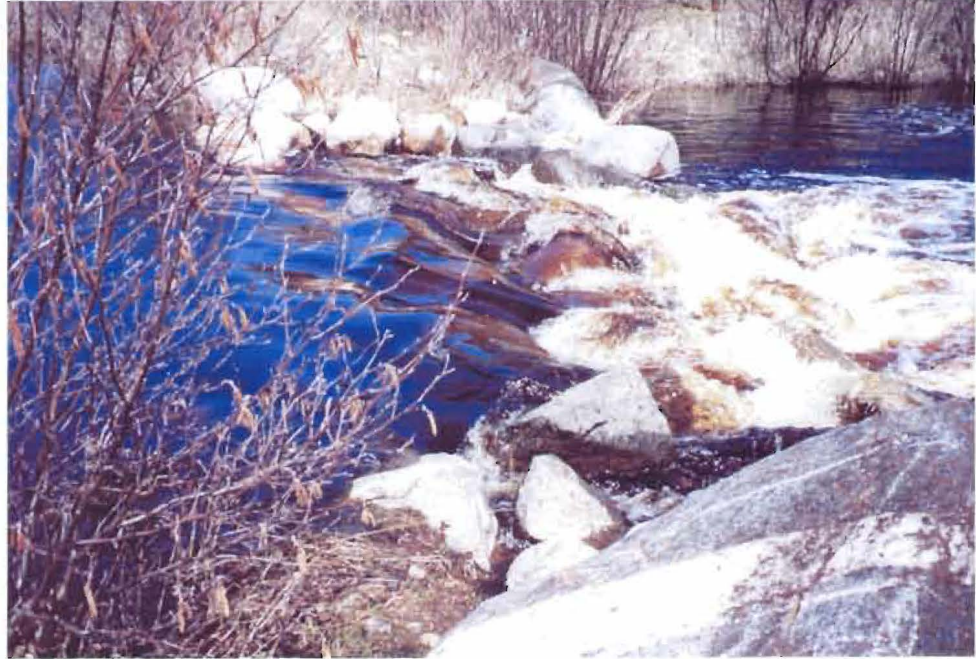
Figure 8. Foulds Creek - April 2001. The creek flows north into Pike Lake with a relatively high flow in spring.

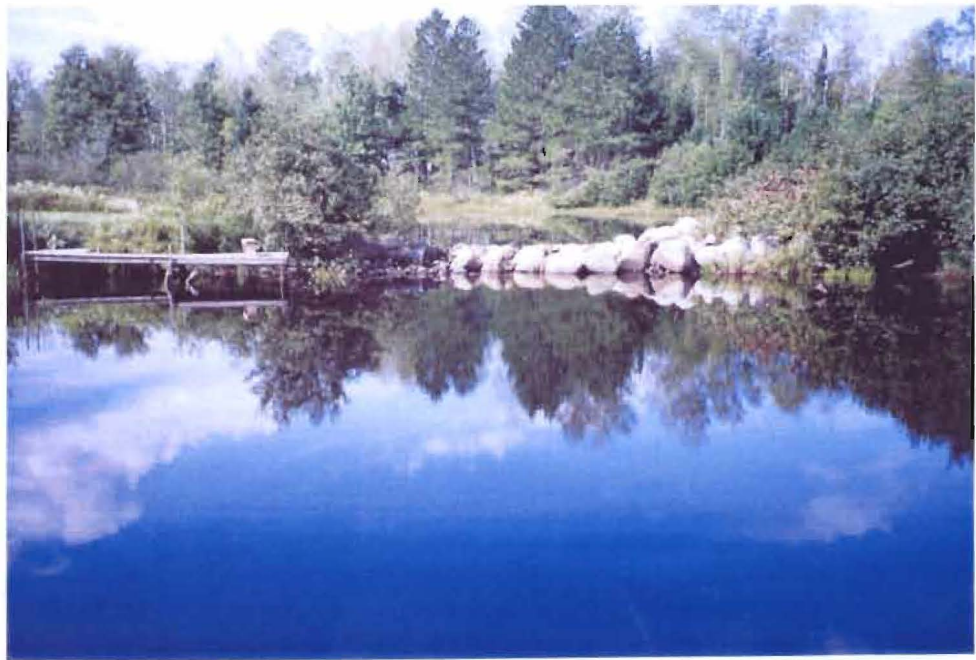
Figure 9. Fould's Creek - September 2001. In the fall, the flow in Foulds Creek is low. The average flow annual flow is estimated at 14 cubic feet per second.

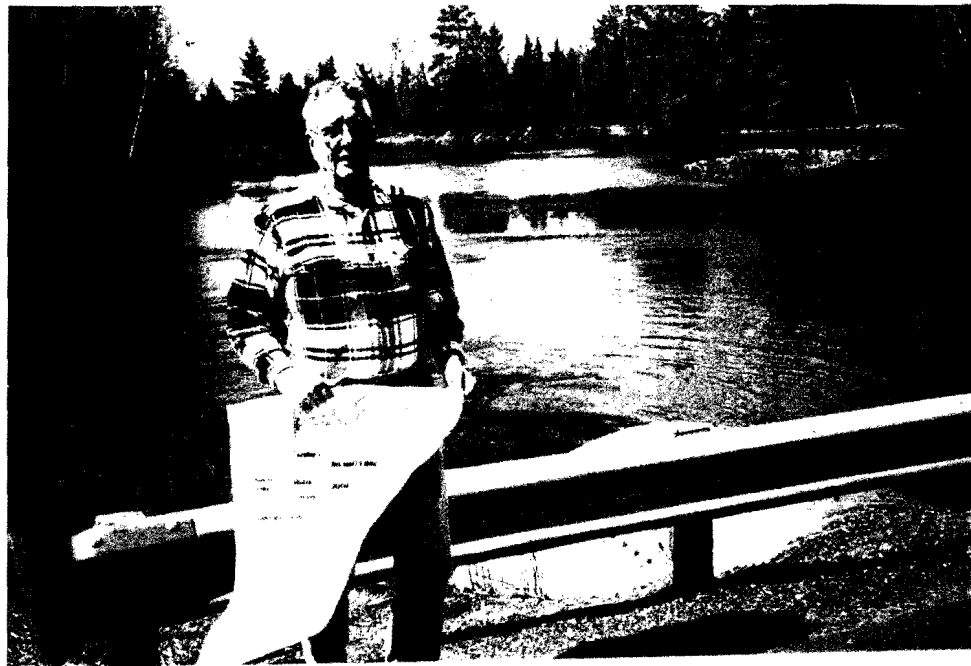
Figure 10. Squaw Creek is a major inflow to Pike Lake.

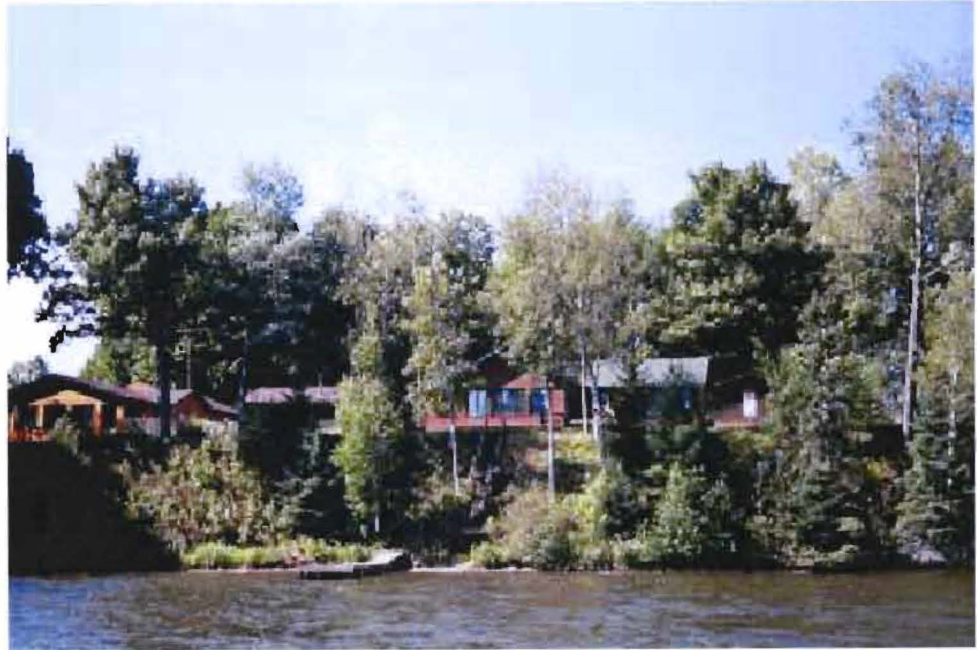
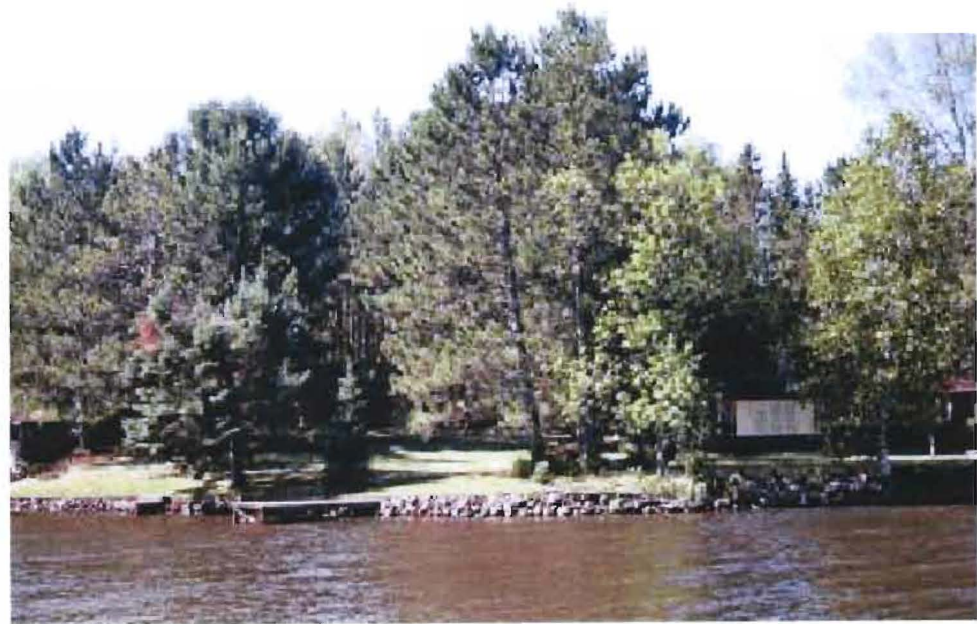
Figure 12. [top] This parcel would rate as having a shoreline with a buffer greater than 50% of the lot width and an understory with greater than 50% natural cover.

[bottom] This parcel would not qualify as having a natural shoreline buffer greater than 50% of the lot width. Also understory in the upland area would be rated as having less than 50% natural cover.

For each photograph we looked at the shoreline and the upland condition. Examples of shoreland conditions are shown in Figure 13. Our criteria for natural conditions were the presence of 50% native vegetation in the understory and at least 50% natural vegetation along the shoreline in a strip at least 15 feet deep. We evaluated shorelands at the 75% natural level as well.

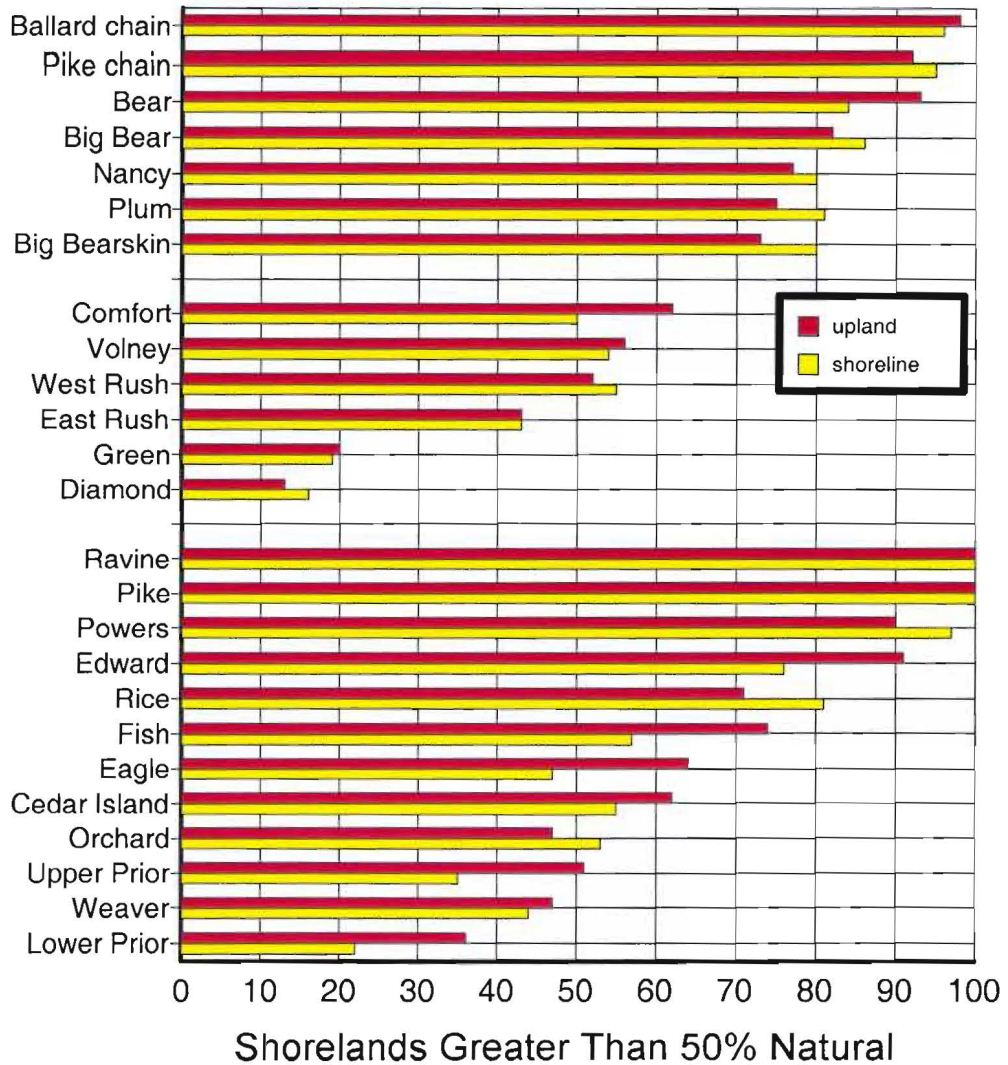
Figure 13. A summary of shoreland inventory results for lakes using an evaluation based on shoreland photographs. For each lake the percentage of shoreline and upland conditions with greater than 50% natural conditions is shown. The first tier of lakes are located in northern Wisconsin. The lower tier of lakes are in the Twin City Metropolitan area and are considered urban lakes. Although several lakes are “urban” lakes most of the shoreland is owned by the city and there is a high percentage of natural conditions. The middle tier of lakes are about an hour’s drive from the Twin Cities, and are not considered to be urban lakes, they are “country” lakes.

A summary of the inventory results is shown in Table 7. Based on our subjective criteria over 95% of the parcels in the Round, Amik and Turner, Pike Lakes shoreland area meet the natural rankings for shorelines and upland areas. This is good for a lake in northern Wisconsin. However in the next 10 years there could be pressure to reduce natural conditions. Proactive volunteer native landscaping should maintain existing conditions and improve other parcels.

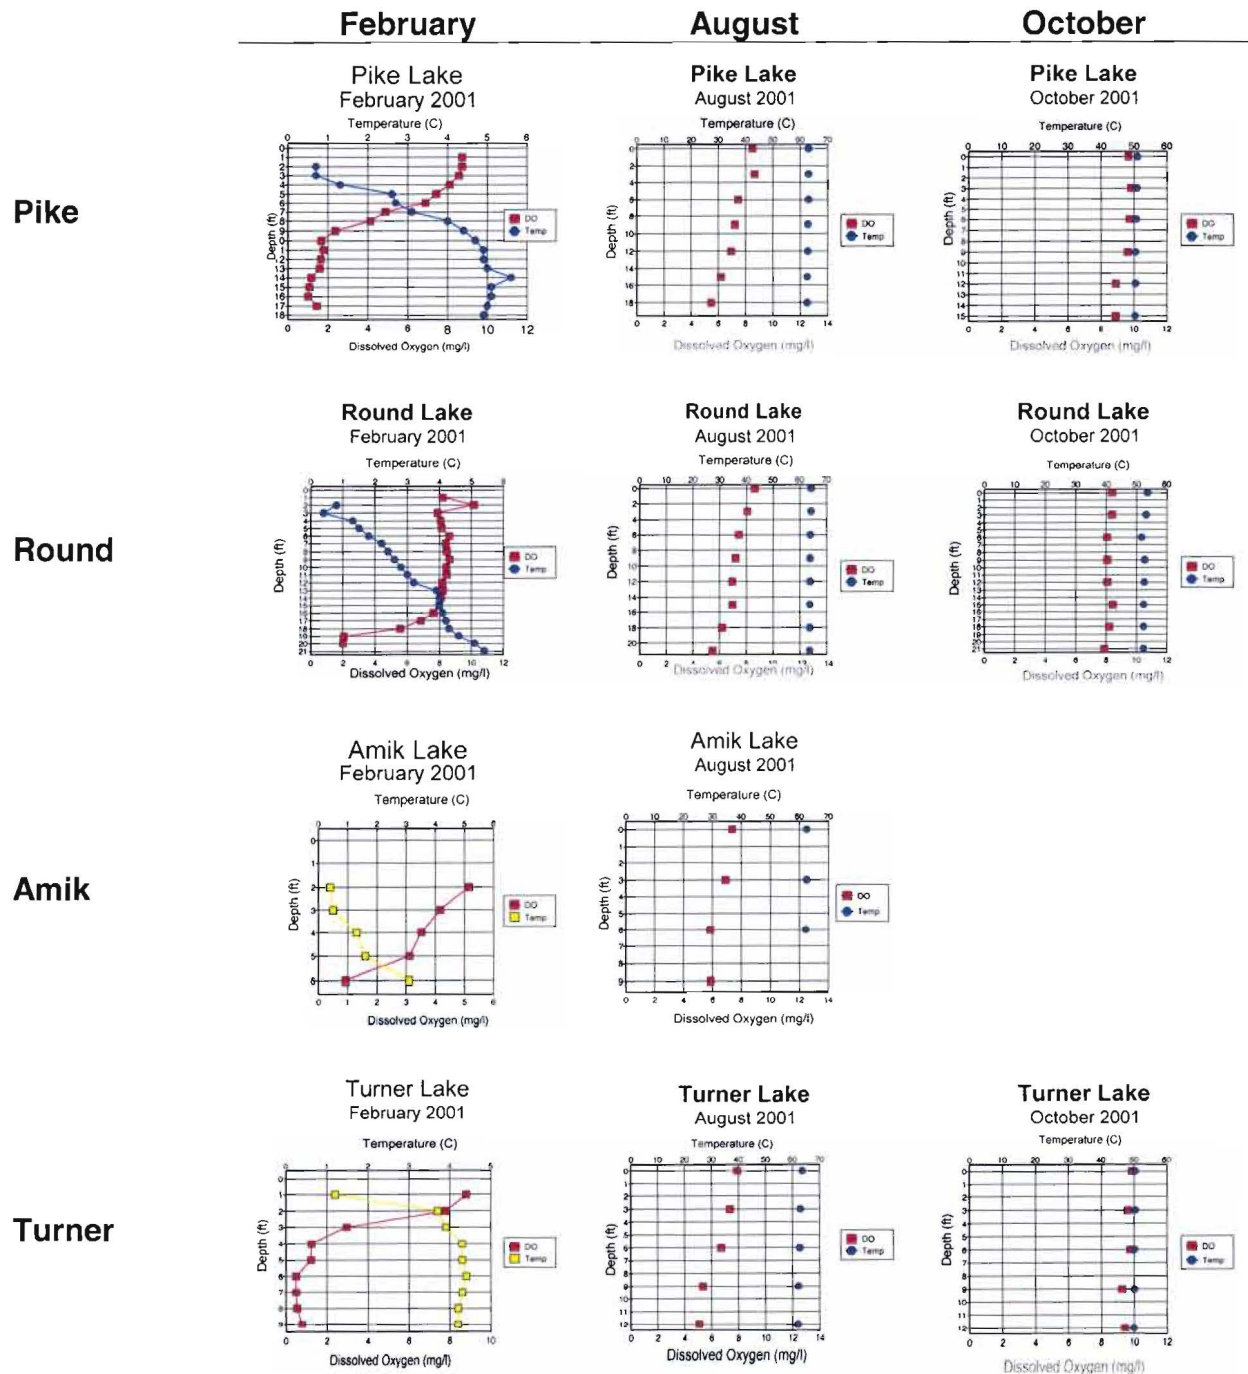
Figure 16. Dissolved oxygen/temperature profiles for Pike, Round, and Amik and Turner Lakes.

Winter oxygen levels can be low in the bottom water of all four lakes, however oxygen is present in the upper water column. In summer, the lakes are well mixed and oxygen is present throughout the summer.

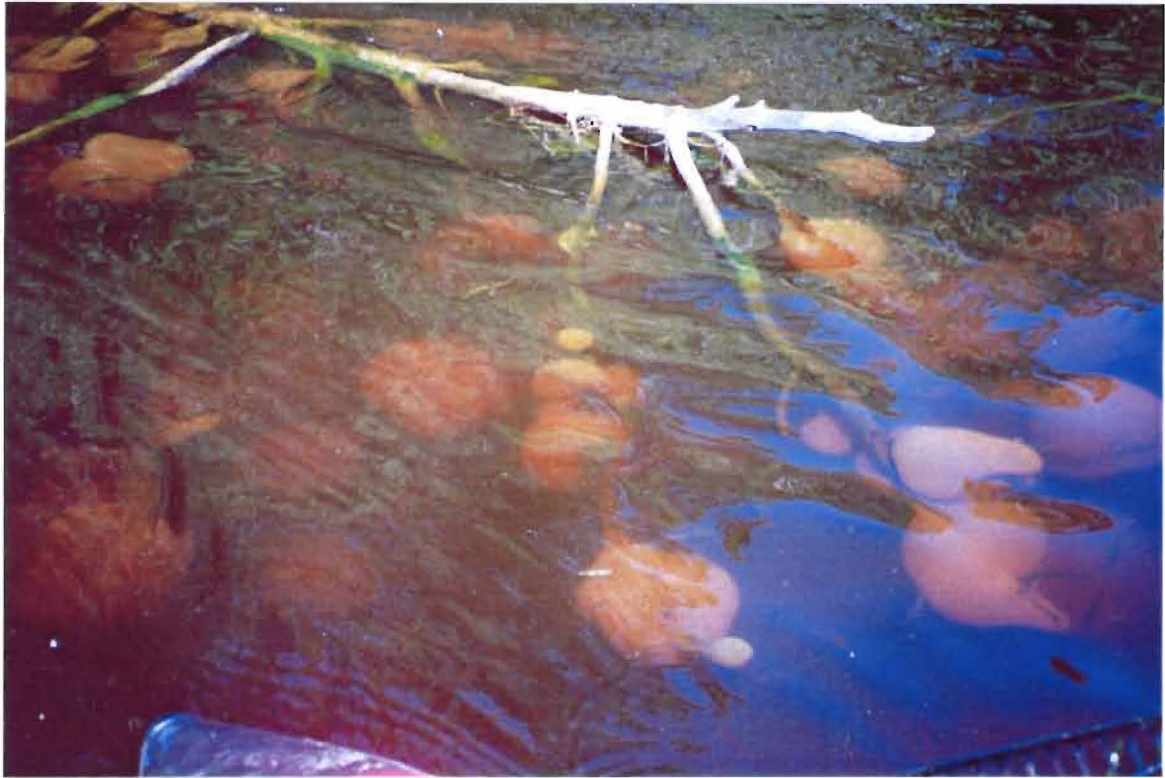
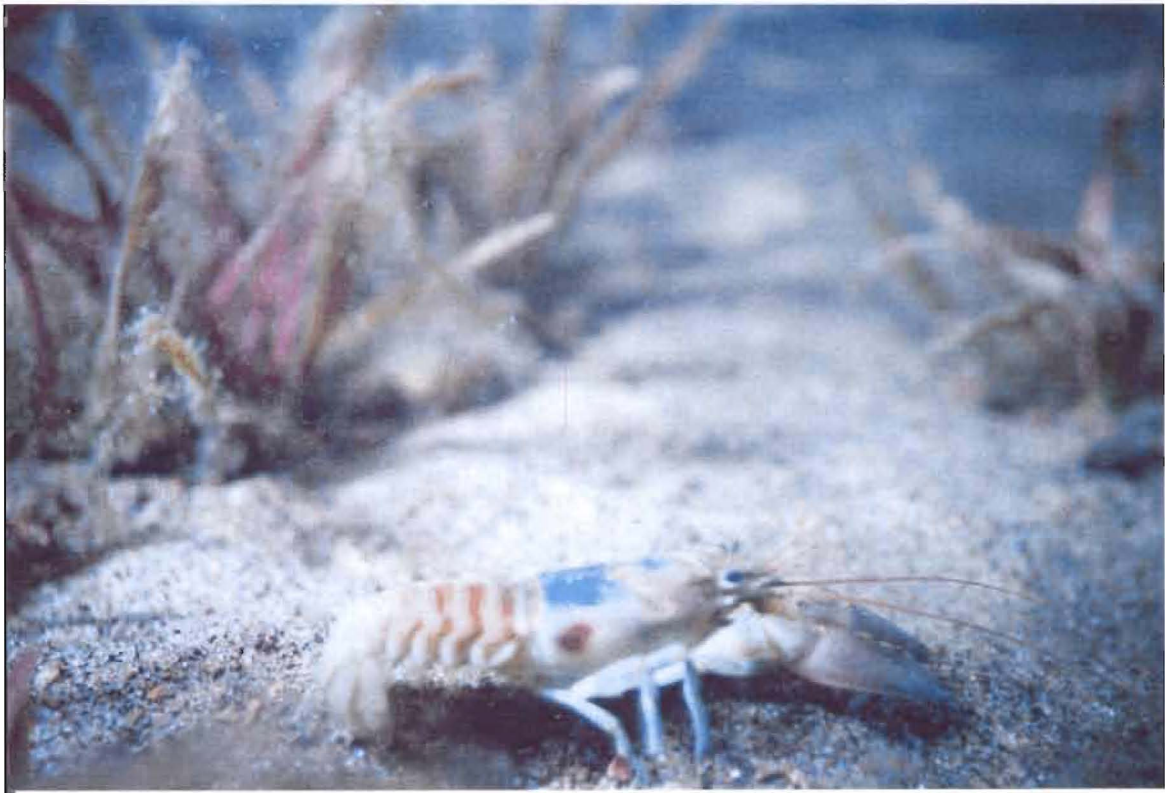
Figure 23. [top] Bryozoan colonies found in Amik Lake, August 4, 2001.
[bottom] Rusty crayfish like the one shown above have been found in Round Lake.

However, there are a couple of invertebrates surprises. In Amik Lake, a colony of bryozoans is present. They are attached to tree branches and can grow to the size of a basketball, but a cantaloupe size is more common in Amik (Figure 23).

There is also a report of rusty crayfish in Round Lake. They are regional exotics and not desirable for a lake. They can decimate plant beds. They will be monitored in the future as one of the lake management recommendations.

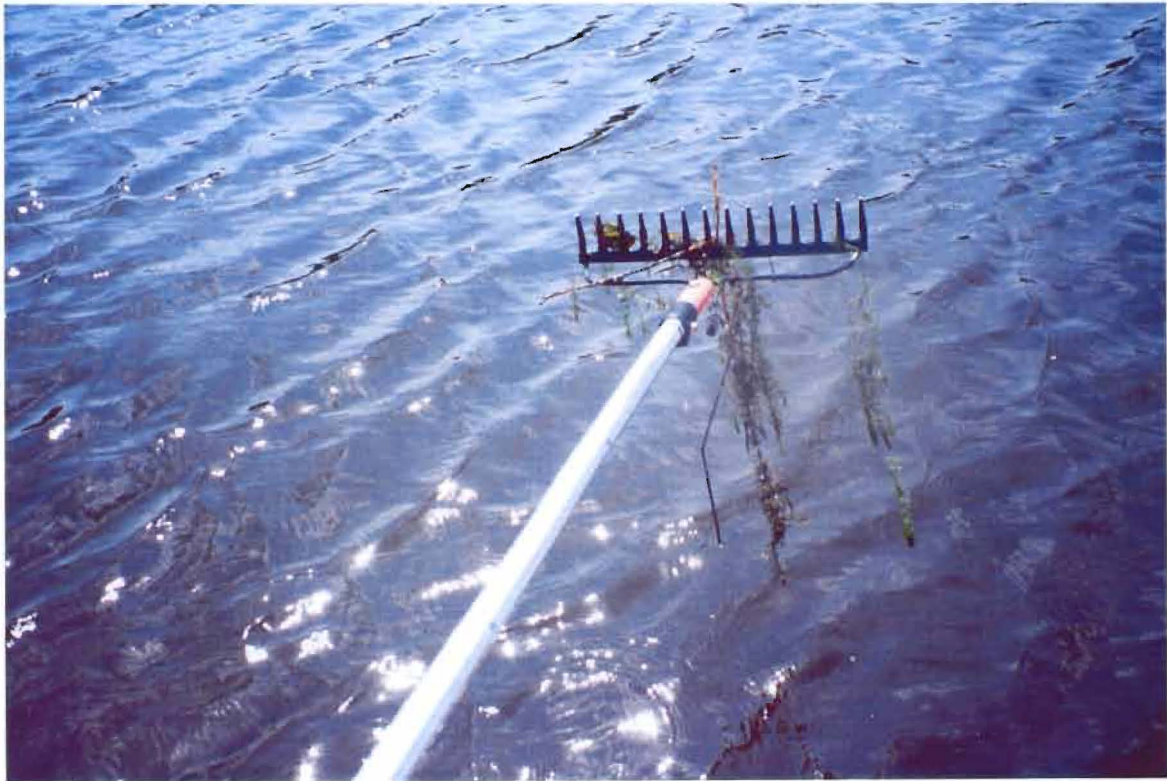
Figure 24. Coontail, a native, non-rooted plant was found in low densities in Pike Lake, June 2001, but found in high densities in Amik Lake.

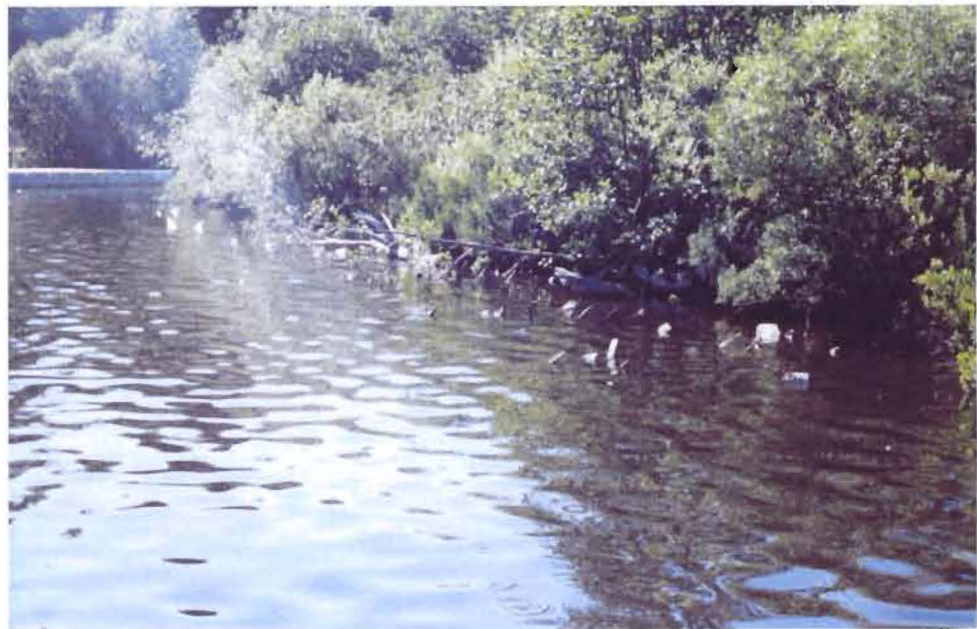
Figure 25. Discarded wooded slabs from the sawmill operation are still found in a southern bay of Pike Lake.

A unique feature of Pike Lake is the bottom covering of wooden slabs in the north shore of the southern bay. They were discarded into the bay during the sawmill operation. No aquatic plants were found (Transect 10 on the map, Figure 27), but they offer some habitat for fish and invertebrates.

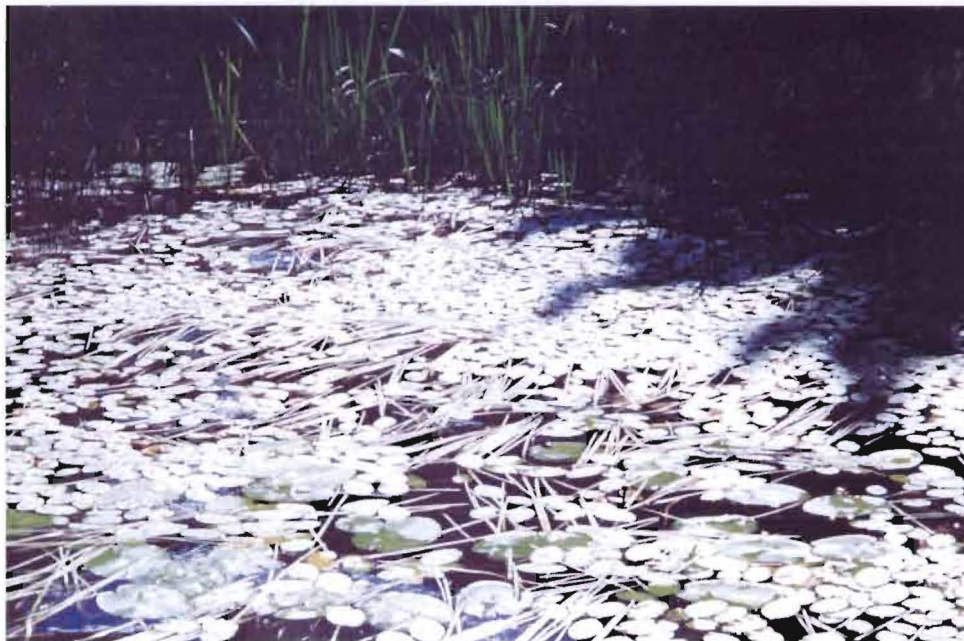
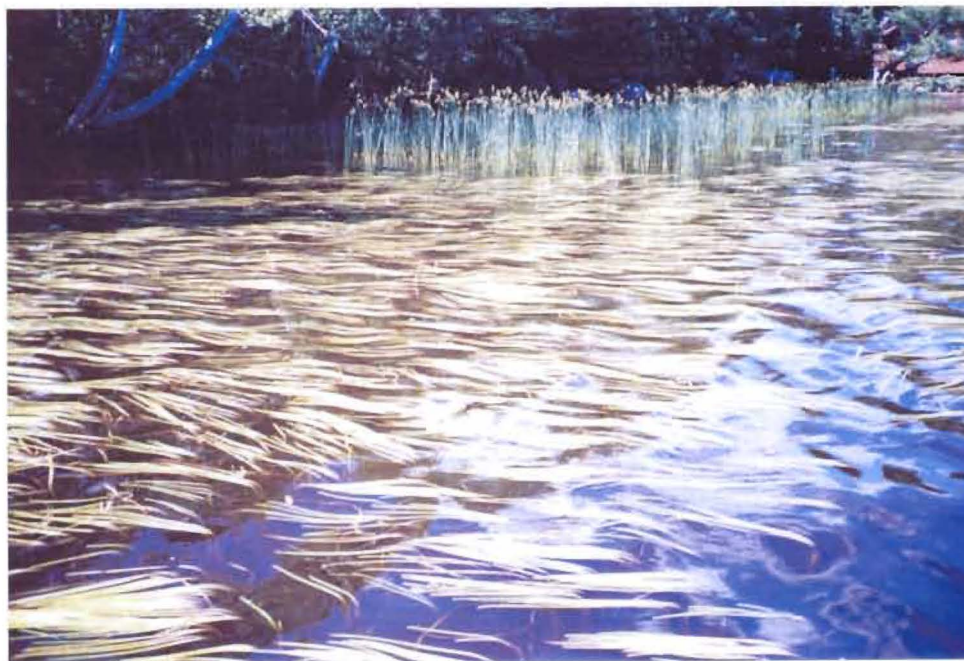
Figure 26. Examples of floatingleaf plants in Pike Lake consisting of watershield and Sparganium on July 26, 2001.

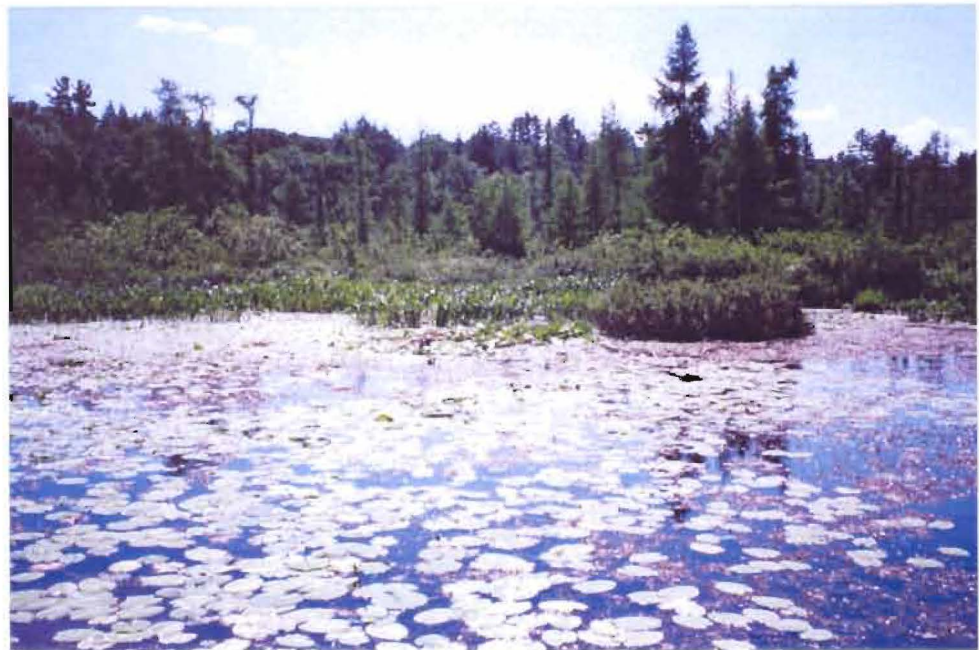
Figure 30. Nearshore growth of aquatic vegetation in Amik Lake, July 2001.

Amik Lake has a rich plant community with over 17 species of floatingleaf and submerged plants. Coontail was the most common species followed by a half dozen other species. Amik Lake is shallow and plant growth can be found throughout the lake, but generally scattered. Plant growth is robust along the nearshore areas (Figure 30).

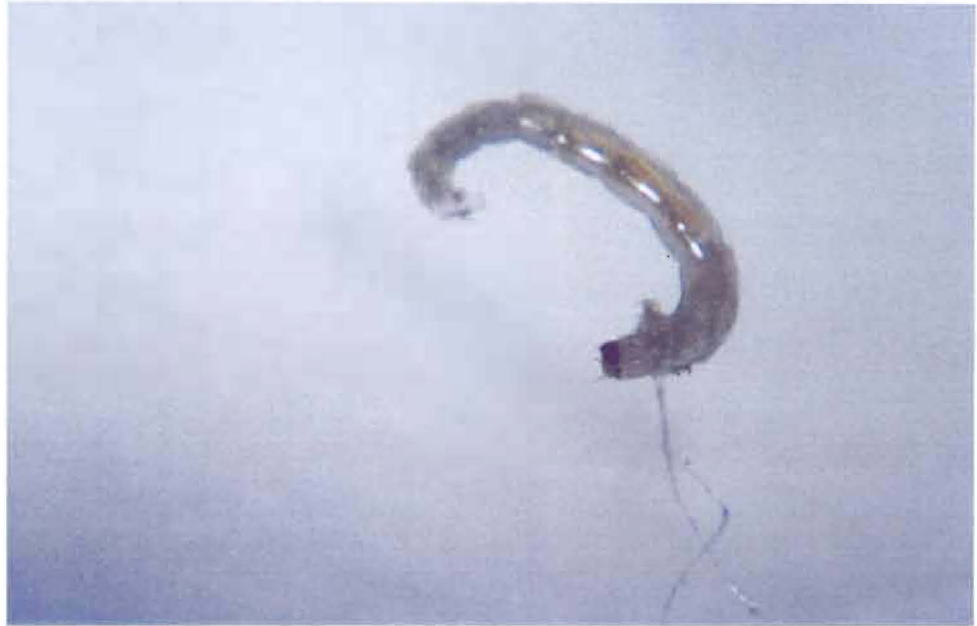
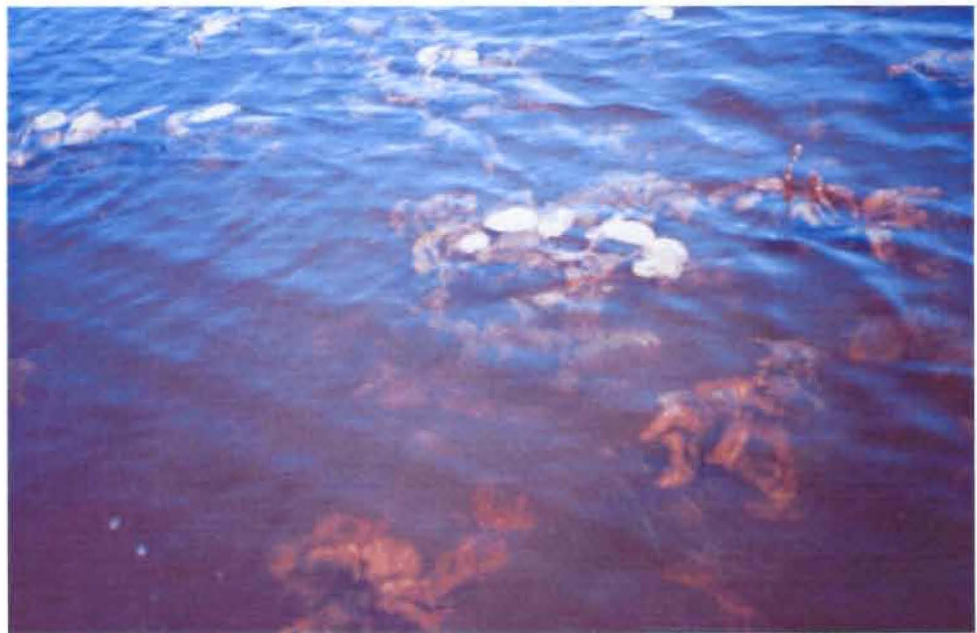
**Figure 31. [top] This chironomid species was found on the underside of cabbage leaves in Amik Lake in 2001.
[bottom] At the time of the plant survey on July 26, 2001, much of the cabbage community was found scattered and not at nuisance densities.**

An interesting plant species in Amik Lake is cabbage (*Potamogeton amplifolius*). In 2000 it was reported to cover almost the entire lake basin. However, in 2001, cabbage was present, but scattered. It had the appearance of a die-back. Upon inspection of leaves and stems, we found that aquatic insect larvae were apparently feeding on the leaves and stems of the cabbage probably causing the die back. Its possible this insect could be responsible for controlling the excessive growth of cabbage (Figure 31).

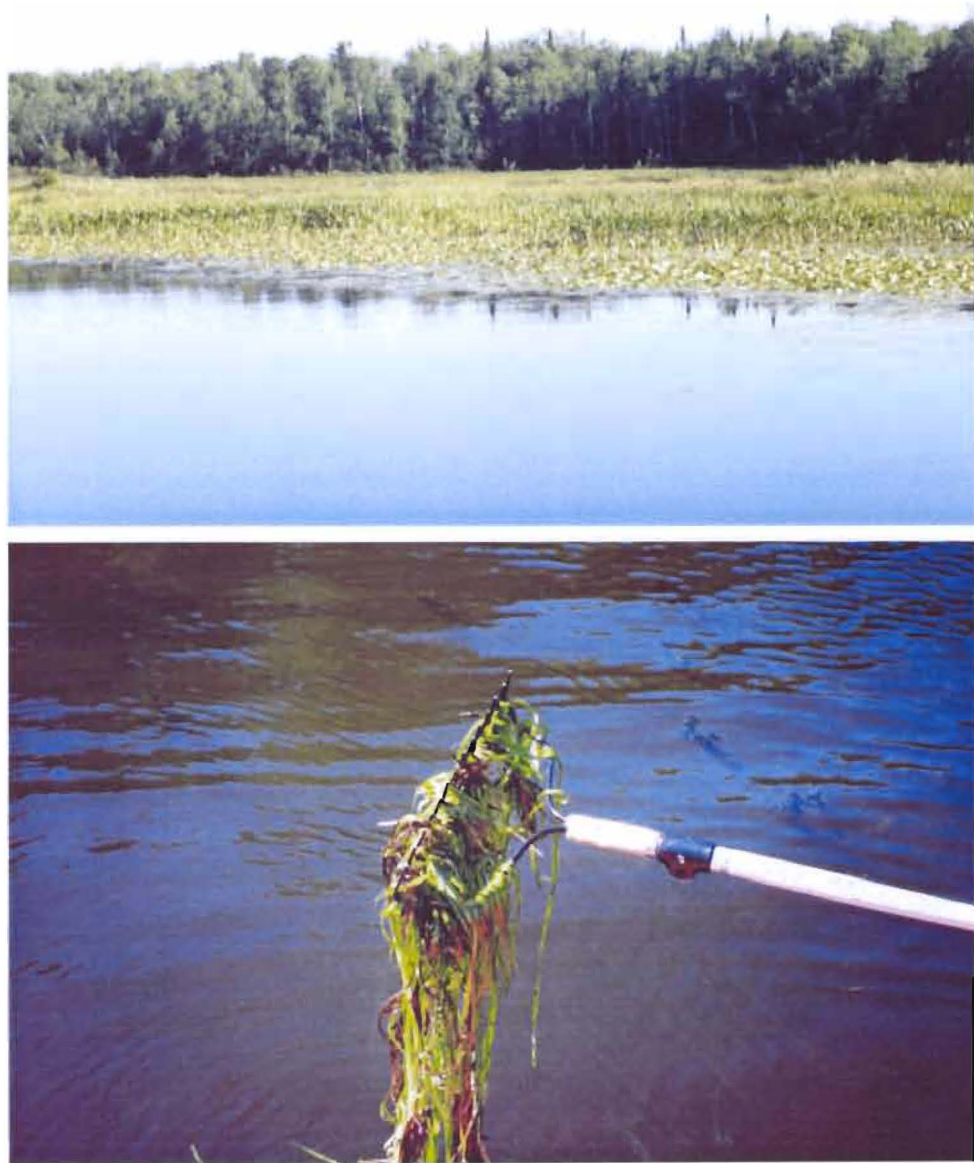
Figure 33. [top] Nearshore vegetation in Turner, on August 4, 2001.
[bottom] Water celery and elodea collected during the plant survey on Turner Lake in 2001.

Turner Lake has a diverse aquatic plant community dominated by fern pondweed, followed by water celery, and several other species (Figure 33). Plant growth goes out to about 7 feet of water depth. Slightly better than Pike and Round Lakes. Plant coverage is shown in Figure 34.

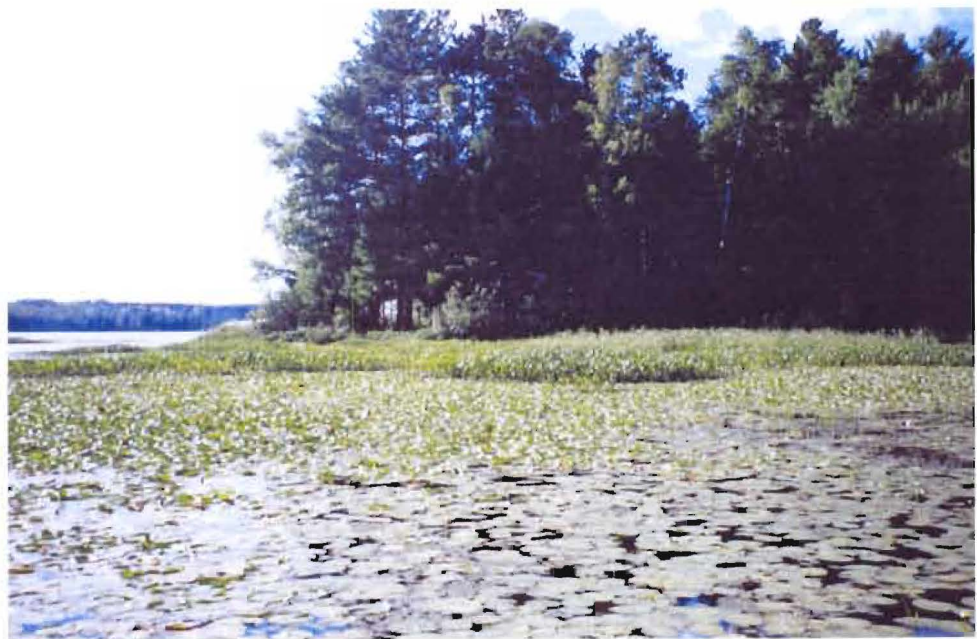
Figure 35. Floating leaf plants (mostly water lilies) and emergent vegetation along the shoreline somewhere on the Pike Chain.

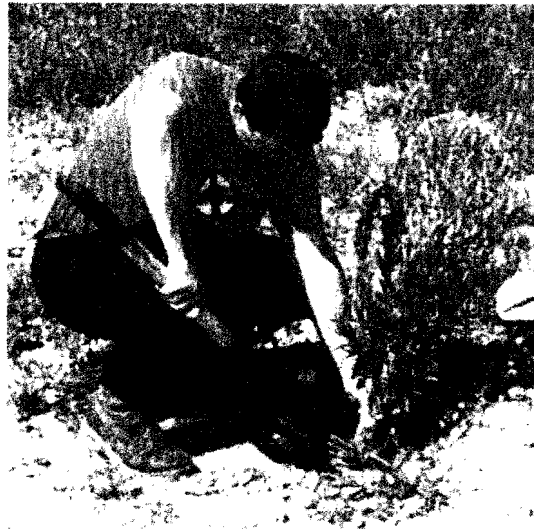
For stubborn, mature purple loosestrife plants, a fork or spade will ease out the root. (From Ontario Federation of Anglers and Hunters, Peterborough, Ontario, with support from several other organizations. With permission.)

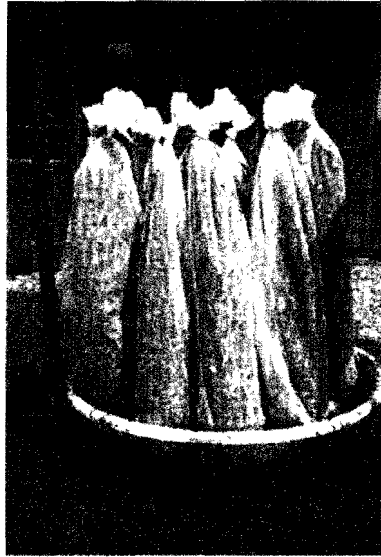
*The Wisconsin Department of Natural Resources and other groups sponsor starter kits for growing the loosestrife leaf-eating beetle (*Galerucella pusilla*). The beetles are raised in large quantities in controlled conditions on loosestrife plants under the netting and then are released into the problem loosestrife patch in the wild.*

In particular, research found a European leaf eating beetle (*Galerucella pusilla*), that fit the criteria for a biological control agent: it was host specific (fed and survived exclusively on purple loosestrife, as far as is known) and caused significant damage to purple loosestrife. In some areas starter kits are available to rear and then release these beetles. Hopefully, these beetles will not become a problem themselves.

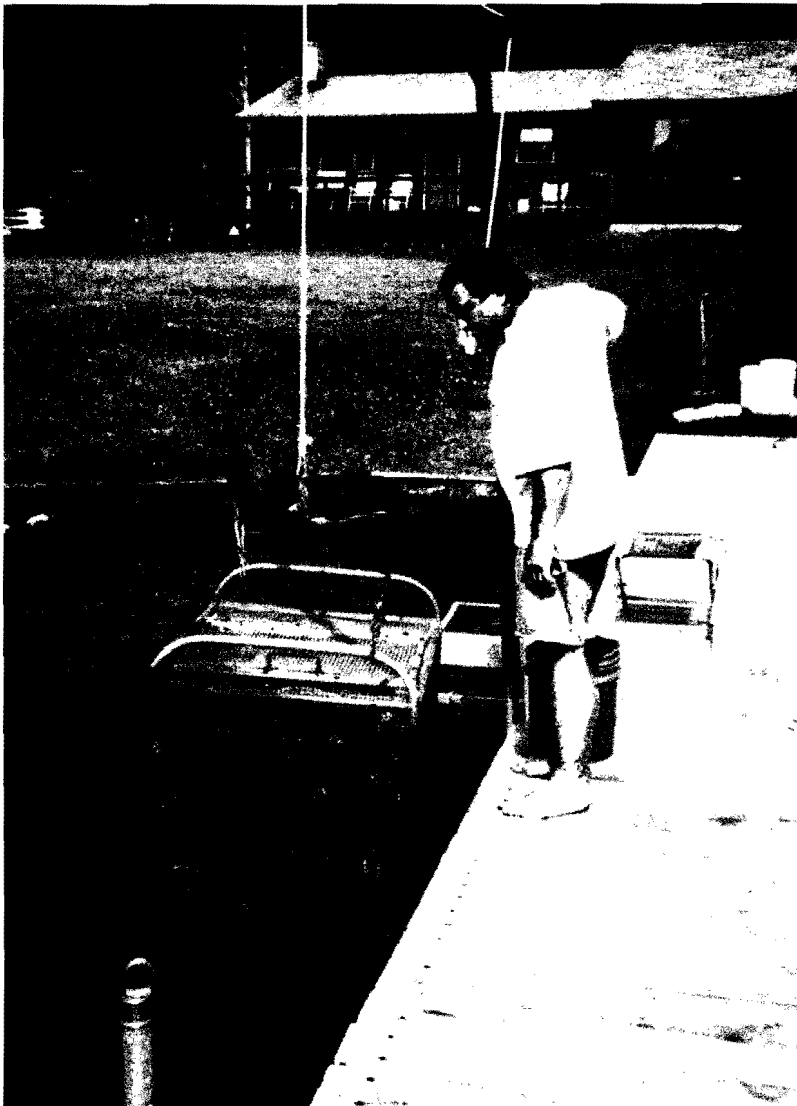
Figure 29. [top] Big Bearskin crayfish traps are ready to go into the lake. Pike Lake Chain volunteers could make and install traps as well. [bottom] Roger Soletski, Big Bearskin Lake, checks the crayfish holding cage at Big Bearskin. The larger crayfish can be sold.

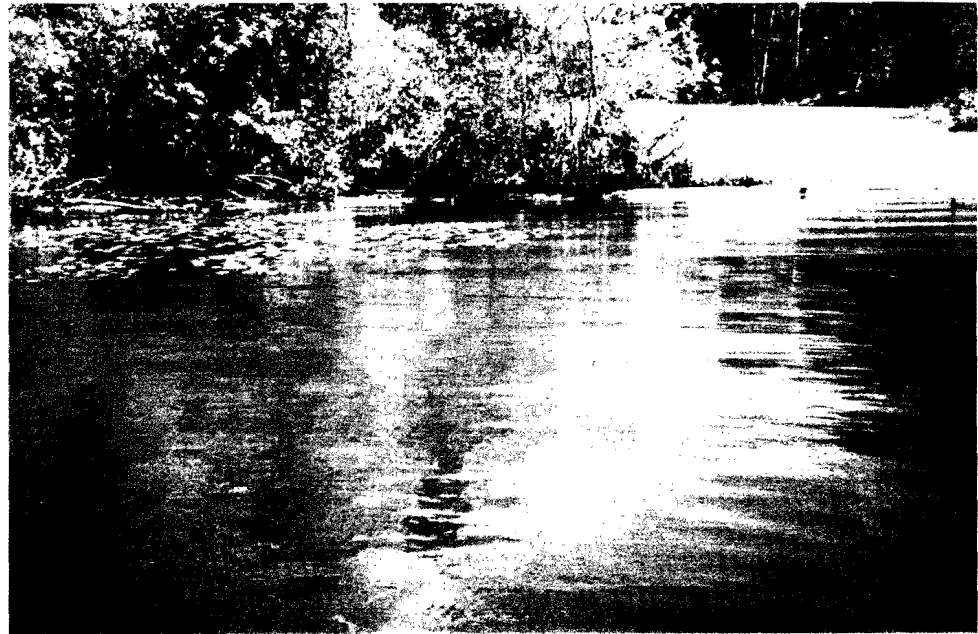
Round Lake has patches of aquatic plants but could use more.

Emergent plants in the Pike Lake Chain are fairly common and submerged plants in Amik are adequate. However, the challenge is to increase submerged aquatic plants in Round and Pike Lakes. Several plant improvement ideas are given below:
