SUBJECT: Unnamed Tributary to Kriwanek Creek (Maribel WWTF)

Overview

On November 24, 2021, I conducted a site visit to the stream that receives the Maribel WWTF discharge (WBIC 3000159) and Unnamed Tributary (WBIC 5021595). This site visit was initiated due to correspondence with Nicole Krueger, WDNR, regarding the appropriate classification of Unnamed Tributary WBIC 3000159. Previous DNR memos classified the stream as limited aquatic life (LAL), however the stream was not codified as LAL.

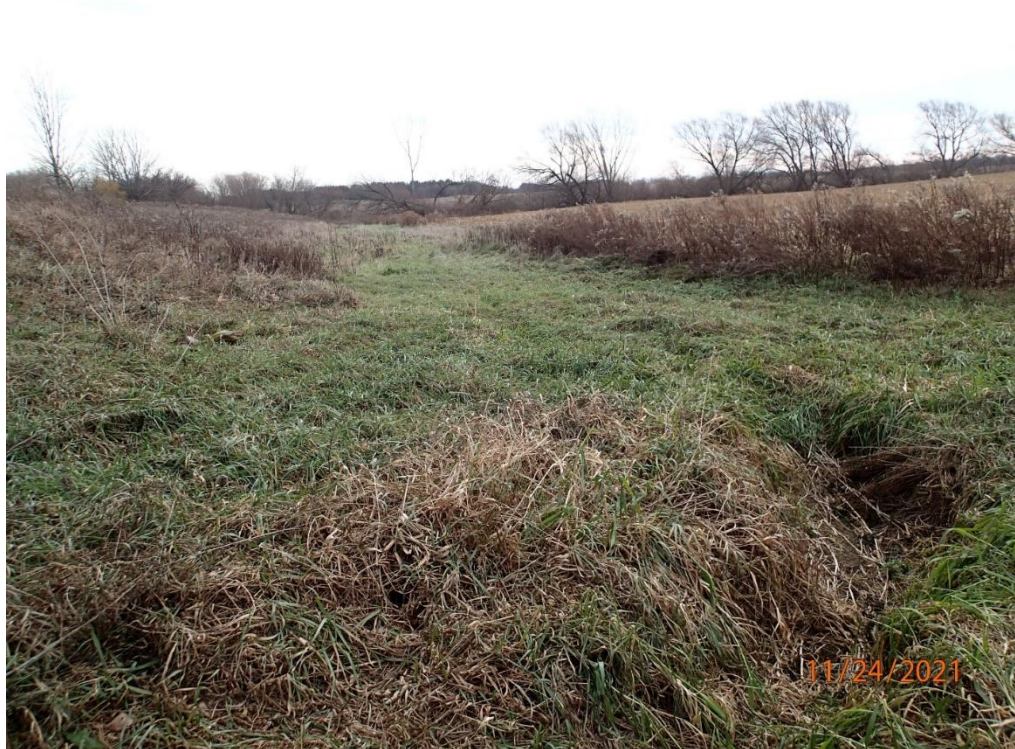
- There was no stream flow at Pleasant Rd directly west of Maribel WWTF (WBIC 3000159). Site and photo #1.
- The stream was flowing upstream of the WWTF at the corner of Pleasant Rd and Hidden Valley Rd (WBIC 5021595). Stream was about 6 inches deep and 2 feet wide. Site and photo #2.

Site #1. Upstream WWTF WBIC 3000159 Pleasant Rd facing east

- Based on my observations, I believe the stream is LAL. I do not believe the stream has the potential to support fish. However, I would recommend an appropriately timed fish survey be conducted to document if fish are present.
- Fish surveys and natural community verifications should be conducted on the Unnamed Tributaries WBIC 3000159 and WBIC 5021595.

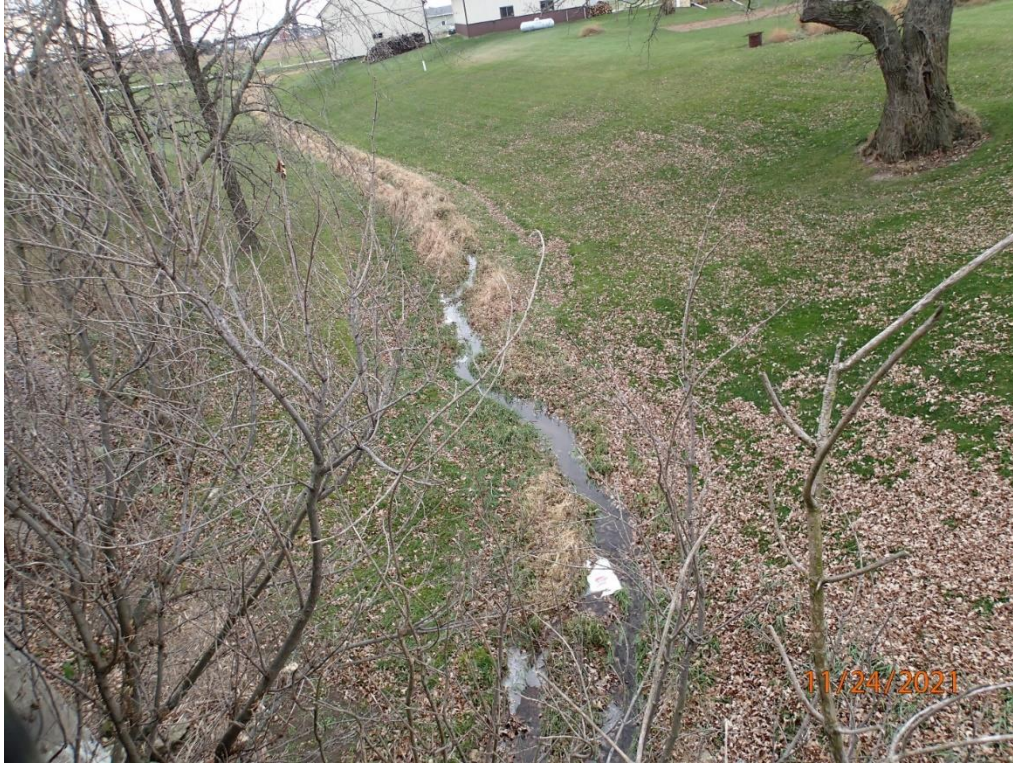
Site #2. Downstream of Hidden Valley Rd WBIC 5021595 facing south

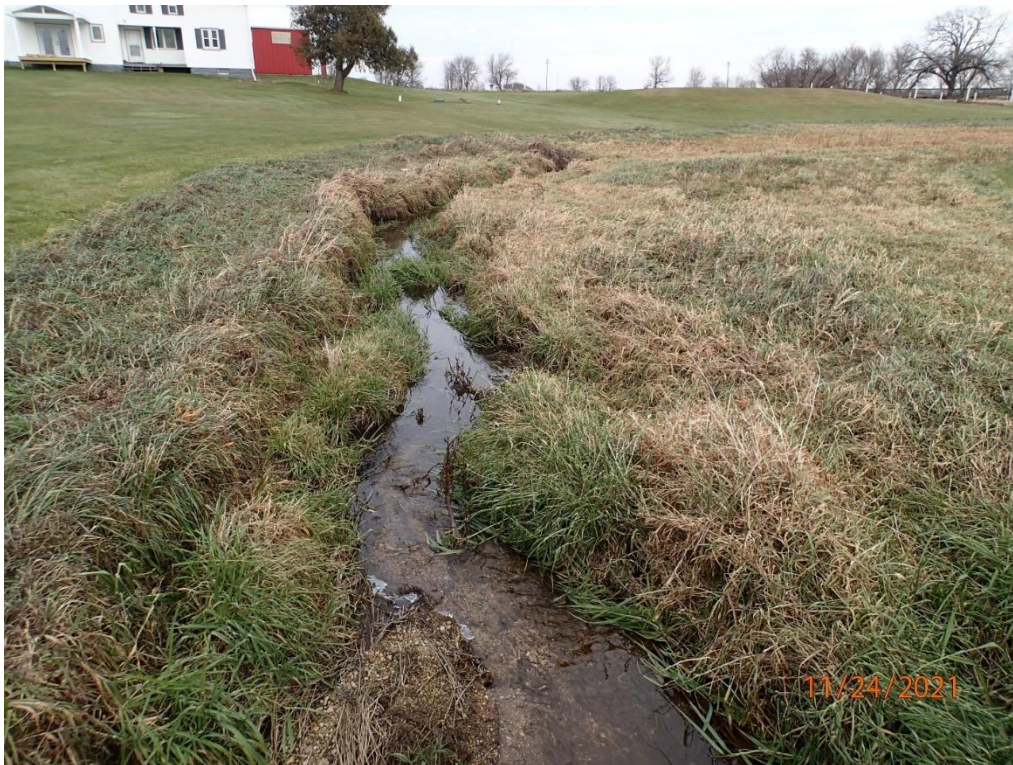
- I did not observe any fish at any stream crossing. A local farmer said the stream at the corner of Pleasant Rd and Hidden Valley Rd (WBIC 5021595) pretty much flows year around but that he has never seen fish, not even minnows there. Site and photo #3.

Site #3. WBIC 5021595 Hidden Valley Rd (west of Pleasant Rd) facing north

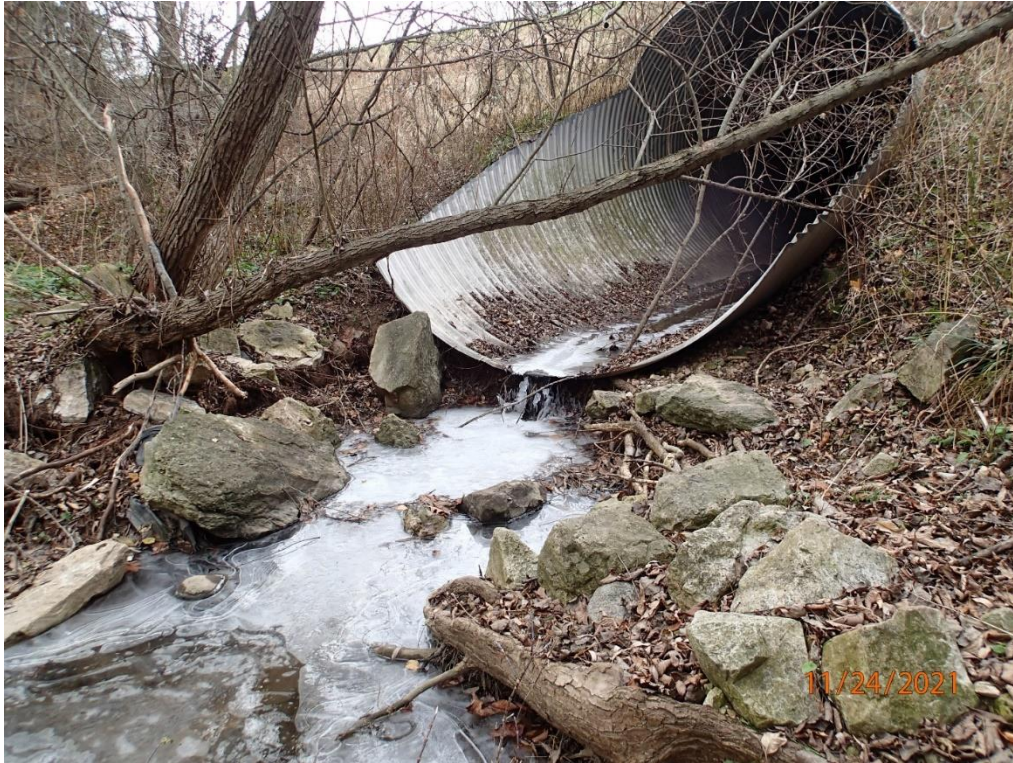
- The perched culvert east side of CTH R (WBIC 3000159) would prevent fish movement during low water levels. Site and photo #4.
- There was less flow under I43 then at sites #2 and #3. The huge drop (like ~6 feet) at the box culvert would prevent fish movement. Site and photo #5

- It is obvious by the size of the culverts, size of downed trees and large stream valleys that these streams get significant flow during runoff events.
- The perched culvert at CTH R and under I43 are barriers to fish movement. Under normal stream flow, fish would not be able to migrate upstream from Kriwanek Creek or the West Twin River.

Site #4. WBIC 3000159 Perched culvert east side of CTH R

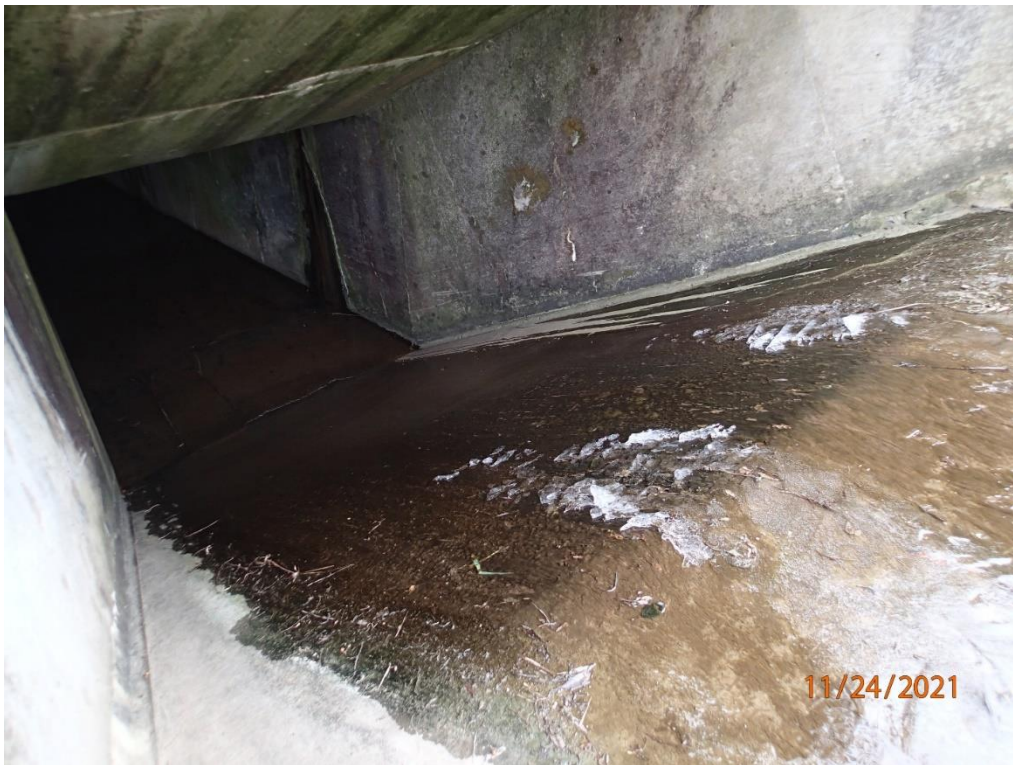
Site #5. WBIC 3000159 under I43
