Dutch Hollow Lake EWM Removal Report 2022

Dutch Hollow Lake EWM Removal Summary 2022

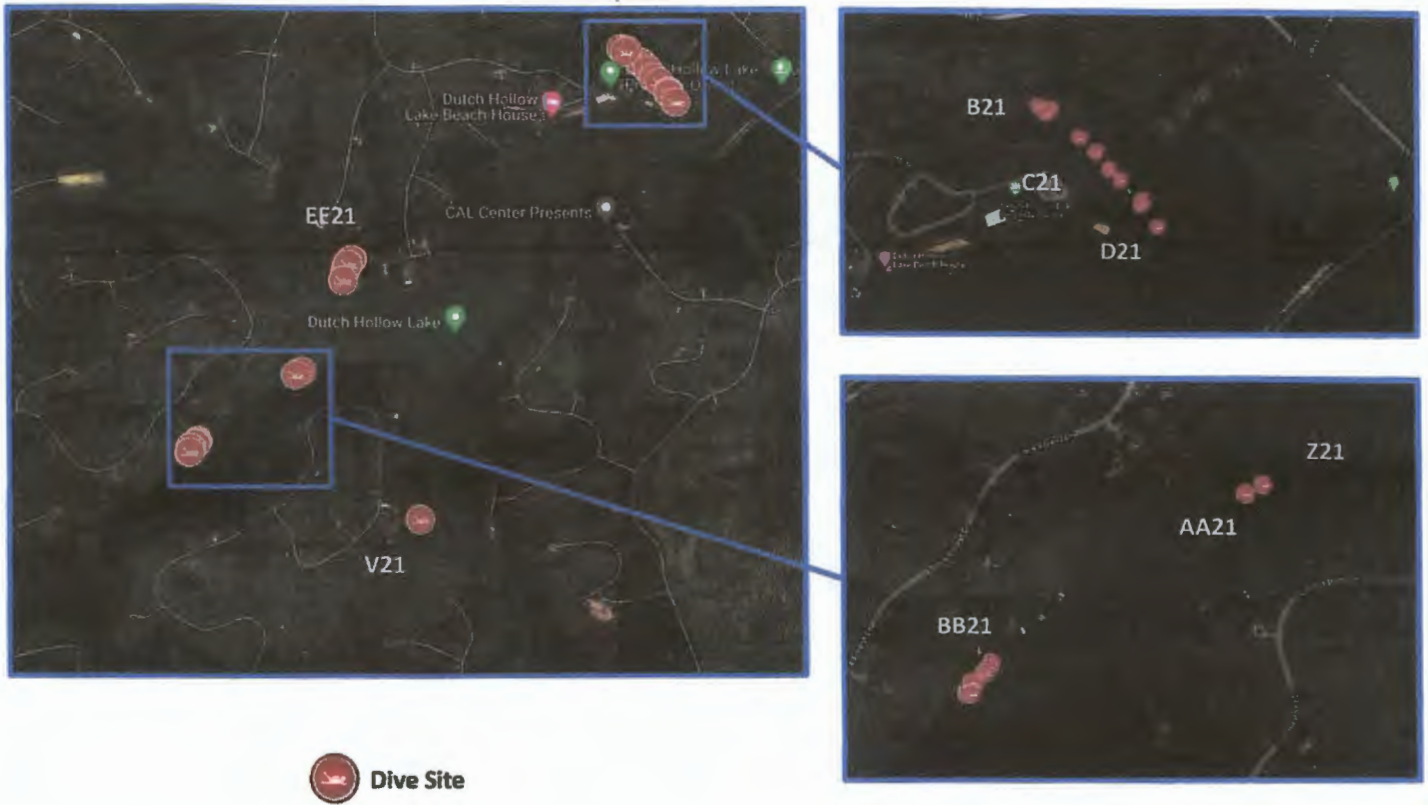
Map of Dutch Hollow Lake Dive Sites

Dive Highlights and Recommendations: The DASH team spent about one third of their time and the biomass removed from site EE21 represented 40% of the total amount of EWM harvested from the lake. Other sites that received significant attention due to the EWM density was black forest bay (BB21) and the bay near the Dutch Hollow Association Clubhouse. Overall, Dutch Hollow Lake should continue to take an Integrated Pest Management (IPM) approach and evaluate different strategies to manage the EWM population on the lake. Continued monitoring and management efforts are important to prevent the spread of EWM throughout Dutch Hollow Lake.
