Water Resources of the Yahara River Basin

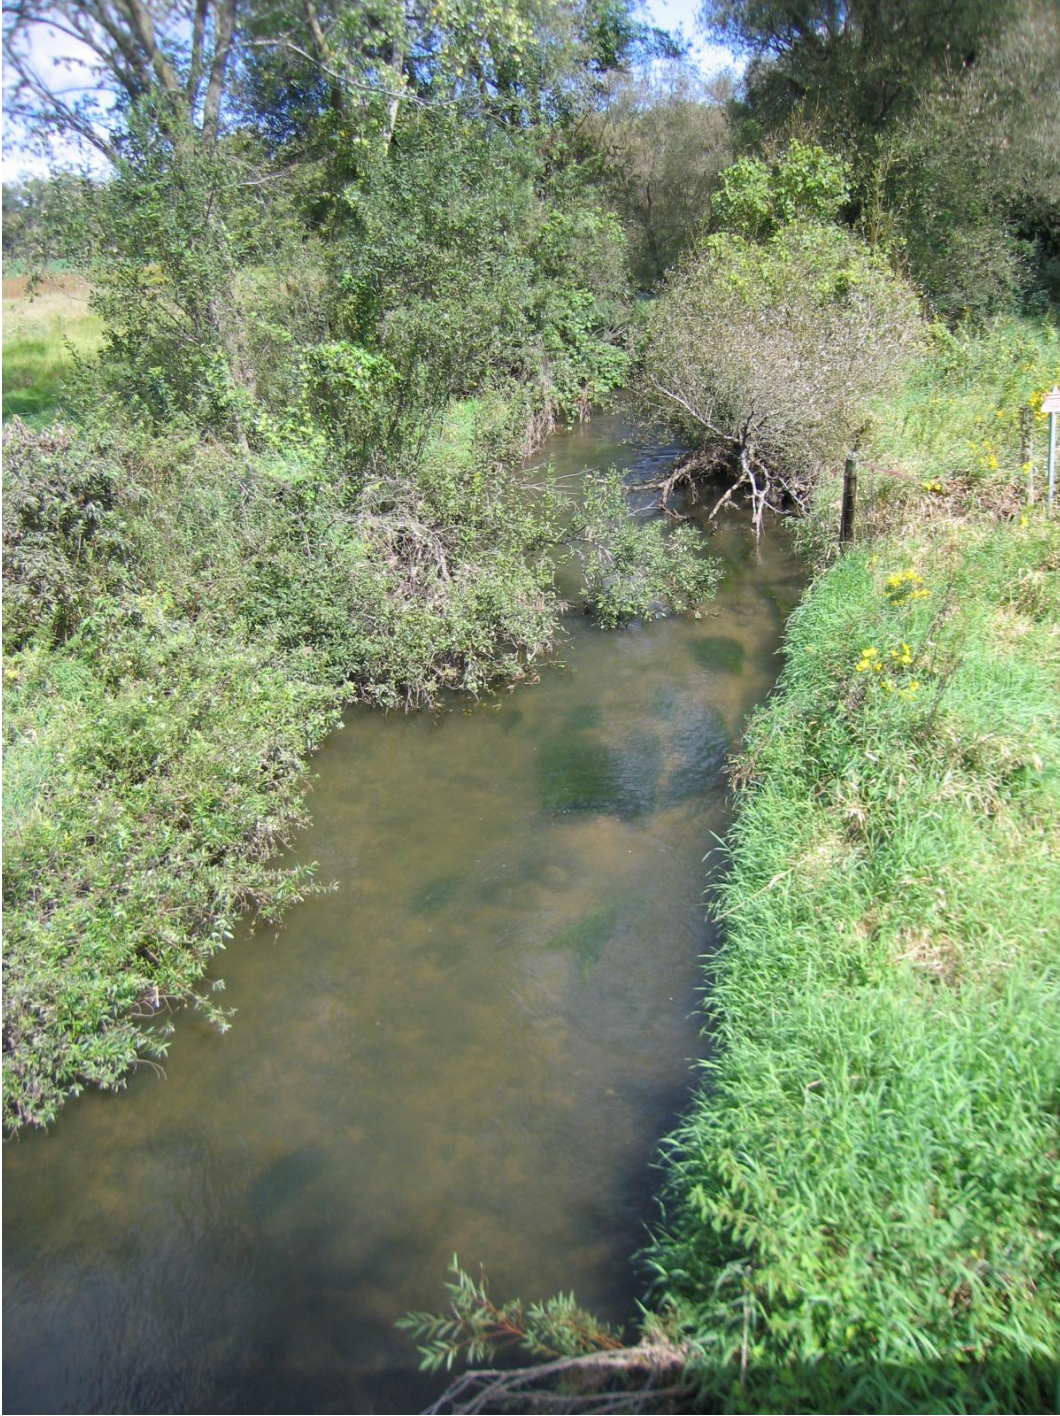
Yahara River at Windsor Road

The draining of wetlands in the watershed and the straightening of small feeder streams coupled with the intensive agriculture of the watershed has resulted in large sediment and nutrient loading to the river and to Lake Mendota.

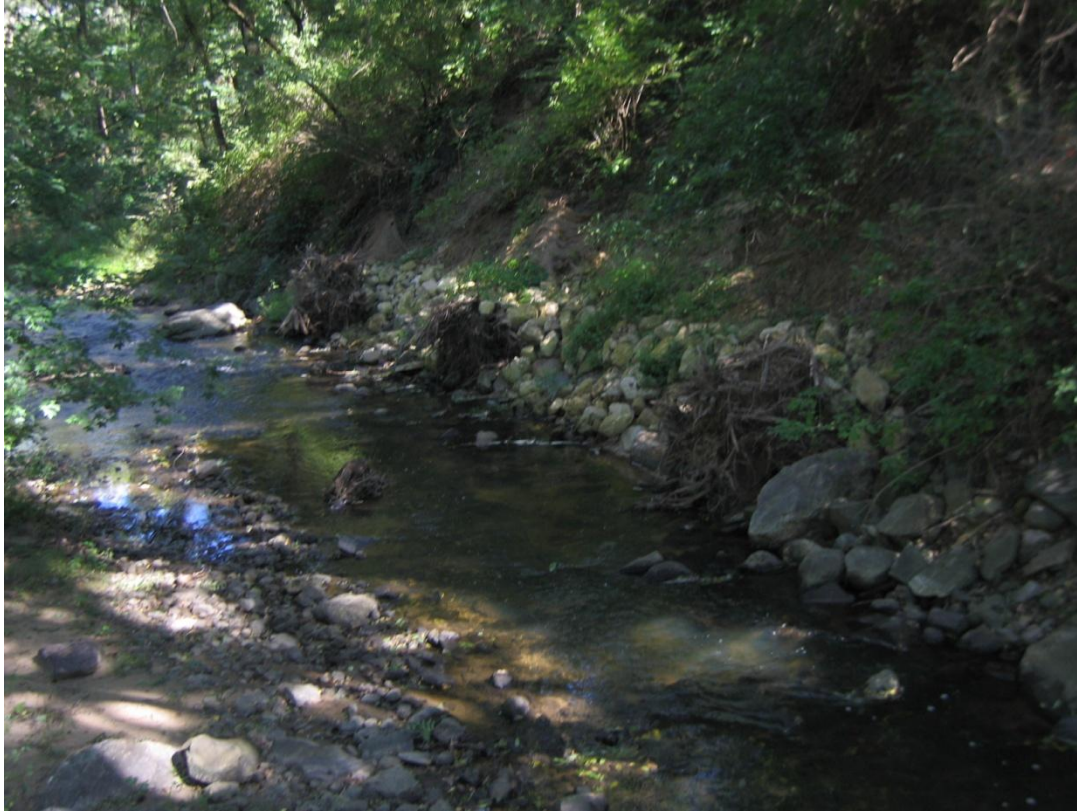
Failing Bank Stabilization Along Pheasant Branch in 2010
