2.1. Project Name: San-Ric Dairy LLC (Previously San-Ric Holsteins)	2.2. Grant Number: TRC-LF01-05000-E09 A	
2.3. Governmental Unit Name: Brown County Land & Water Conservation Department	2.4. Primary Watershed Name: East River	2.5. Watershed Code: LF01

San-Ric Dairy 2009

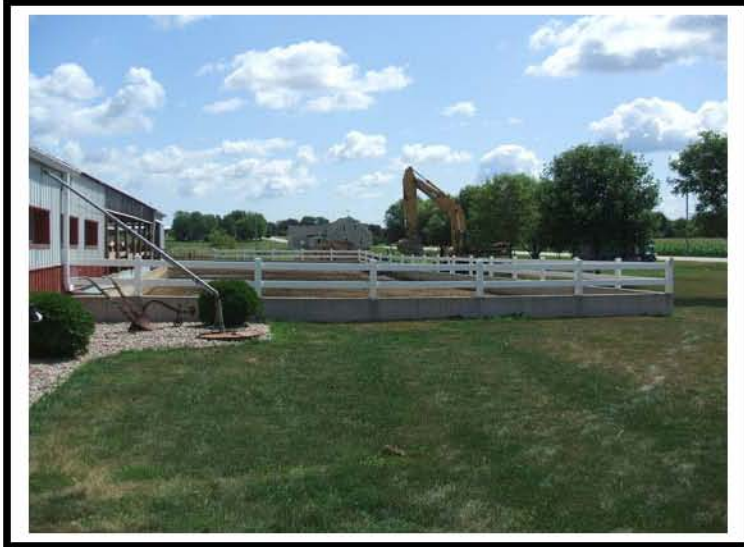
Photo #: 1
Photo Depicts: Existing bamyard and milkhouse tank.

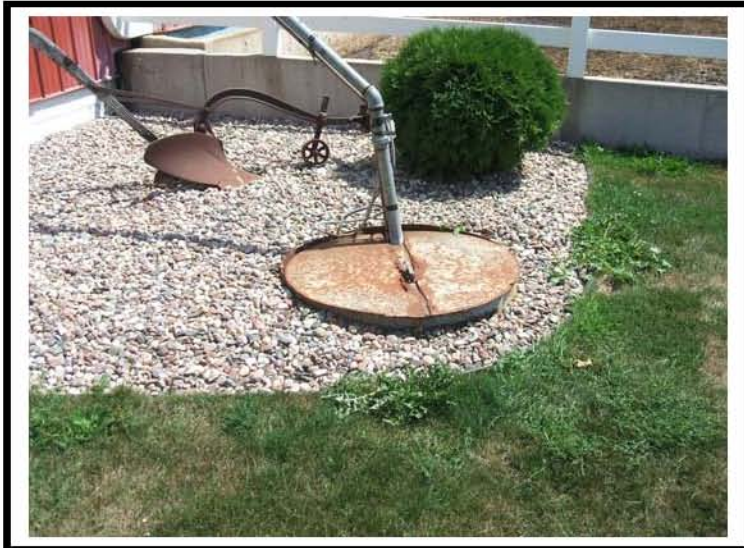
Photo #: 2
Photo Depicts: Existing milkhouse tank

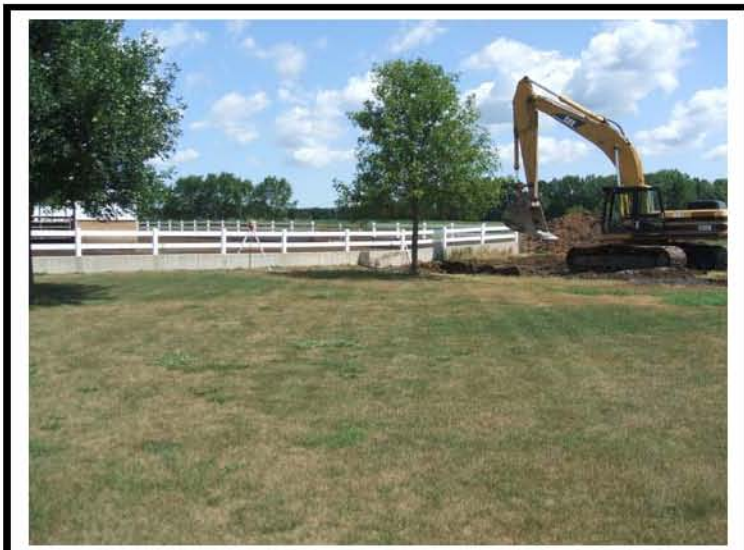
Photo #: 3
Photo Depicts: Excavation for new tank to store barnyard runoff and milkhouse waste.

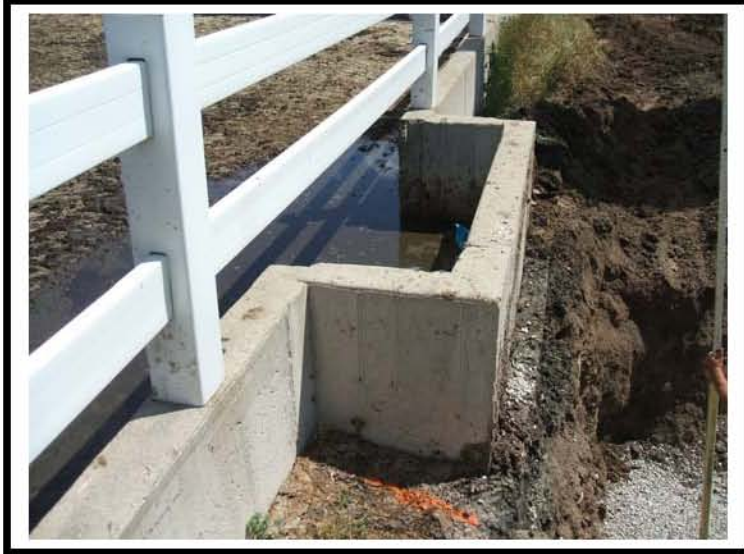
Photo #: 4
Photo Depicts: Existing barnyard runoff to filter box. Location for new tank.

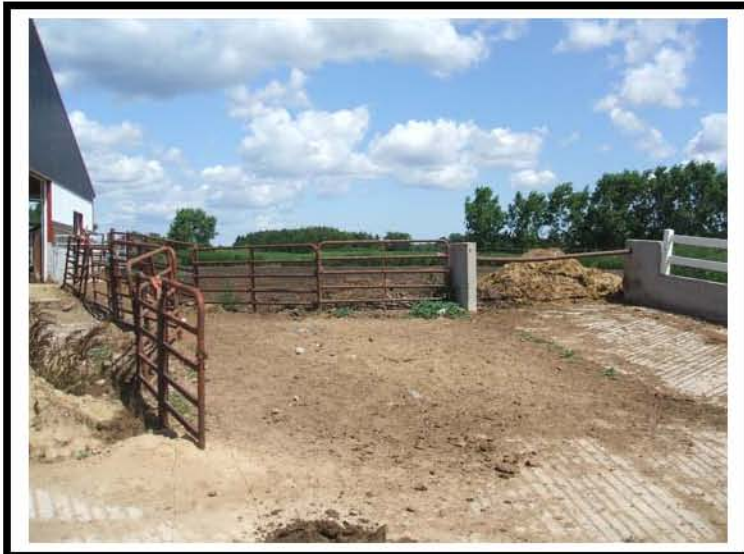
Photo #: 5
Photo Depicts: Existing pit and barnyard area

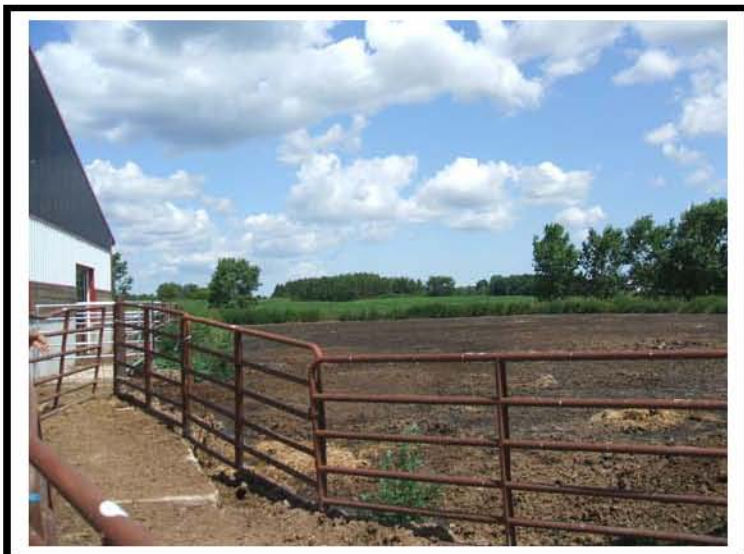
Photo #: 6
Photo Depicts: Existing Pit

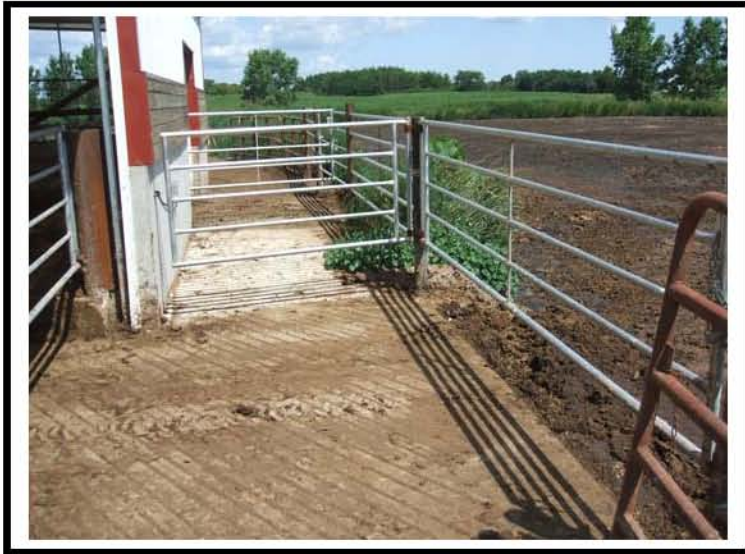
Photo #: 7
Photo Depicts: Existing concrete adjacent to pit.
Area to be modified.

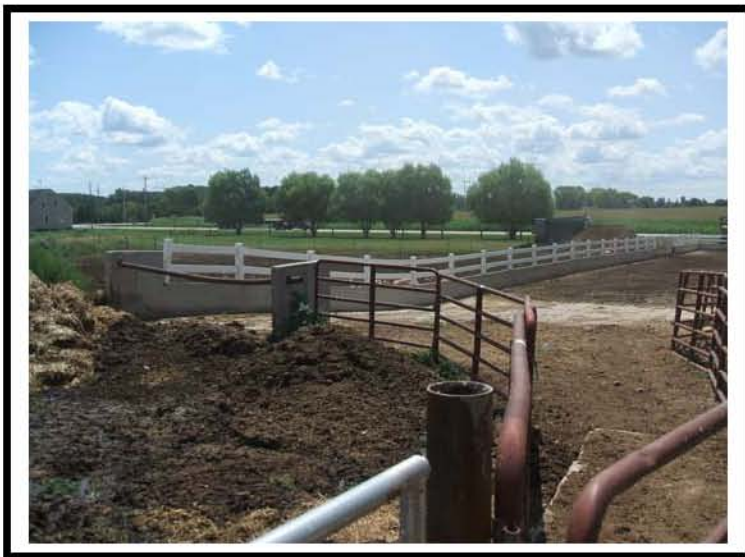
Photo #: 8
Photo Depicts: Existing barnyard and scrape in
area to pit

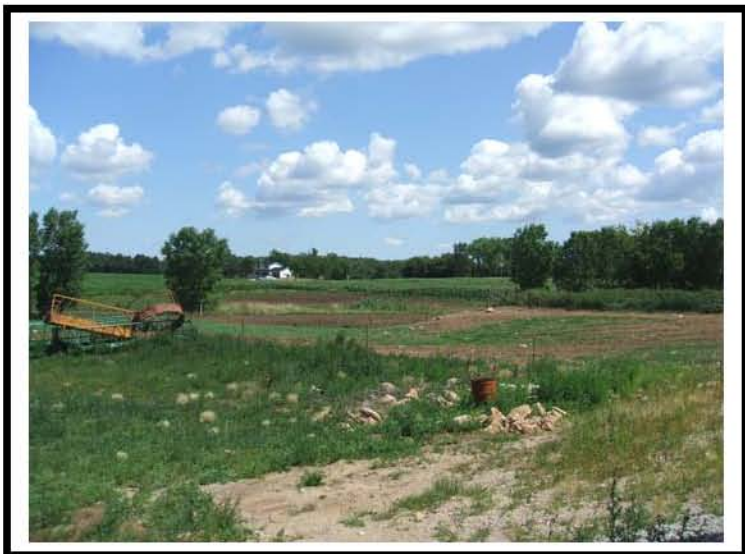
Photo #: 9
Photo Depicts: Existing ground north of the
existing pit.

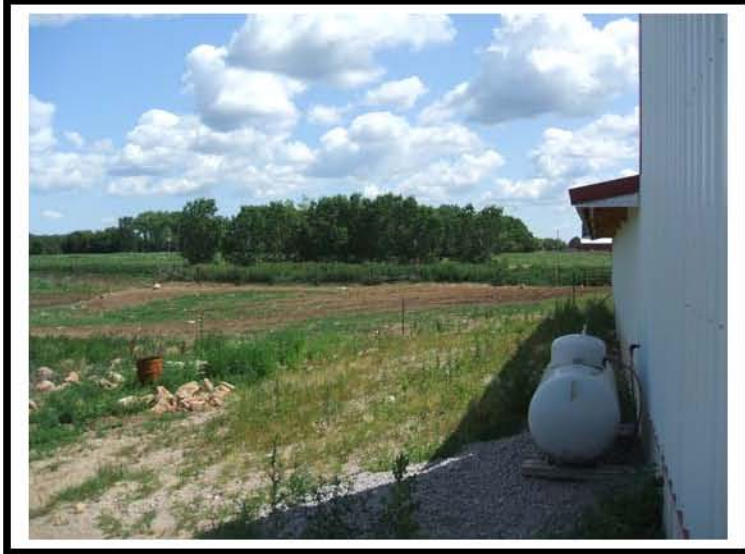
Photo #: 10
Photo Depicts: Existing pit in the background.
Direction Pointed: East

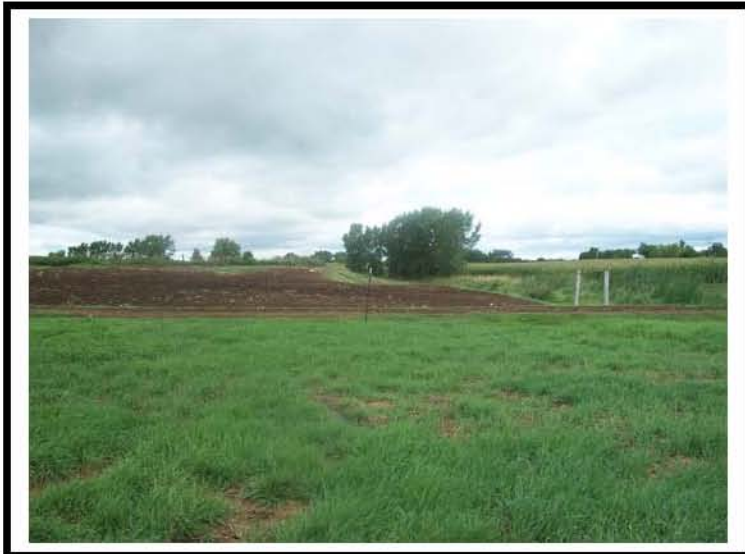
Photo #: 11
Photo Depicts: Existing pit and waterway.
Direction Pointed: North

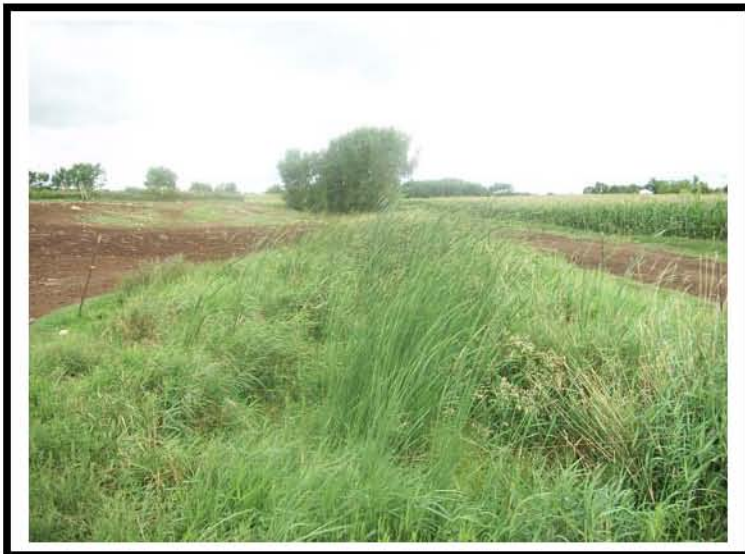
Photo #: 12
Photo Depicts: Existing waterway to be rerouted.
Direction Pointed: North

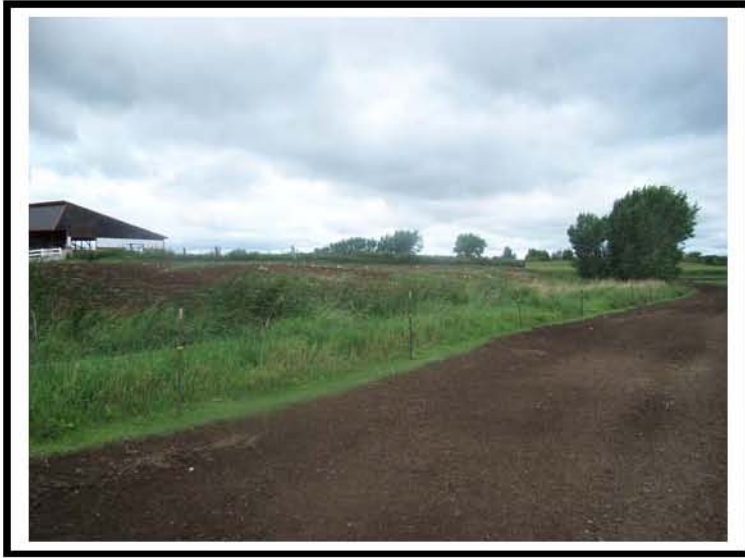
Photo #: 13
Photo Depicts: Existing waterway and pit.
Direction Pointed: Northward

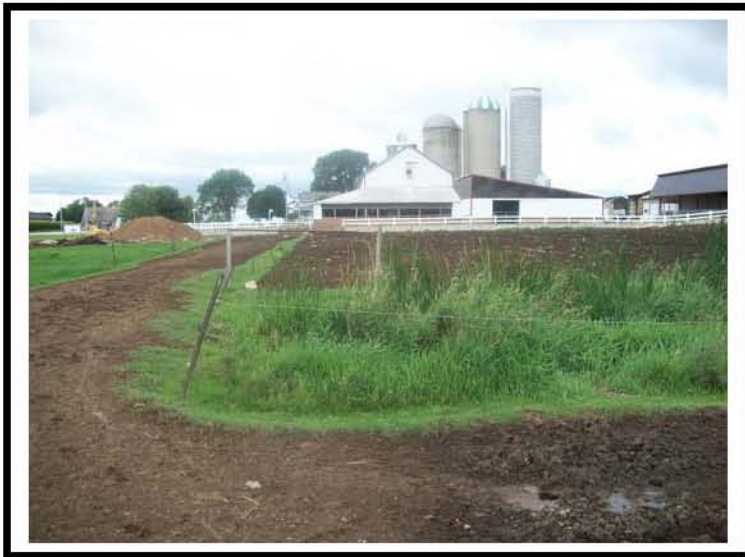
Photo #: 14
Photo Depicts: Existing waterway to be rerouted.
Direction Pointed: Westward

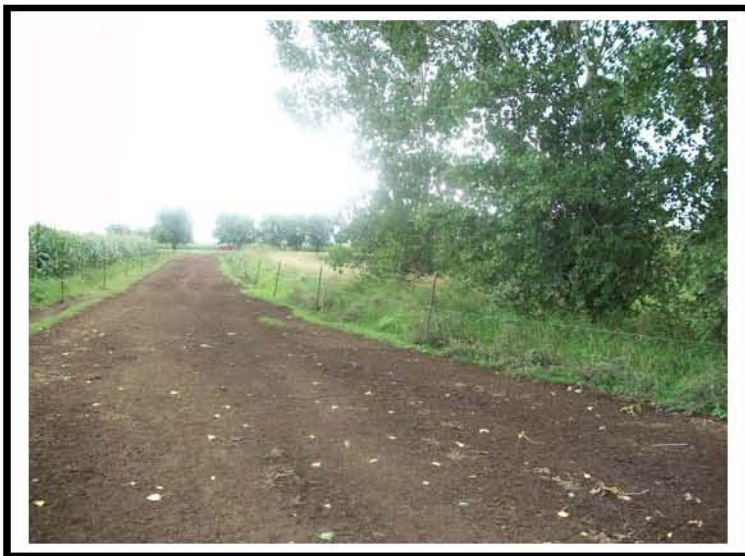
Photo #: 15
Photo Depicts: Existing waterway to be rerouted.
Direction Pointed: Southward

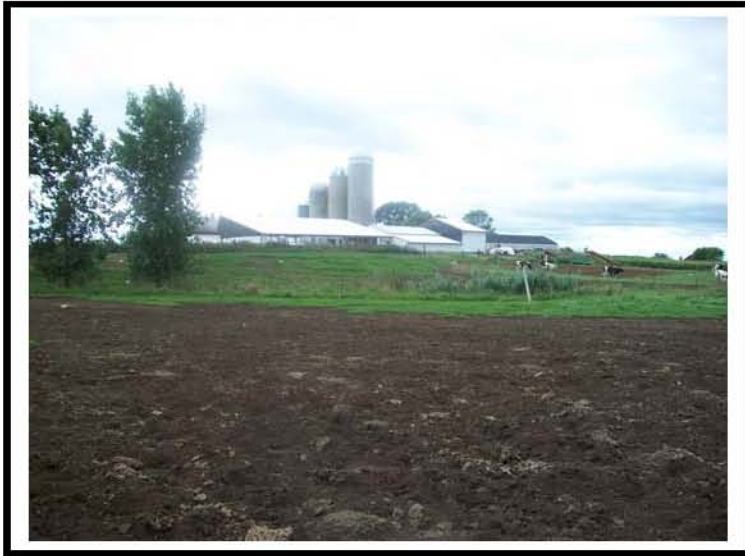
Photo #: 16

Photo Depicts: Existing waterway below existing pit.

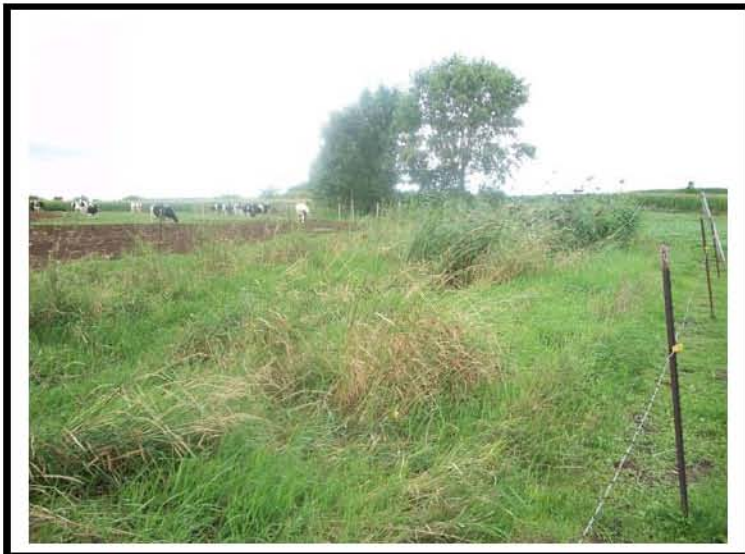
Photo #: 17

Photo Depicts: Existing waterway to be rerouted.

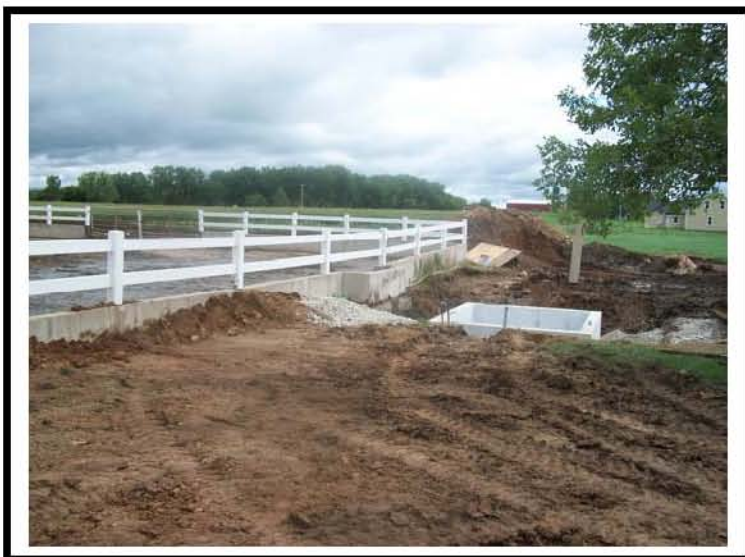
Photo #: 18

Photo Depicts: Tank construction

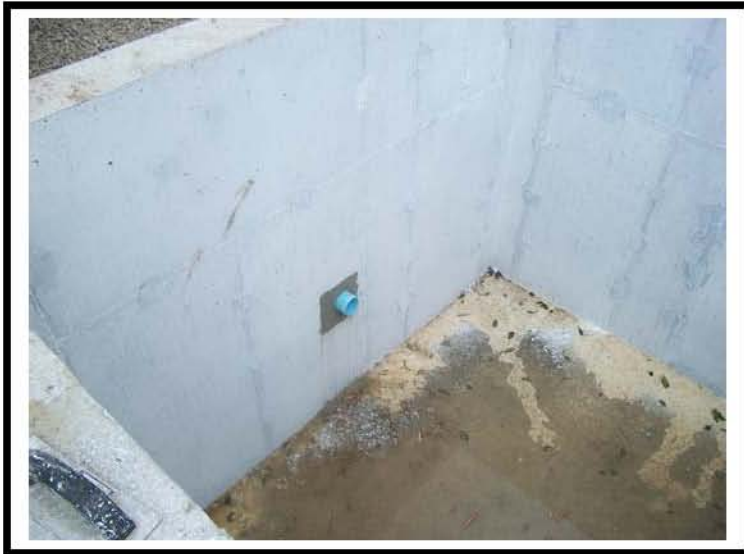
Photo #: 19
Photo Depicts: Tank Construction & transfer outlet from milkhouse tank.

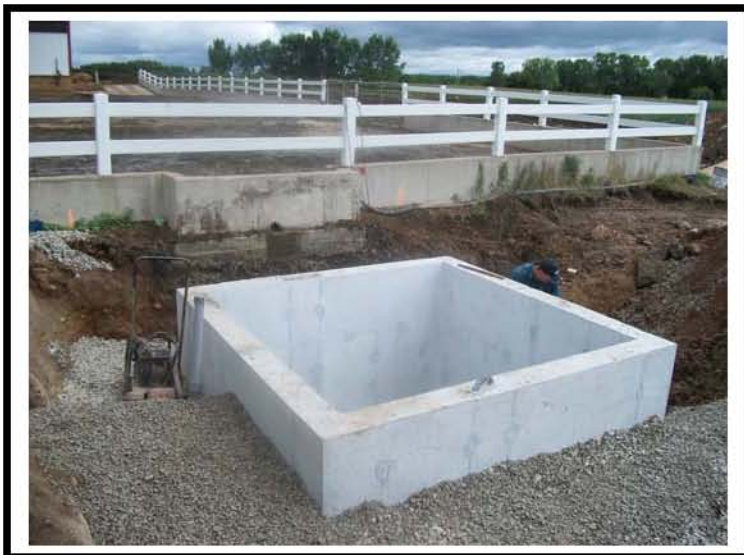
Photo #: 20
Photo Depicts: Tank construction

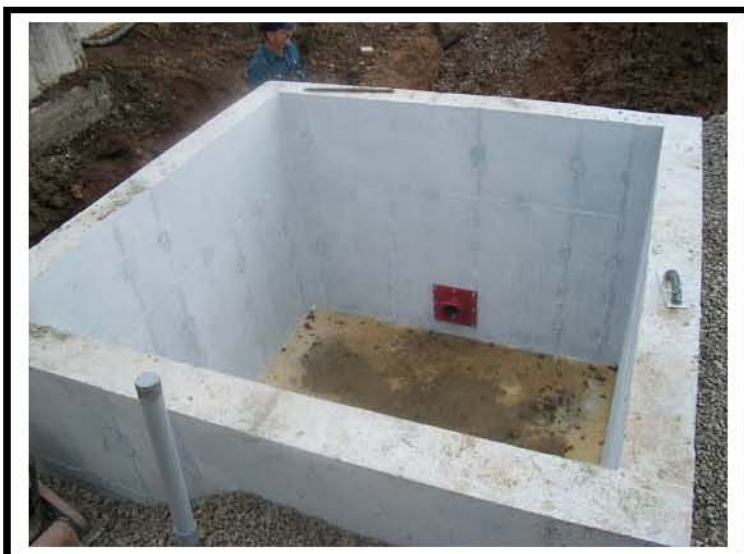
Photo #: 21
Photo Depicts: Tank construction & transfer inlet to new concrete storage facility.

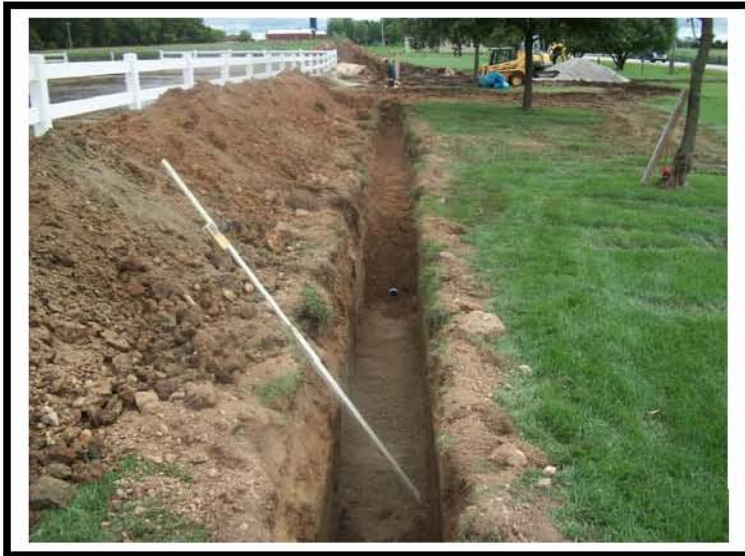
Photo #: 22

Photo Depicts: Milkhouse transfer line to new tank.

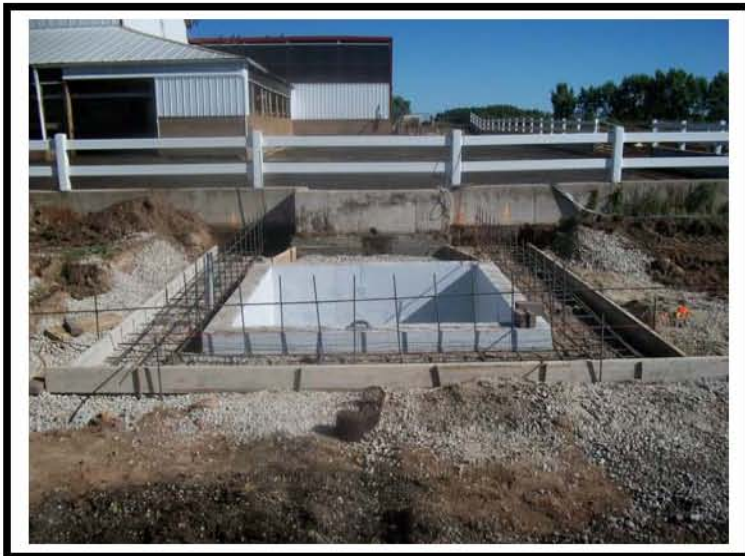
Photo #: 23

Photo Depicts: Tank construction

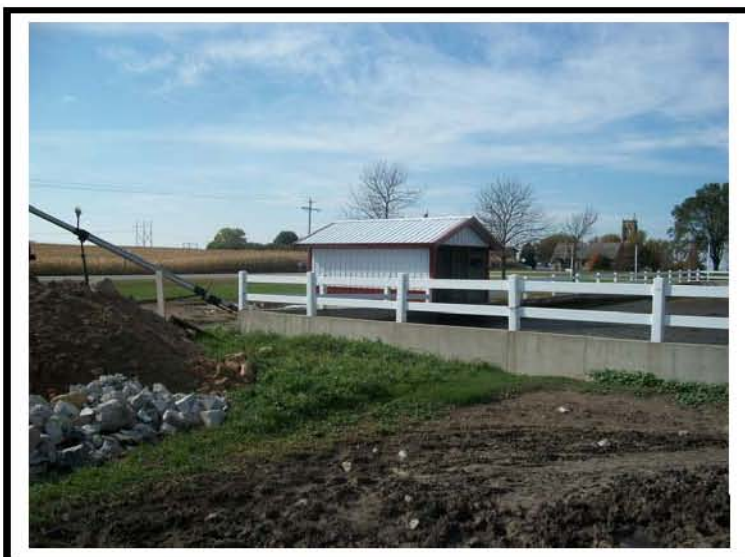
Photo #: 24

Photo Depicts: Framed steel sided building over new tank.

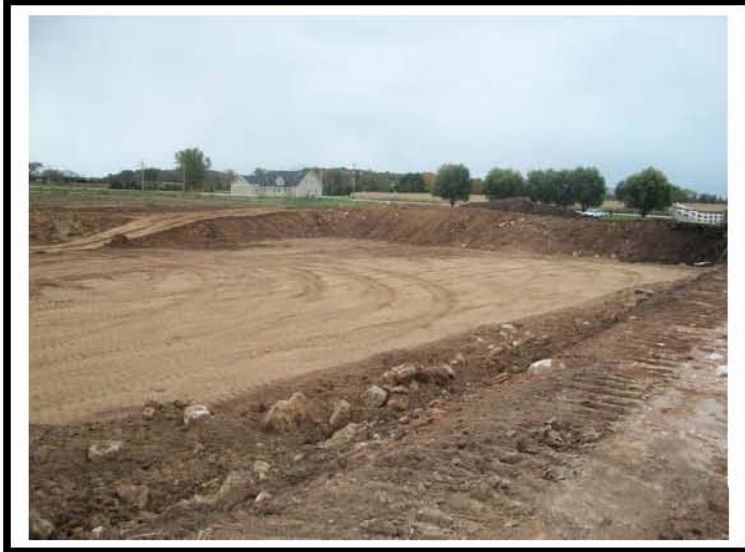
Photo #: 25
Photo Depicts: Pit construction after abandonment of existing earthen storage facility.

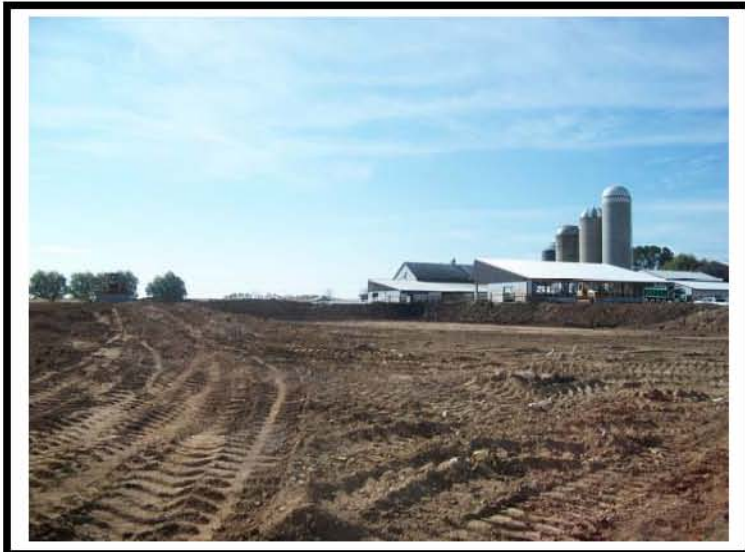
Photo #: 26
Photo Depicts: Pit construction

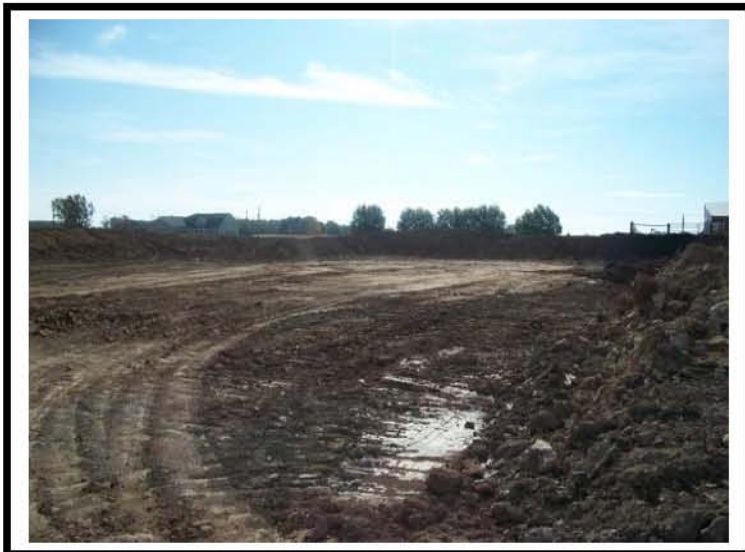
Photo #: 27
Photo Depicts: Pit construction

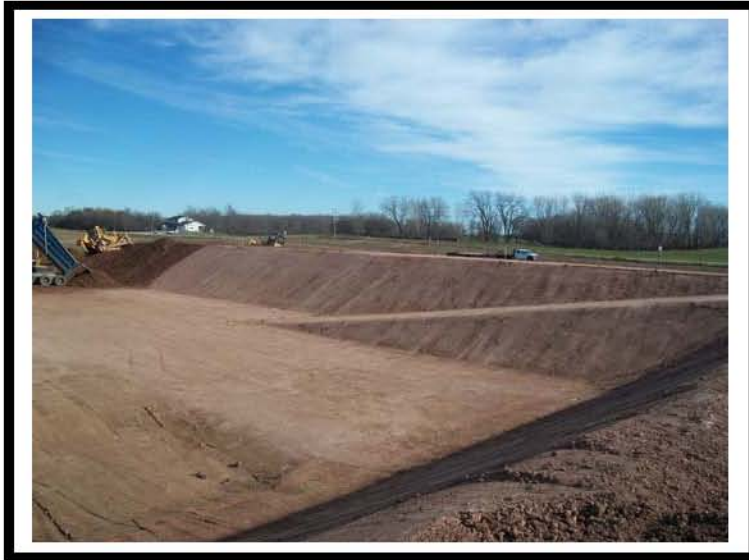
Photo #: 30
Photo Depicts: Pit construction
Direction Pointed: Eastward

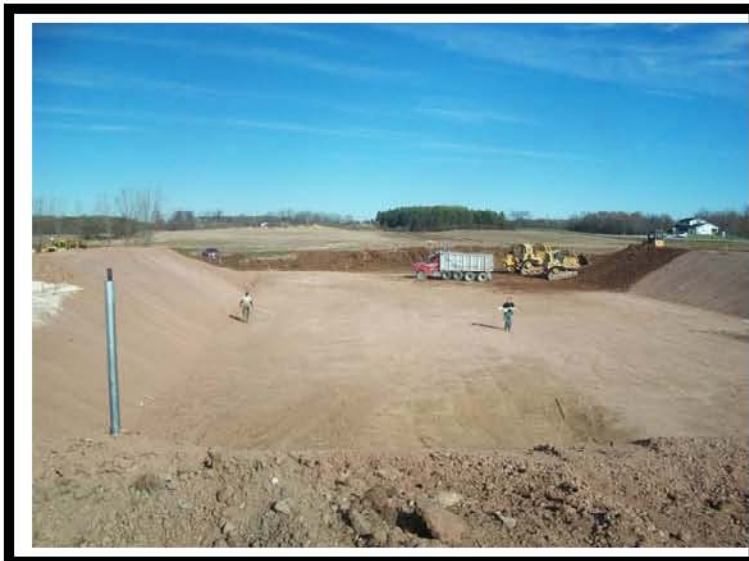
Photo #: 31
Photo Depicts: Pit construction
Direction Pointed: Northward

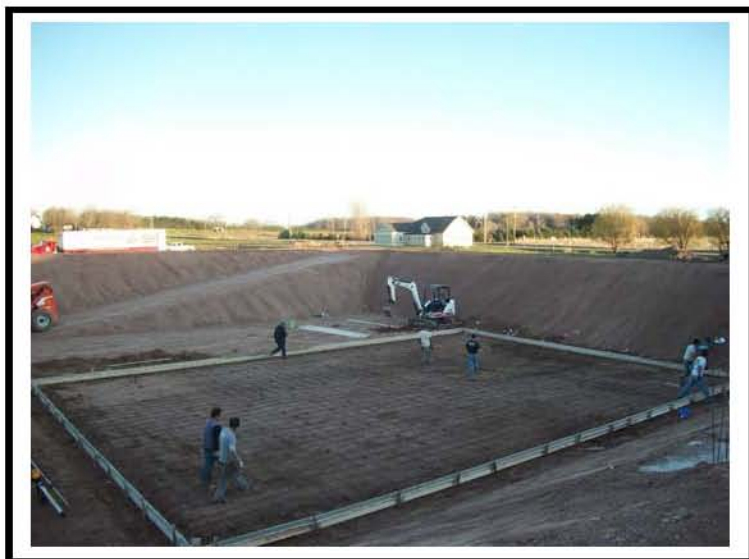
Photo #: 32
Photo Depicts: Pit construction. Forming and placing steel for first pour.
Direction Pointed: Eastward

Project was complicated by wet weather in the fall and cold weather during final construction which required additional measures to protect the concrete from freezing.

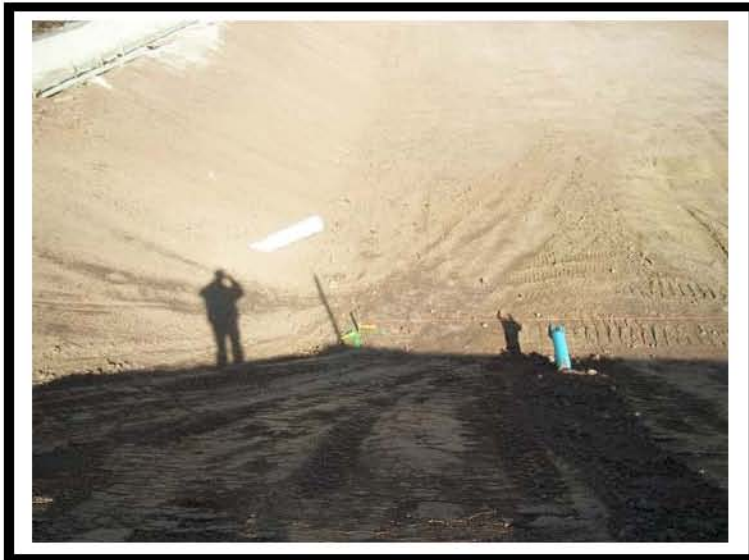
Photo #: 33

Photo Depicts: Pit construction (transfer pipe outlets from piston pump in barn and from chopper pump in new tank).

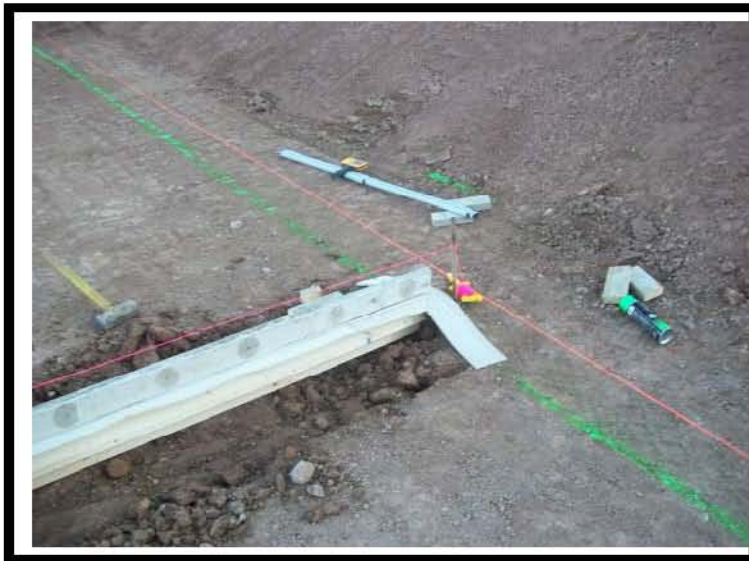
Photo #: 34

Photo Depicts: Installation of keyway form and PVC waterstop, and also a factory welded Tee intersection.

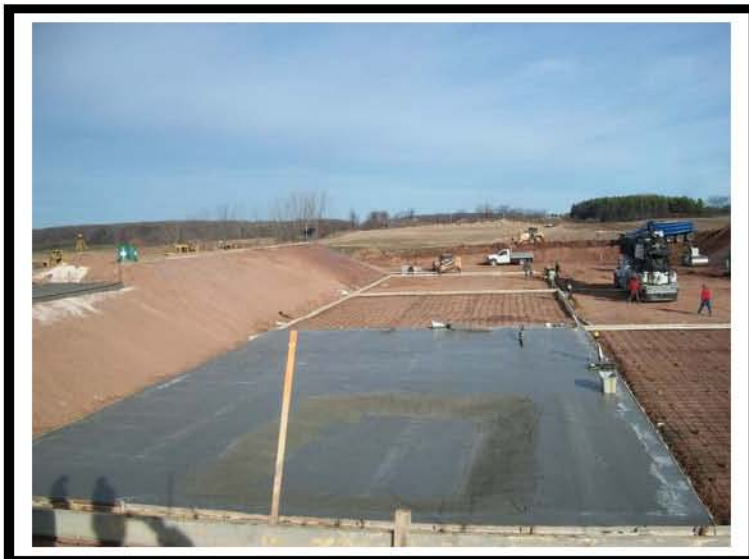
Photo #: 35

Photo Depicts: Poured concrete section with sump.

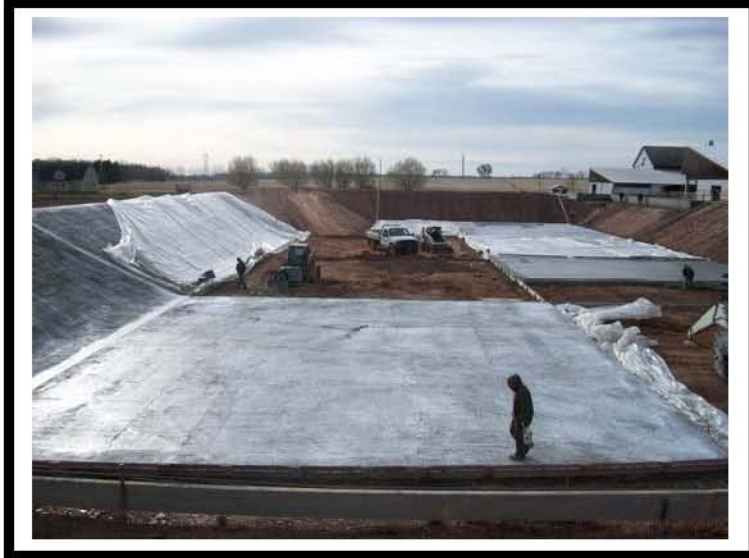
Photo #: 36
Photo Depicts: Concrete construction
Direction Pointed: Southward

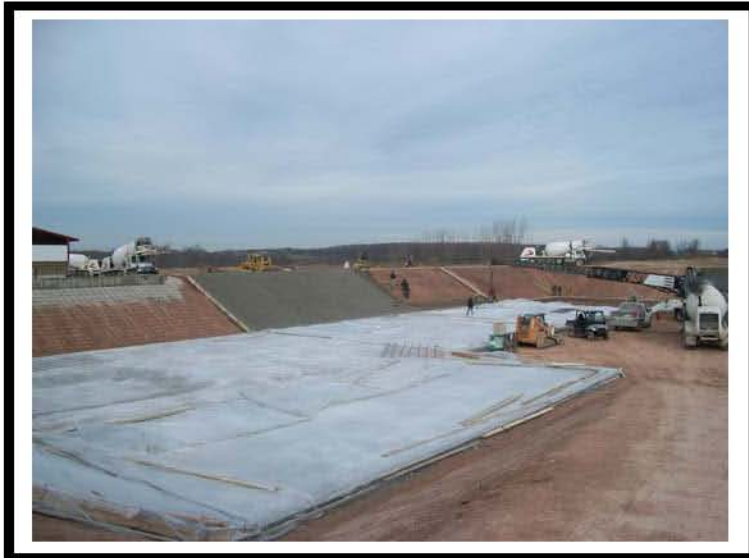
Photo #: 37
Photo Depicts: Concrete construction
Direction Pointed: Westward

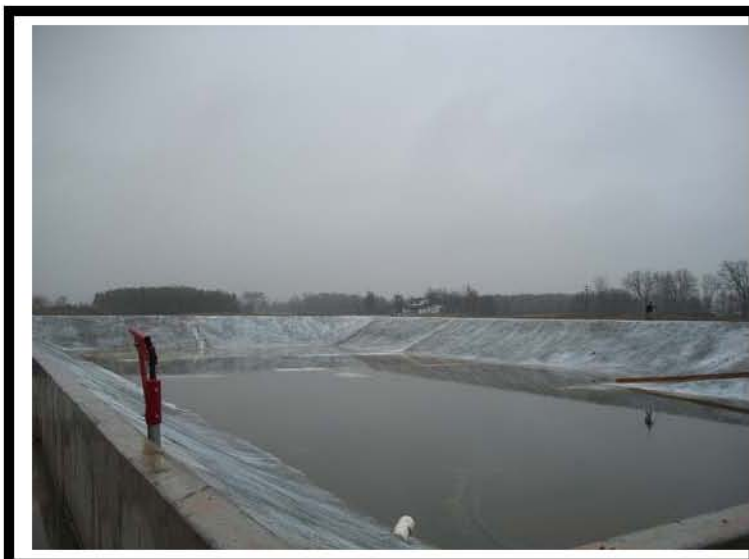
Photo #: 38
Photo Depicts: Pit construction
Direction Pointed: Northward

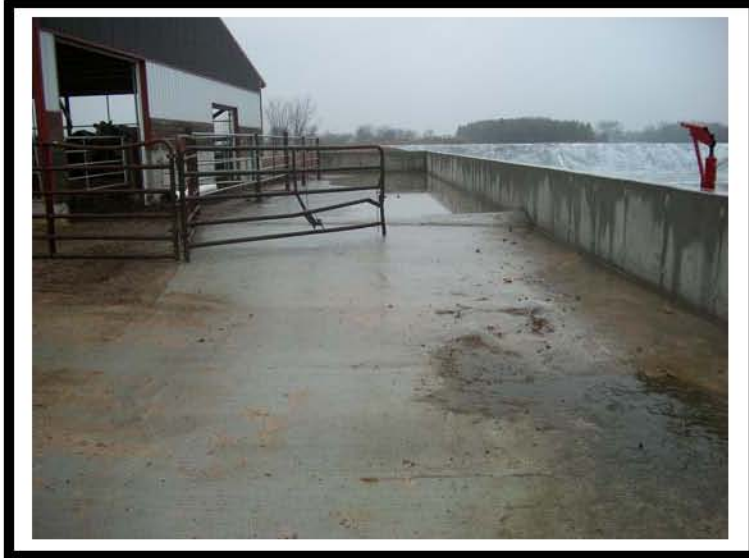
Photo #: 39
Photo Depicts: Heavy use protection area and walls.

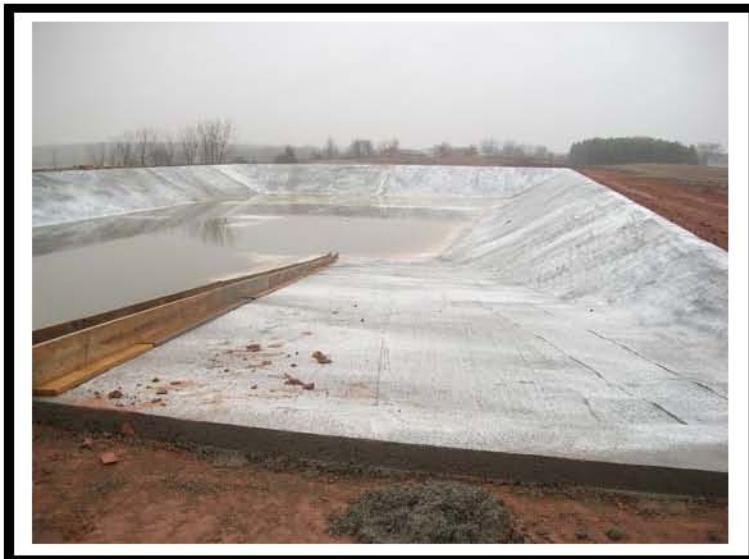
Photo #: 40
Photo Depicts: Pit construction

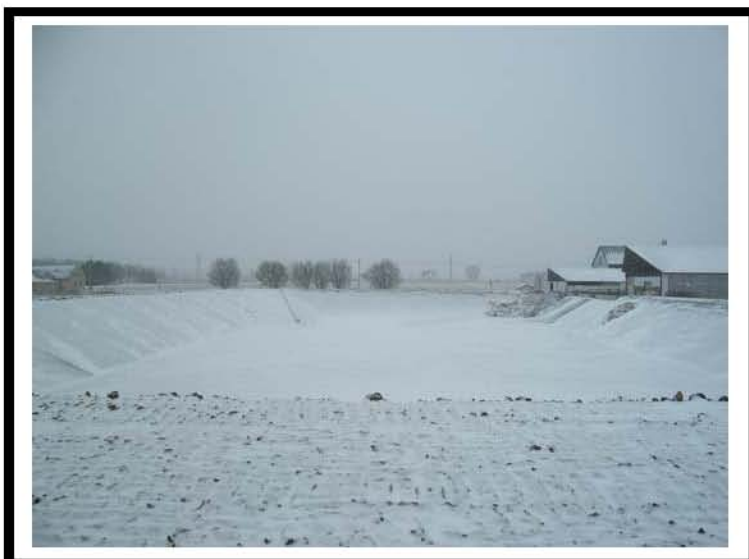
Photo #: 41
Photo Depicts: Pit completed

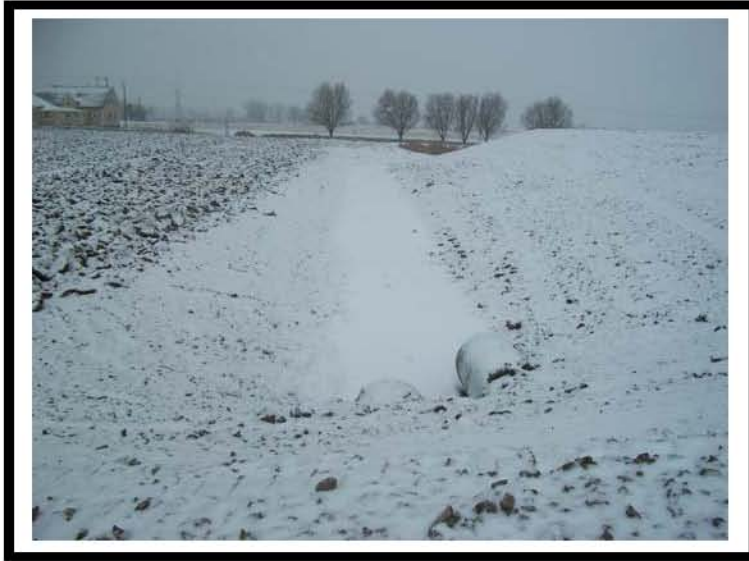
Photo #: 42
Photo Depicts: Waterway and culverts

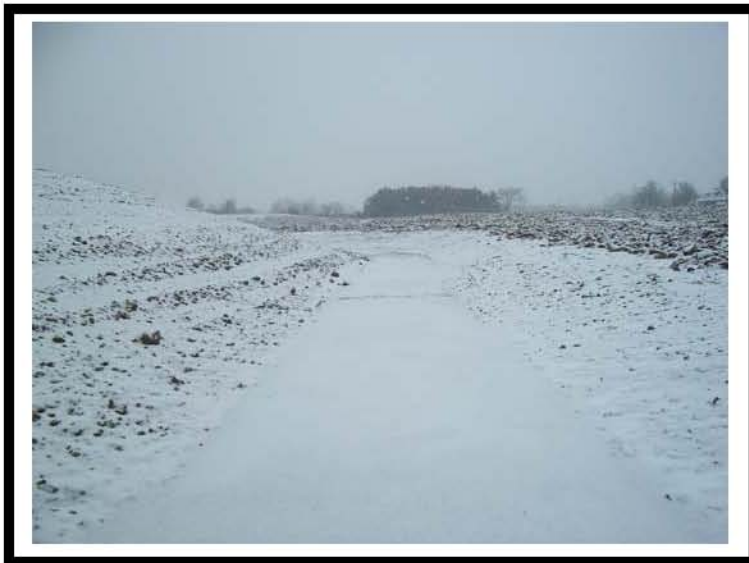
Photo #: 43
Photo Depicts: Waterway

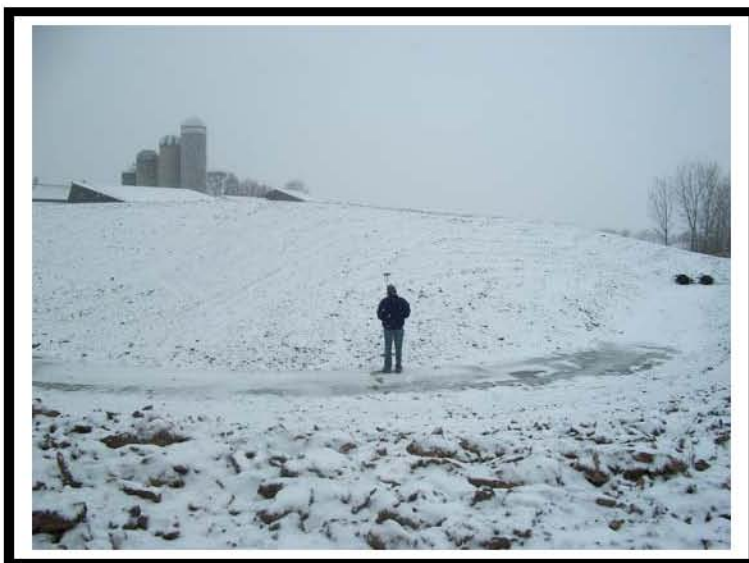
Photo #: 44
Photo Depicts: Waterway

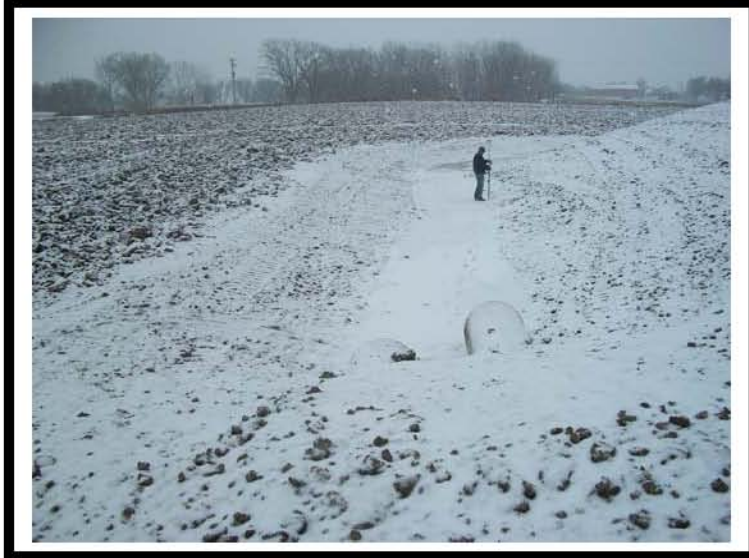
Photo #: 45
Photo Depicts: Waterway & Culverts
Direction Pointed: Eastward

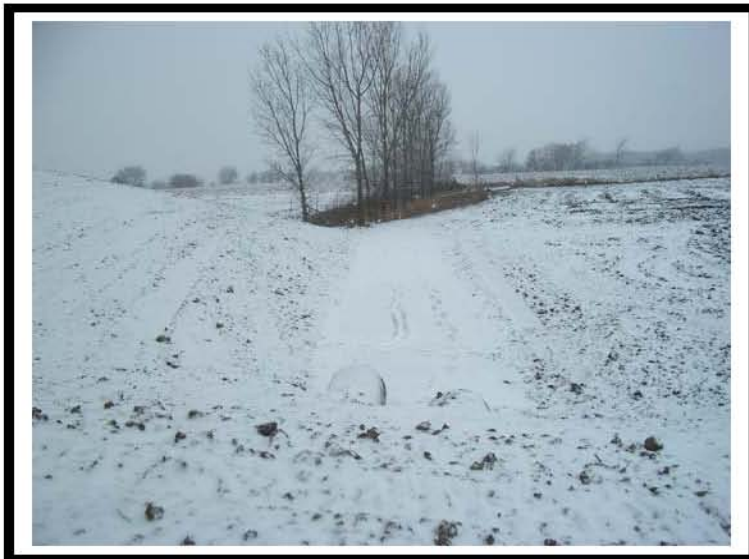
Photo #: 46
Photo Depicts: Waterway & Culverts
Direction Pointed: Westward
