**Subject: 2013 Purple Loosestrife Monitoring Report  
Holcombe Hydro (P-1982), Cornell Hydro (P-2639), Jim Falls Hydro  
(P-2491), Wissota Hydro (P-2567), Chippewa Falls Hydro (P-2440) and  
Dells Hydro (P-2670)**

***PURPLE LOOSESTRIFE ASSESSMENT – 2013***

**Dells Pond, Chippewa Falls Flowage, Lake Wissota, Old Abe Lake, Cornell  
Flowage, Lake Holcombe and Jim Falls Spillway Channel**

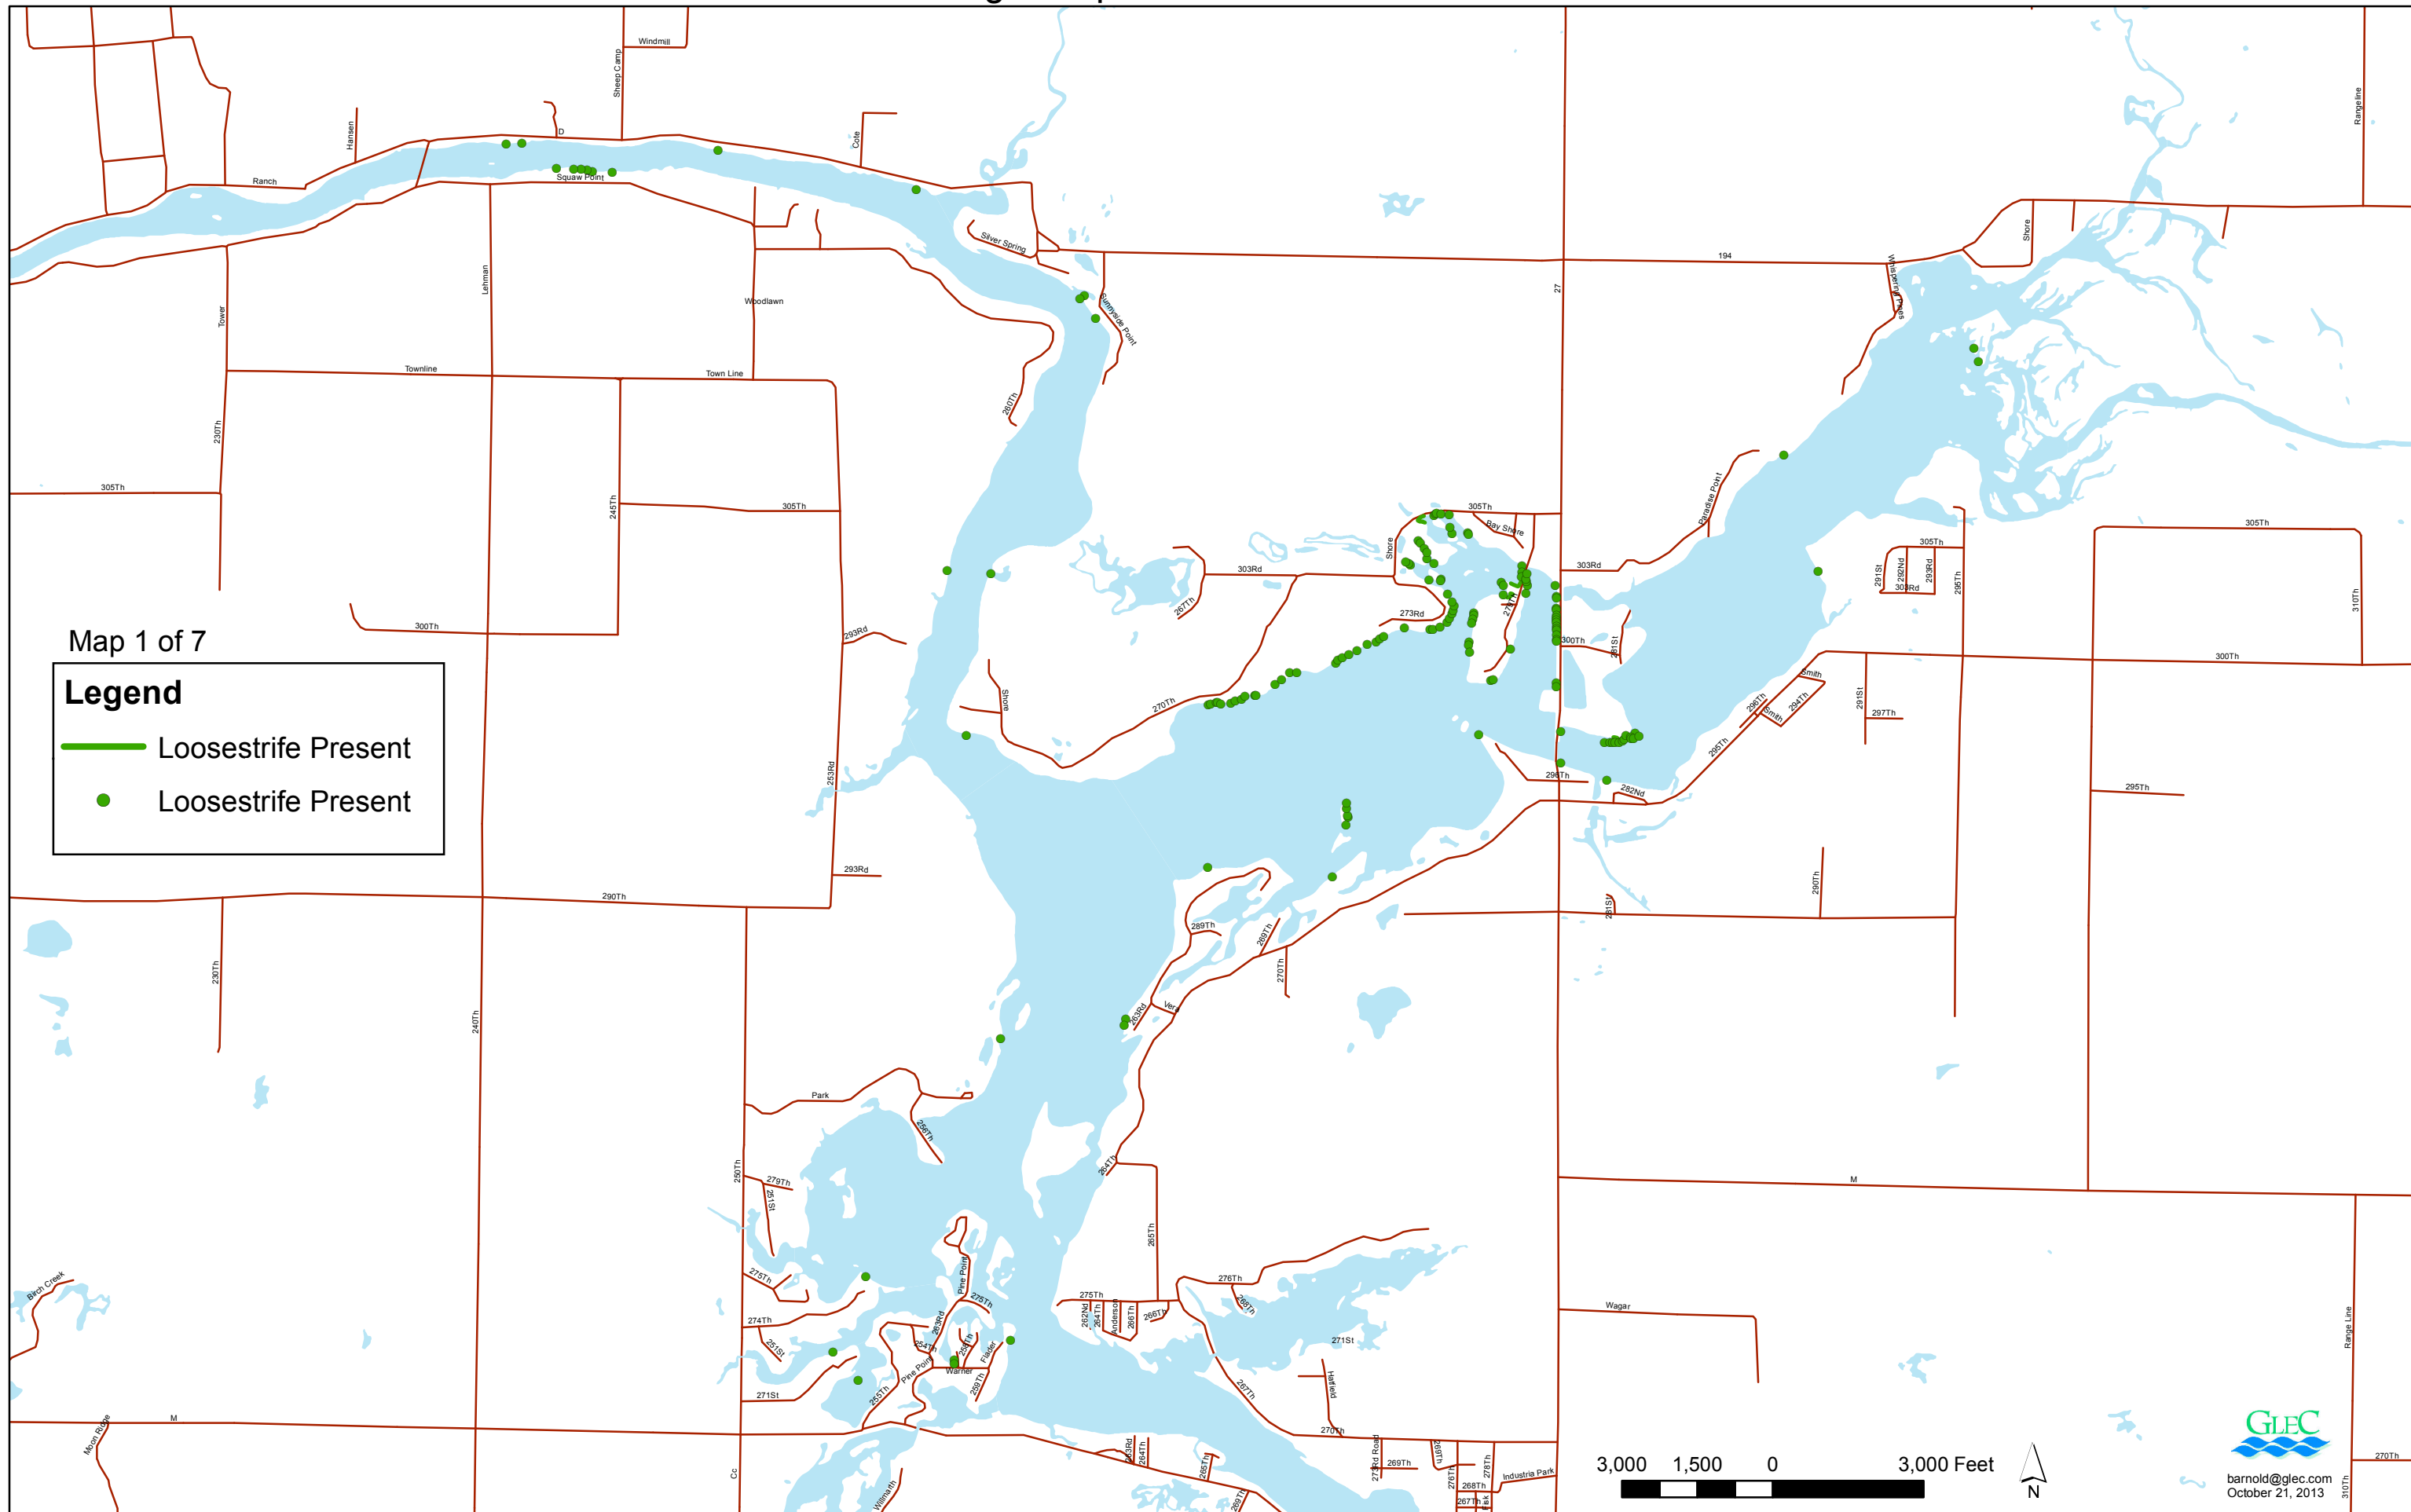
# Holcombe Flowage Purple Loosestrife Assessment - 2013

Holcombe Flowage contained the most purple loosestrife among the six impoundments surveyed. 151 locations were noted as present and no locations were noted as abundant (see Holcombe Flowage Map 1). While a few new plants were found during the survey, the majority of the infested areas have been noted in previous years. New infestation is generally associated with areas where the native vegetation has been disturbed. This disturbance can come from urbanization (clearing for home sites, swimming areas or fishing areas), road improvements, or erosion. It is also common to have plants grow only during select years. This may be the case on Holcombe Flowage, with new plants growing this year, while previously observed plants did not.

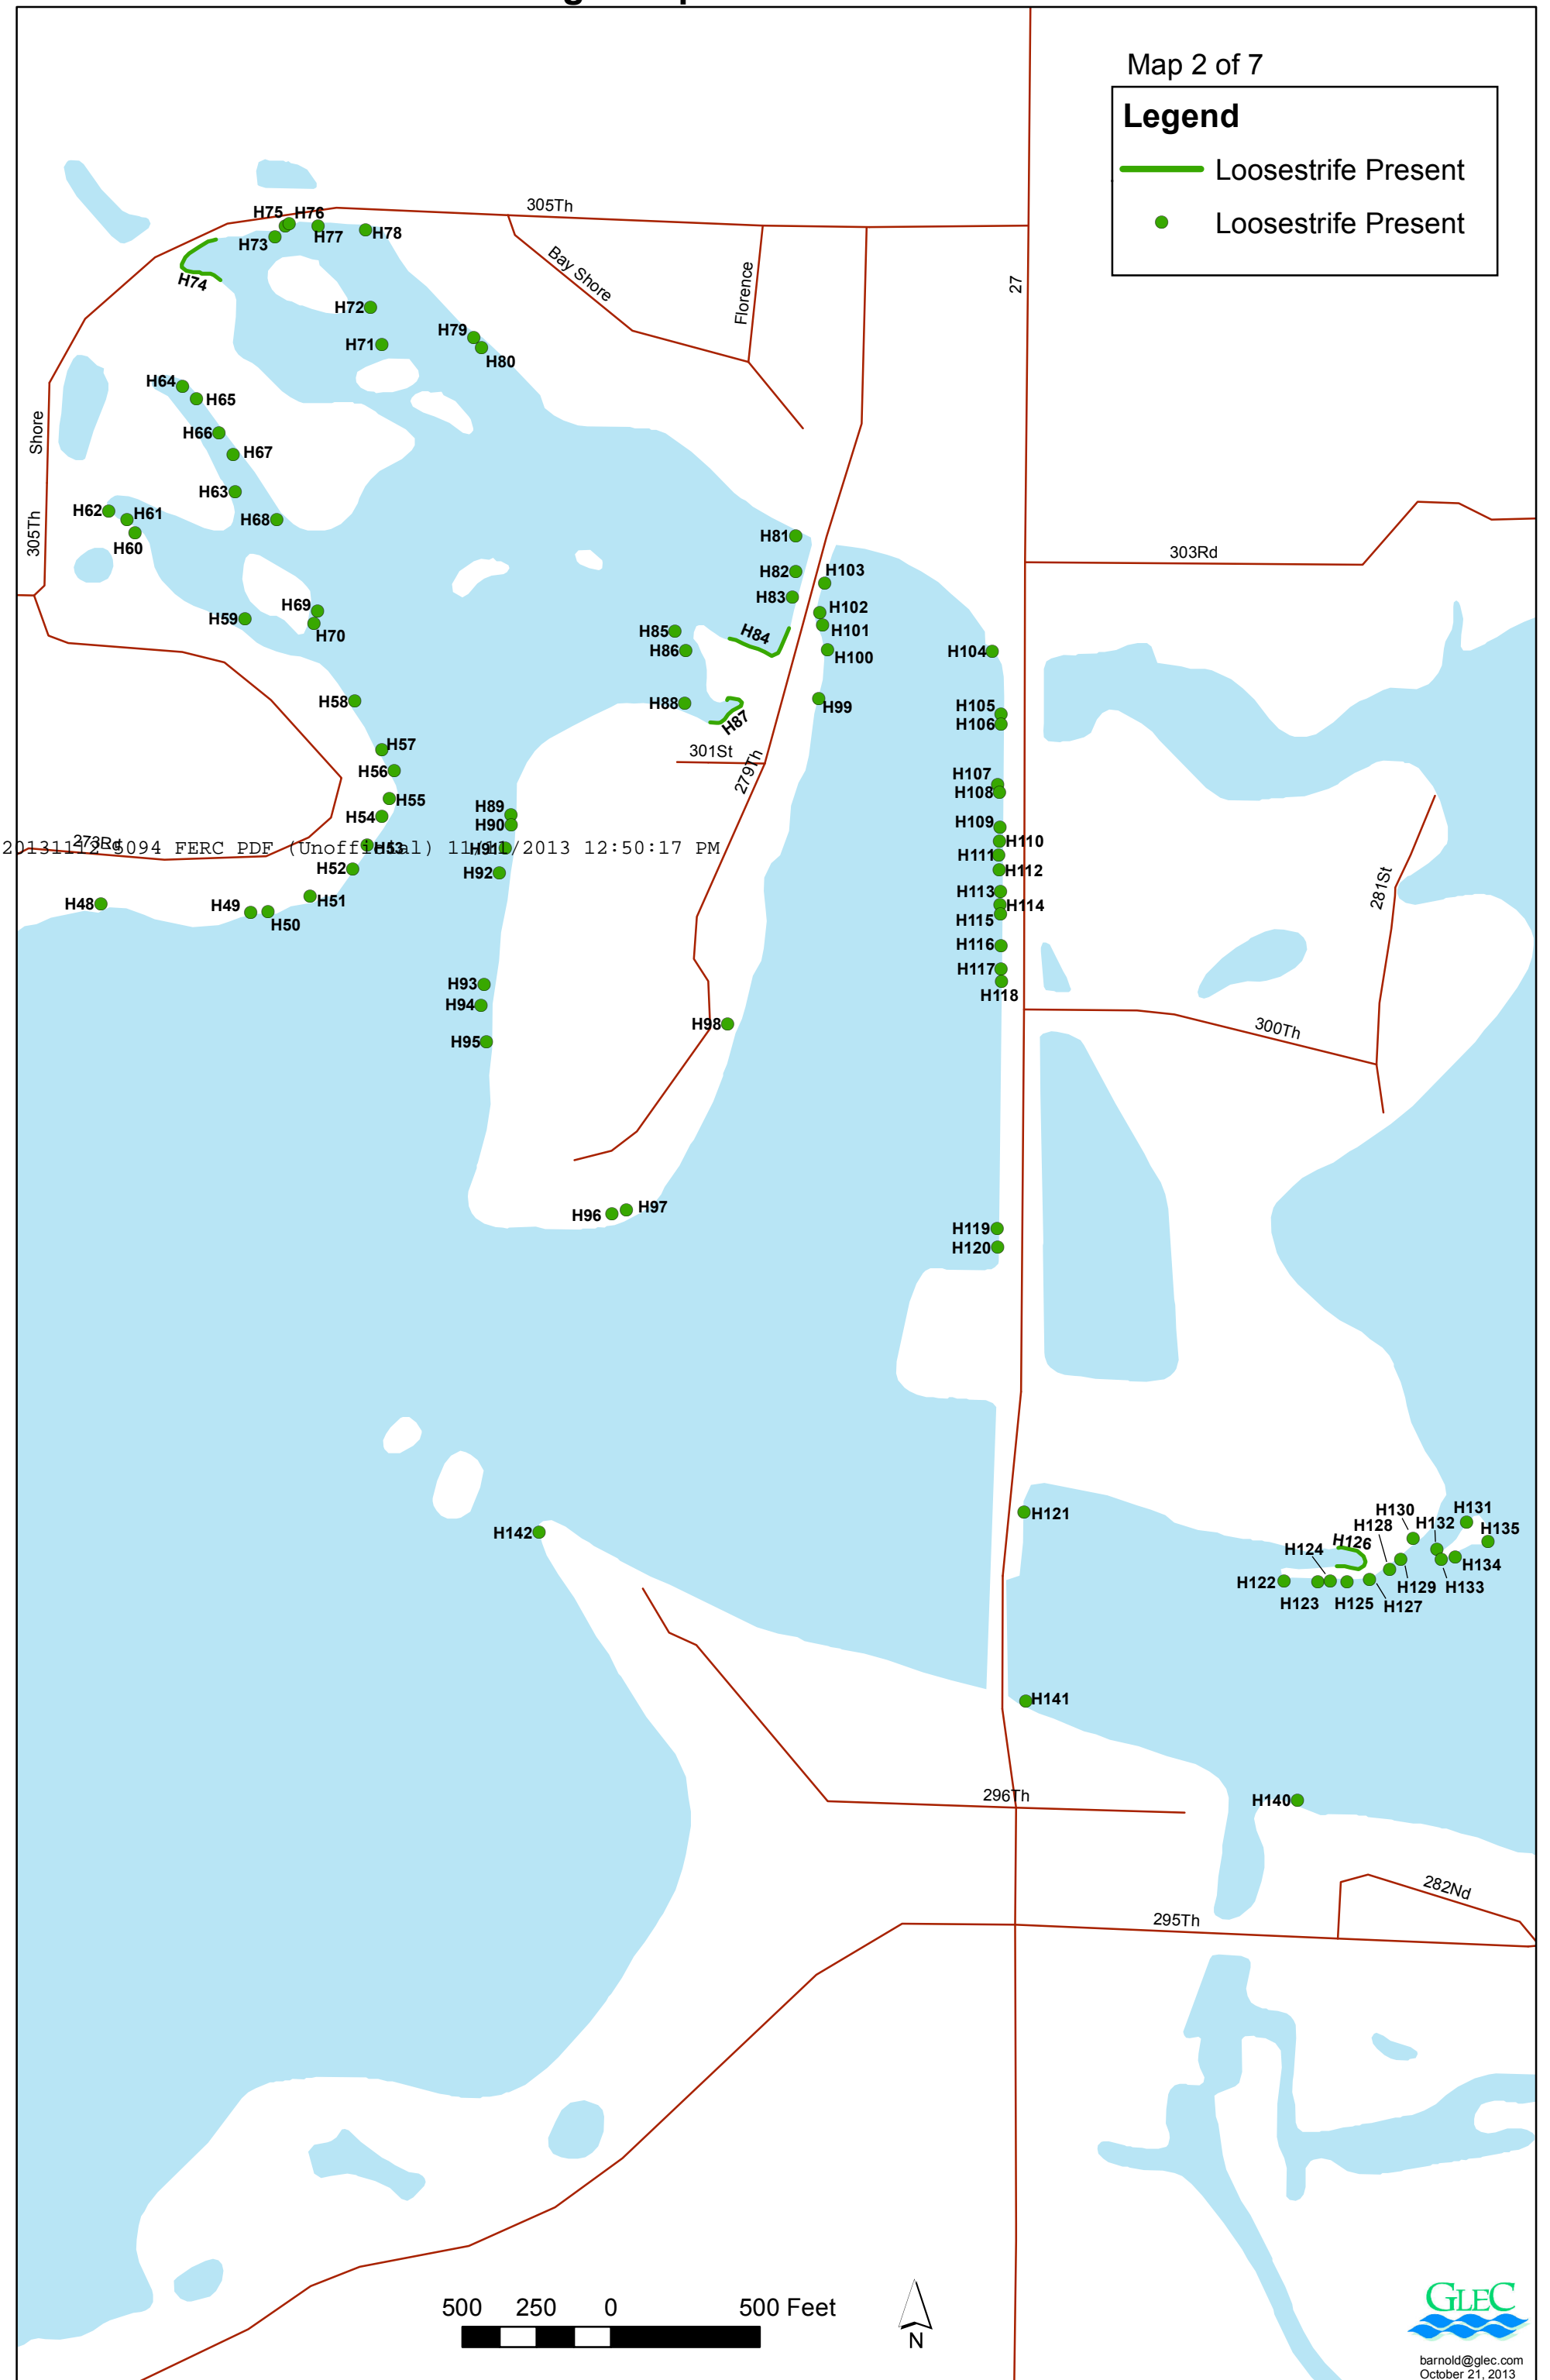
Map 2 of 7

The majority of plants on Lake Holcombe were again found in the area on and around Pine Island and along Highway 27. While a comparison to the 2012 survey shows a clear increase in the overall loosestrife populations in this area (see Holcombe Map 2); the level of infestation is not as great as the historic levels seen over the past decade. Several small infestations were again found just to the east of the Highway 27 Bridge. This area showed a slight increase from last year's survey. The only area of abundant plant growth documented in 2012 was classified as present in 2013, indicating a general decline in the number of plants in this area. No purple loosestrife was found in Main Creek, Jump River, Pine Lake, or Cranberry Lake.

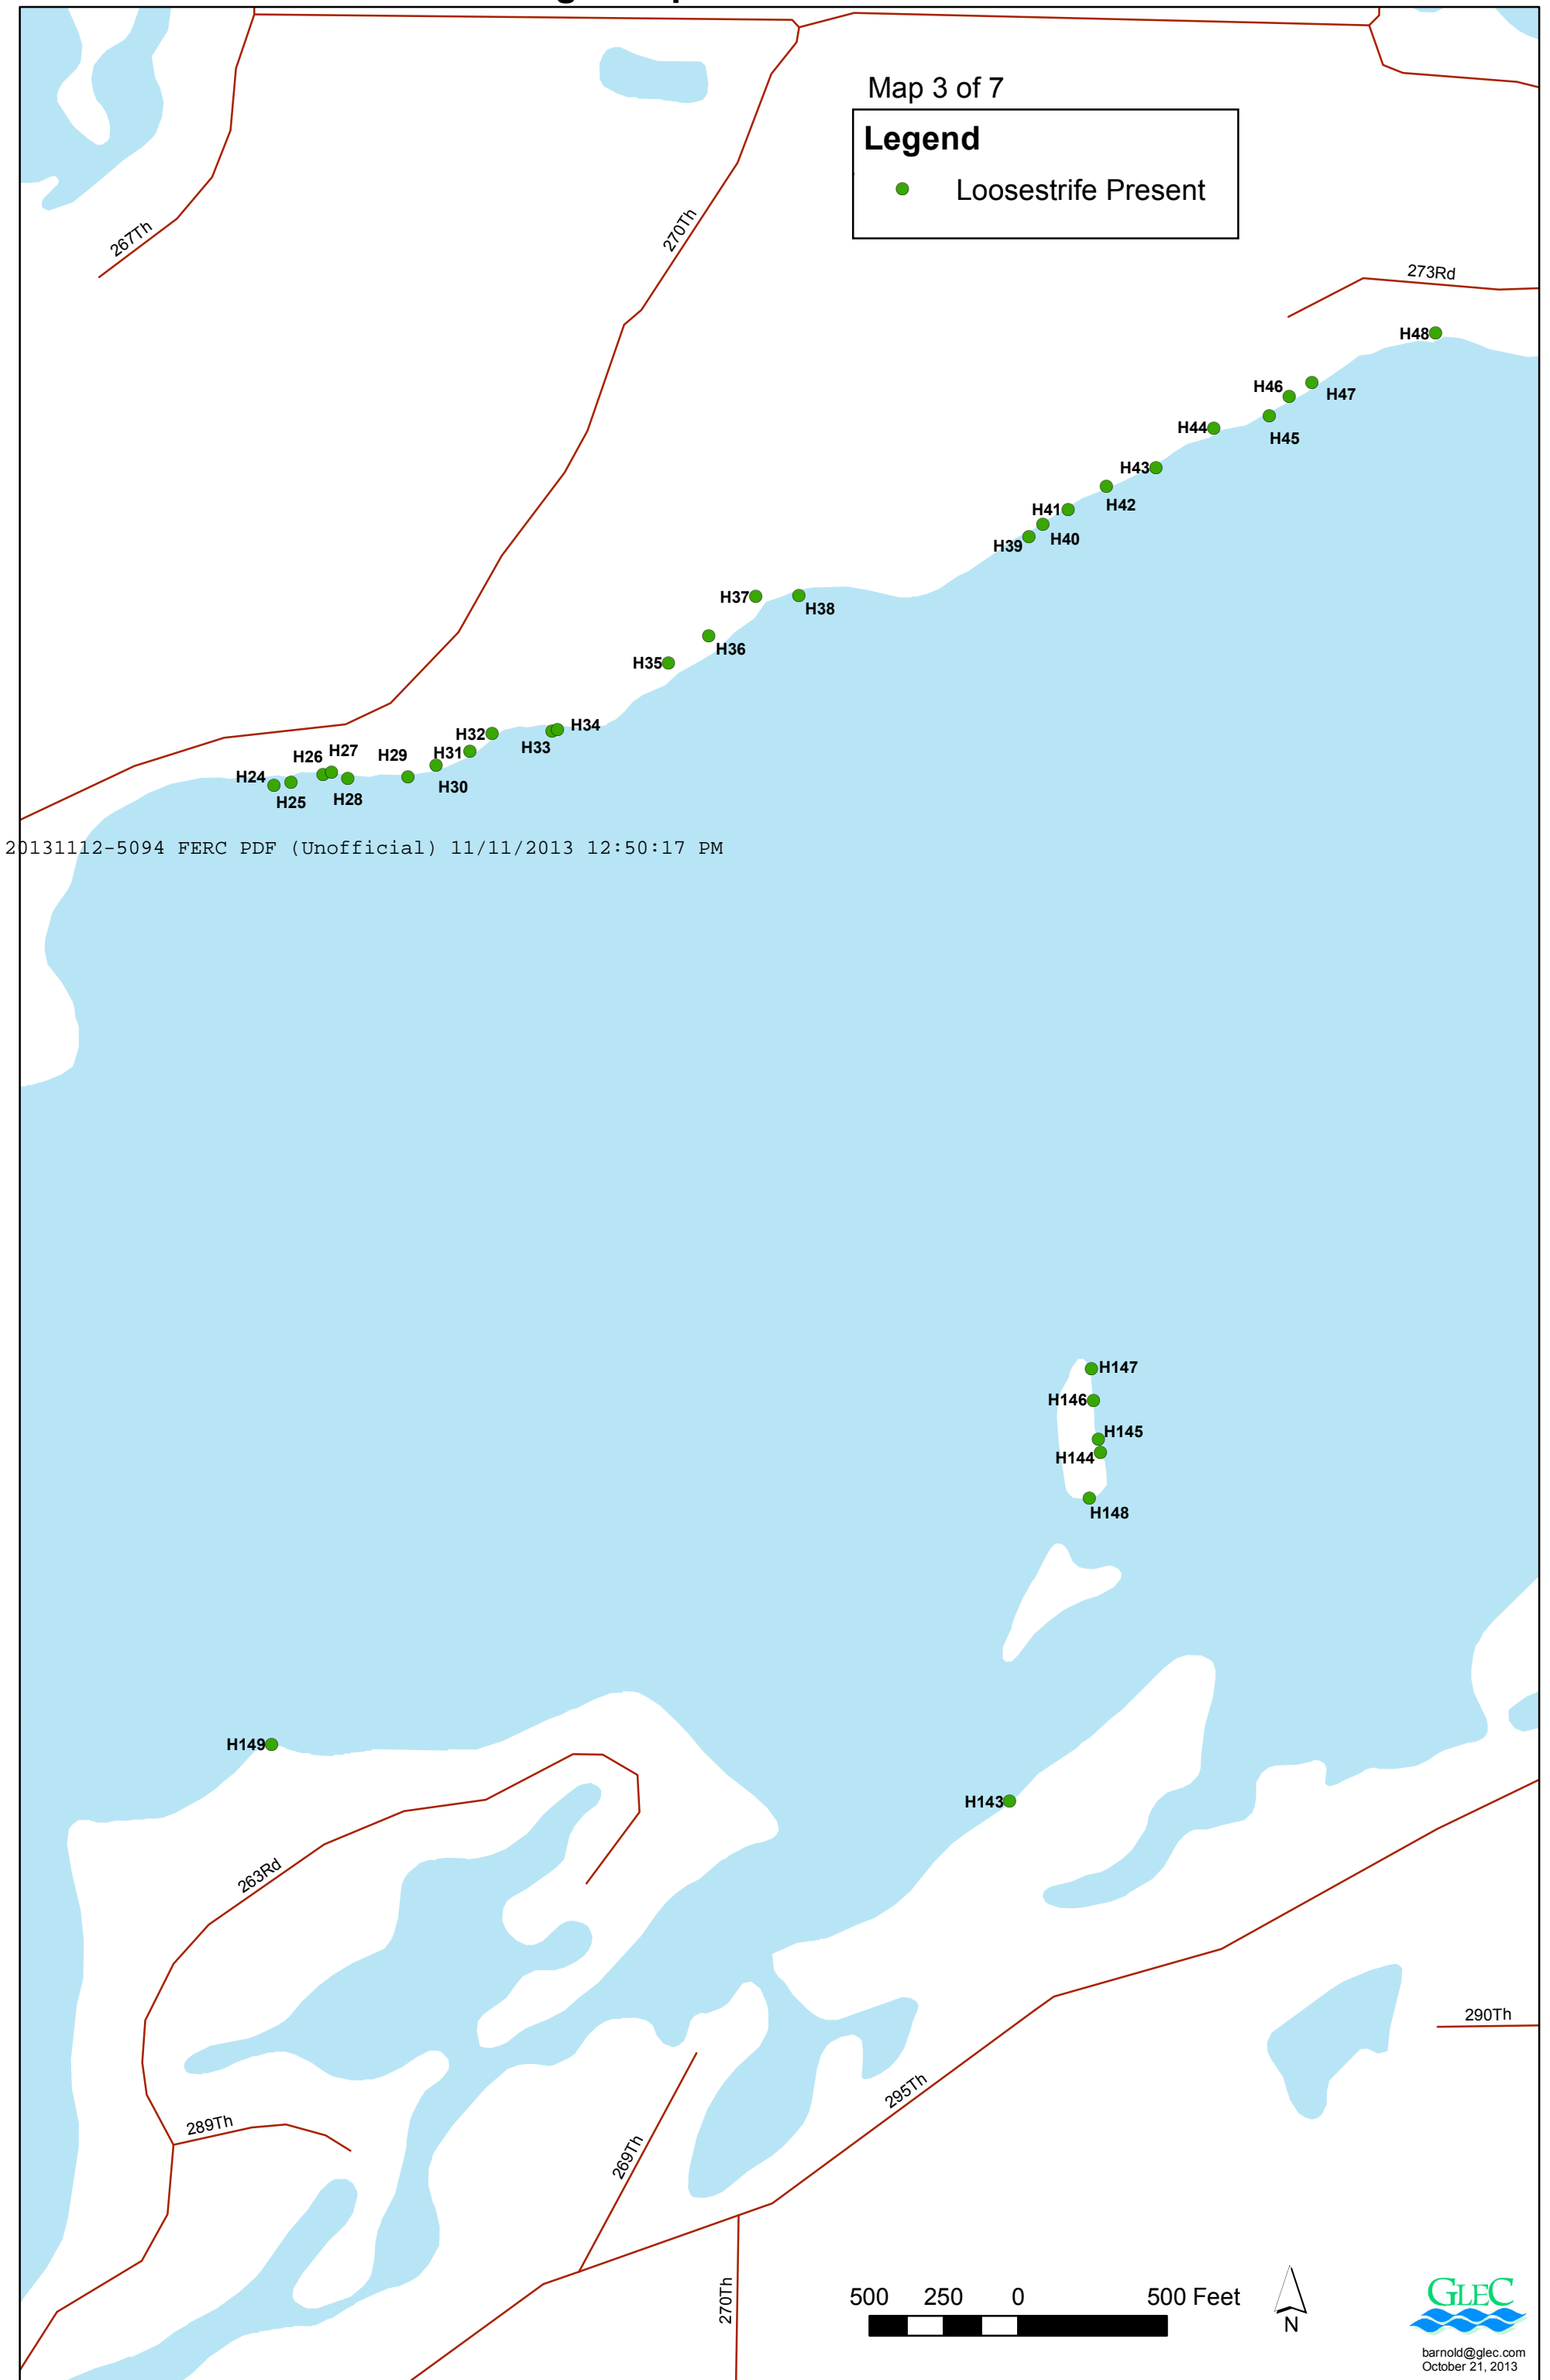
Map 3 of 7

Several plant clumps were found scattered along the north and south shores of the main flowage (see Holcombe Map 3 and 4) with many of these plants having been documented in the past. The large islands near the south shore of the main flowage also contain several plants. Overall, there was a general increase in plant density in the main basin.

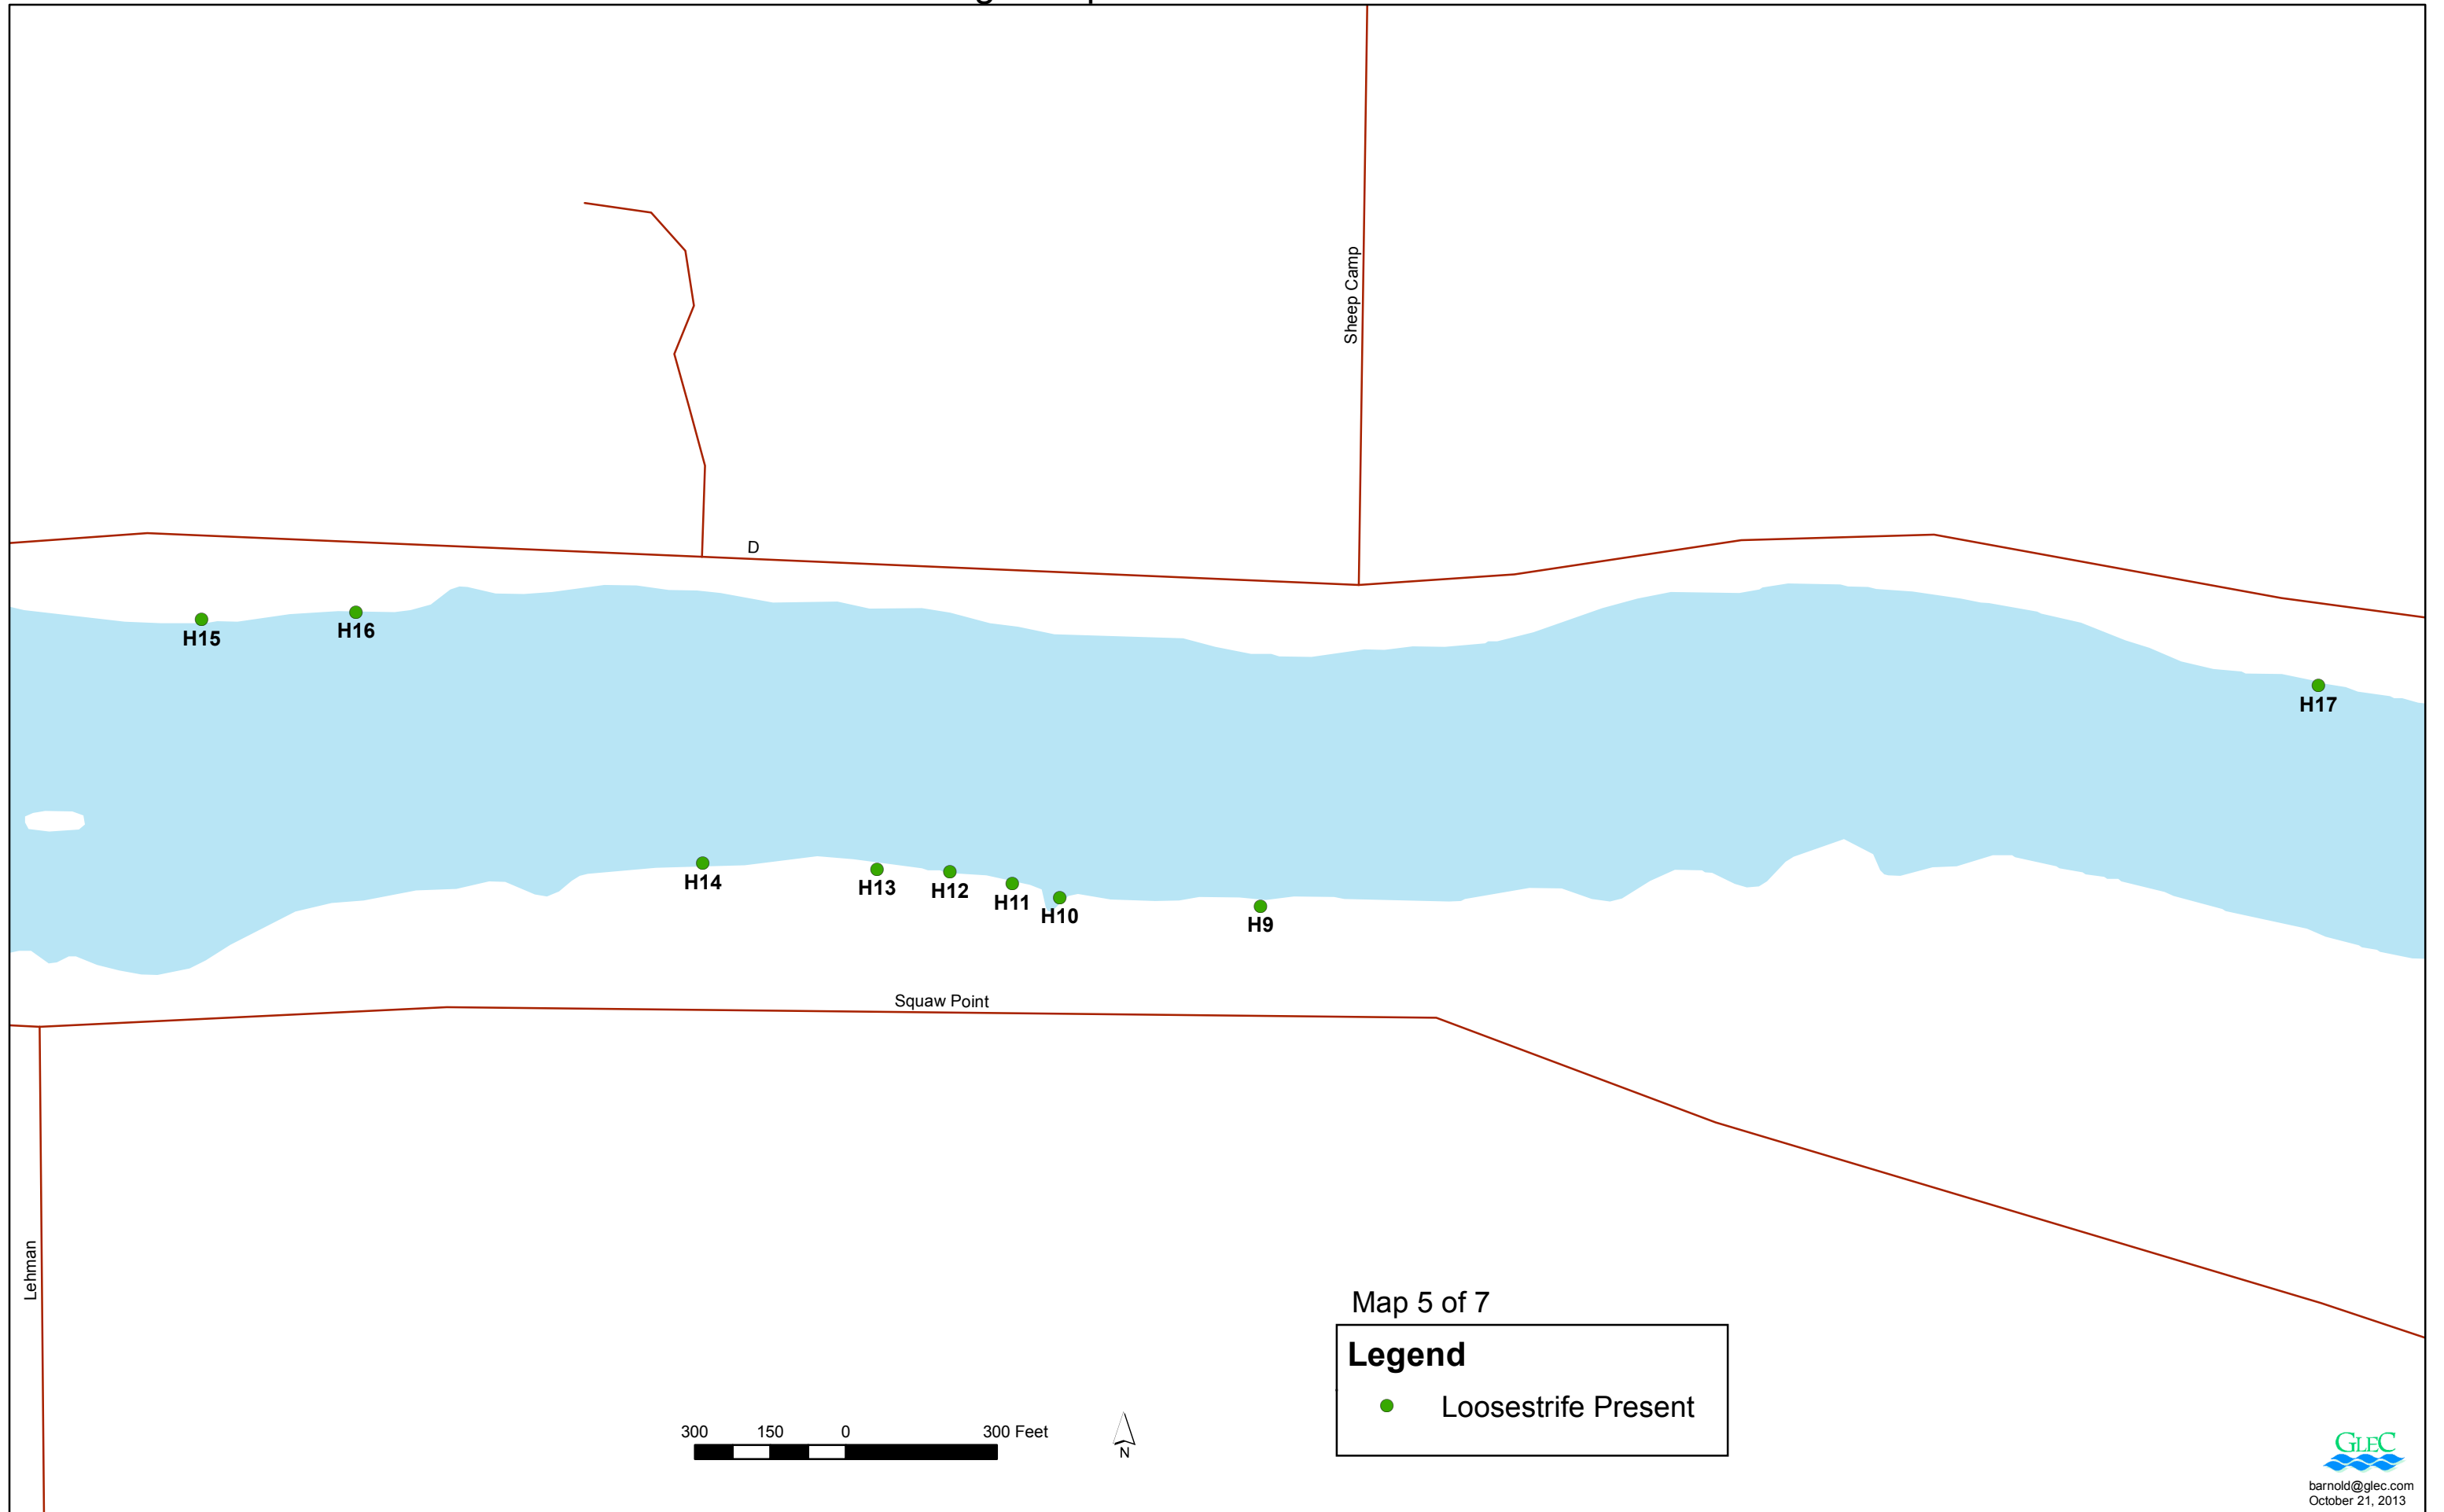
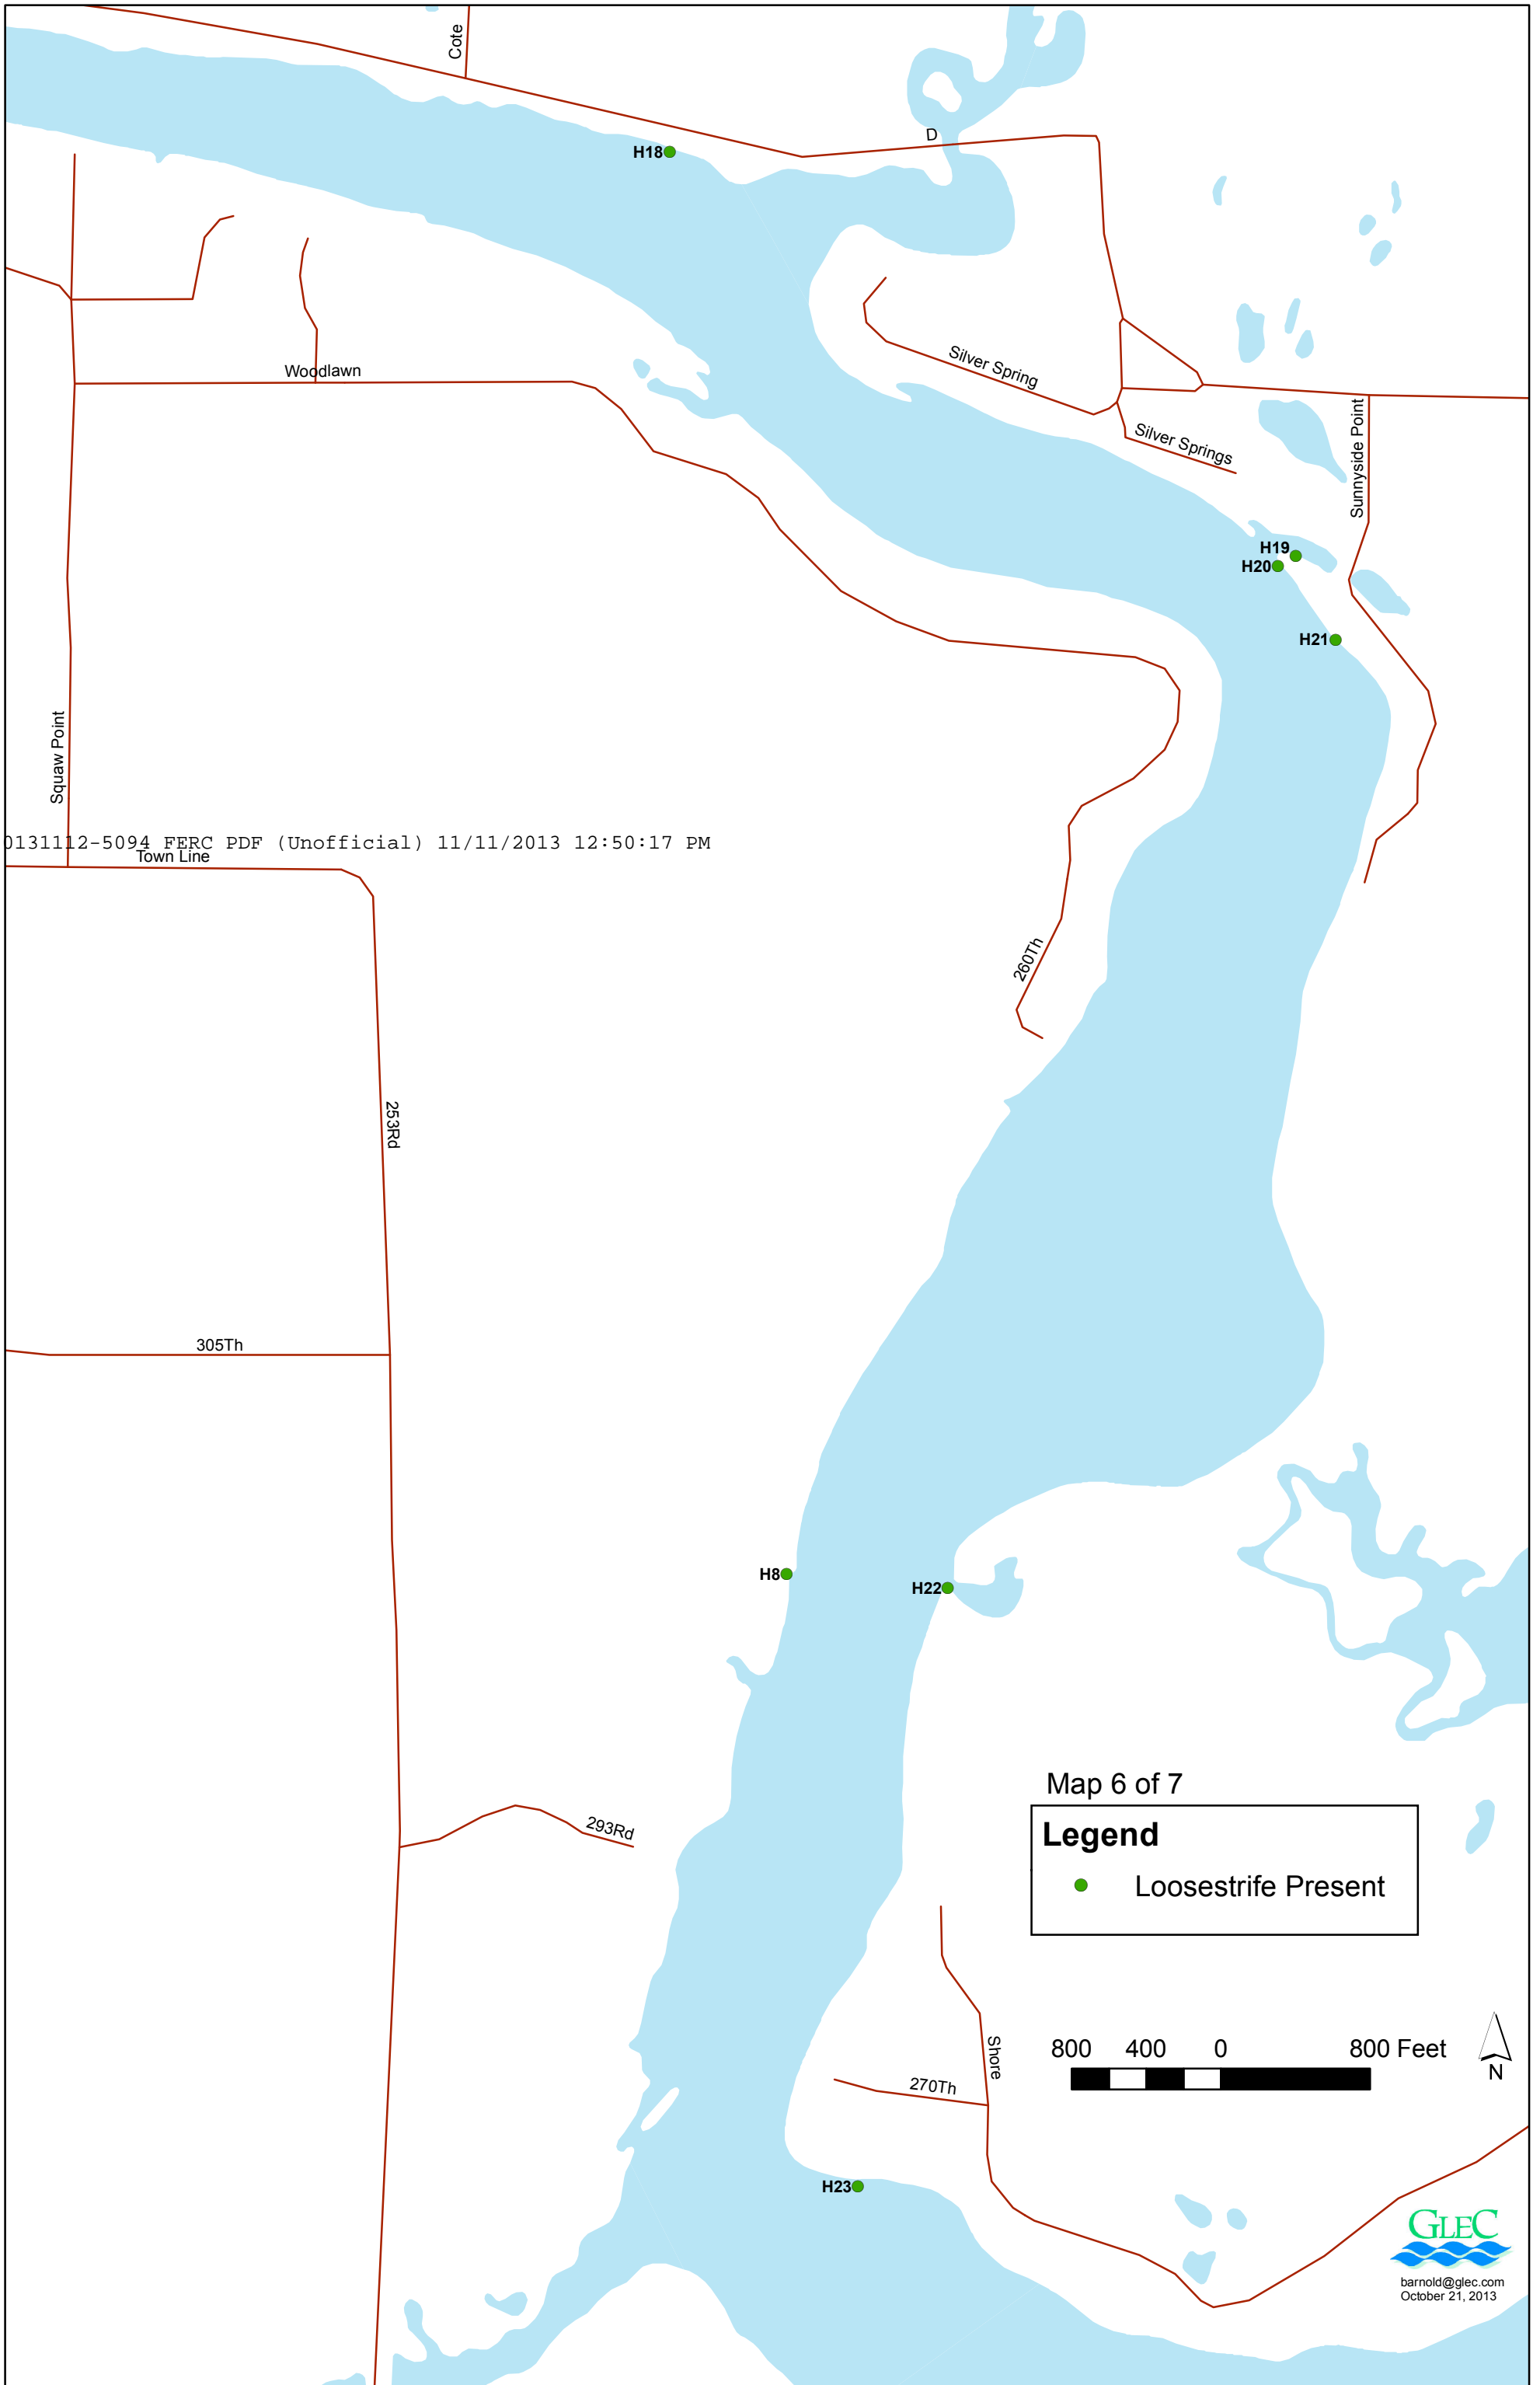
The upstream reach of the flowage (see Holcombe Maps 5 and 6) also contains a number of purple loosestrife plants that have been noted in past surveys. The overall plant density in these areas was similar to what was documented in 2012.

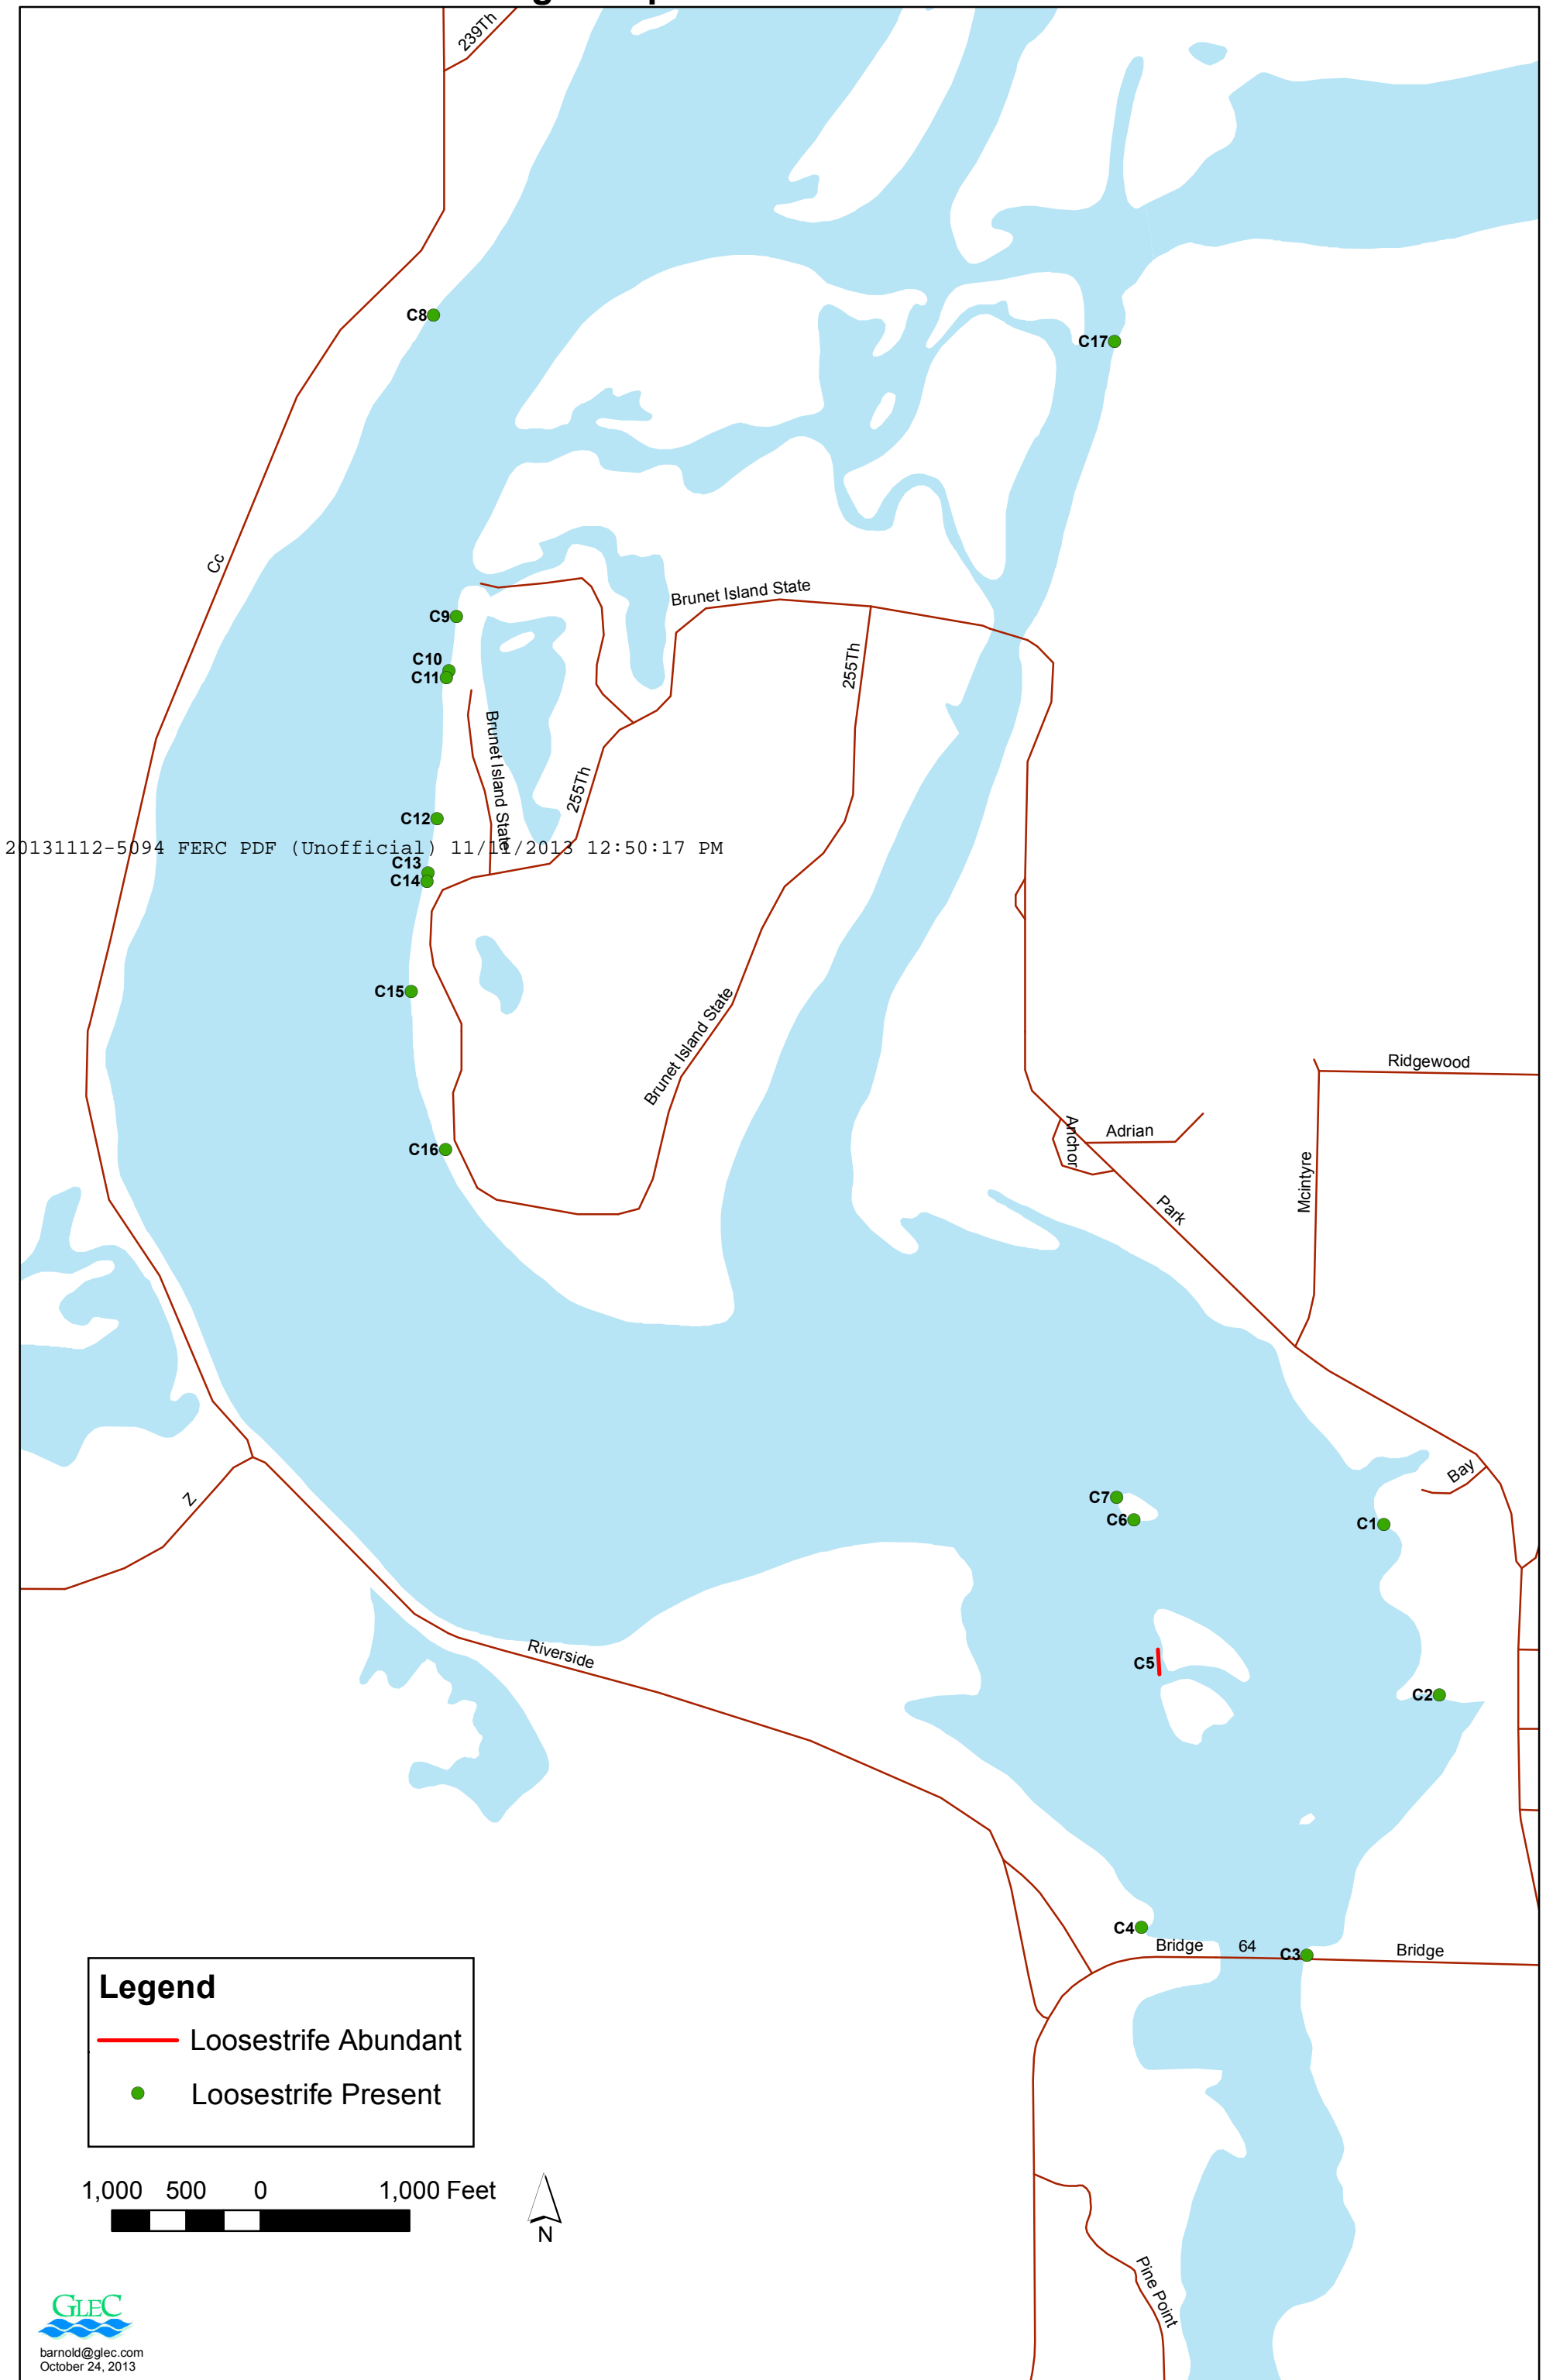
# Cornell Flowage Purple Loosestrife Assessment - 2013

Cornell Flowage was found to contain 16 small infestations of purple loosestrife (classified as present) and one location classified as abundant (see map of Cornell Flowage). All of these locations had been noted in surveys from the last several years. The only abundant location was found in a low lying area on an island just upstream from the State Highway 64 Bridge. Although this location was classified as present in 2010, it has been classified as abundant in several previous surveys, including 2012. A total of 139 feet of shoreline was found to contain purple loosestrife in 2013, compared to 155 feet in 2012.
