**Subject: 2013 Purple Loosestrife Monitoring Report  
Holcombe Hydro (P-1982), Cornell Hydro (P-2639), Jim Falls Hydro  
(P-2491), Wissota Hydro (P-2567), Chippewa Falls Hydro (P-2440) and  
Dells Hydro (P-2670)**

***PURPLE LOOSESTRIFE ASSESSMENT – 2013***

**Dells Pond, Chippewa Falls Flowage, Lake Wissota, Old Abe Lake, Cornell  
Flowage, Lake Holcombe and Jim Falls Spillway Channel**

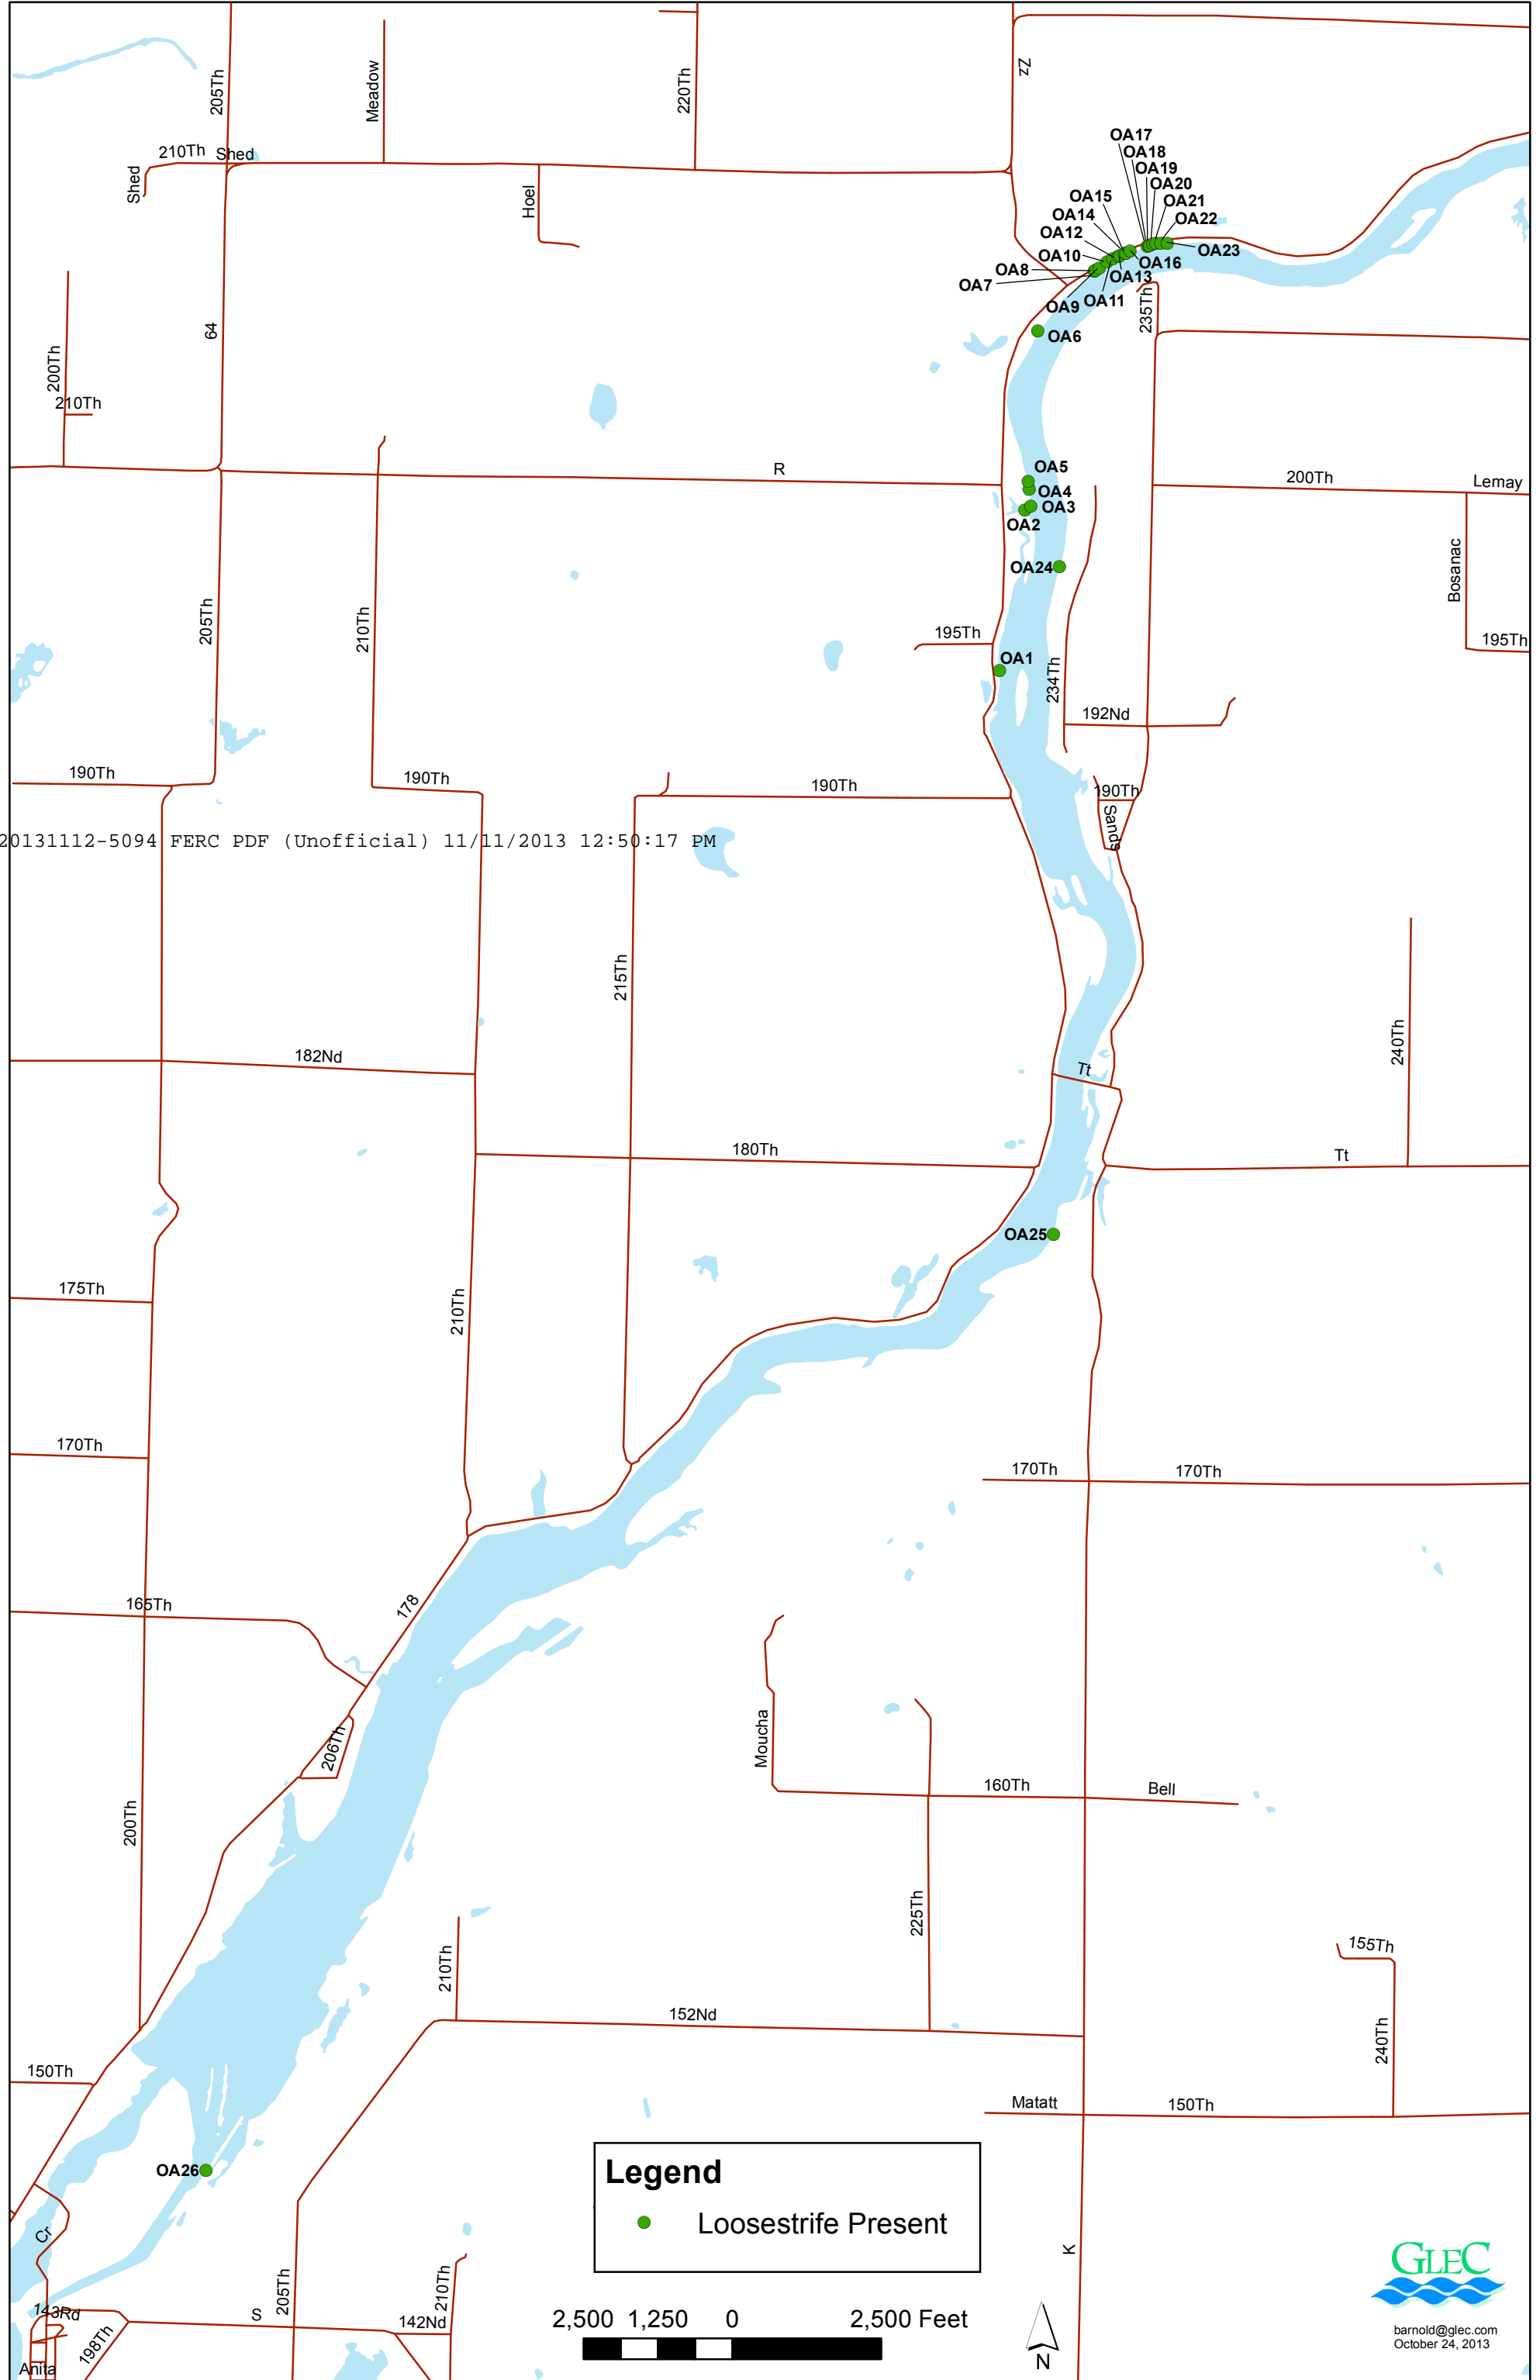
# Old Abe Flowage Purple Loosestrife Assessment - 2013

Twenty-six areas of loosestrife infestation were found on Old Abe Lake (see map of Old Abe Flowage) all of which were classified as present. This represents a slight increase in plant abundance from last year. Twenty-four locations were noted in the upper reaches of the flowage and consisted of single plants or a few plant clumps, many of which had been noted in past surveys. The single location documented last year near the downstream end of the flowage was noted again this year while a new single location was noted in the central portion of the flowage. The total amount of shoreline infested by purple loosestrife this year on Old Abe Lake was approximately 142 feet. This compares to 76 feet in 2012.

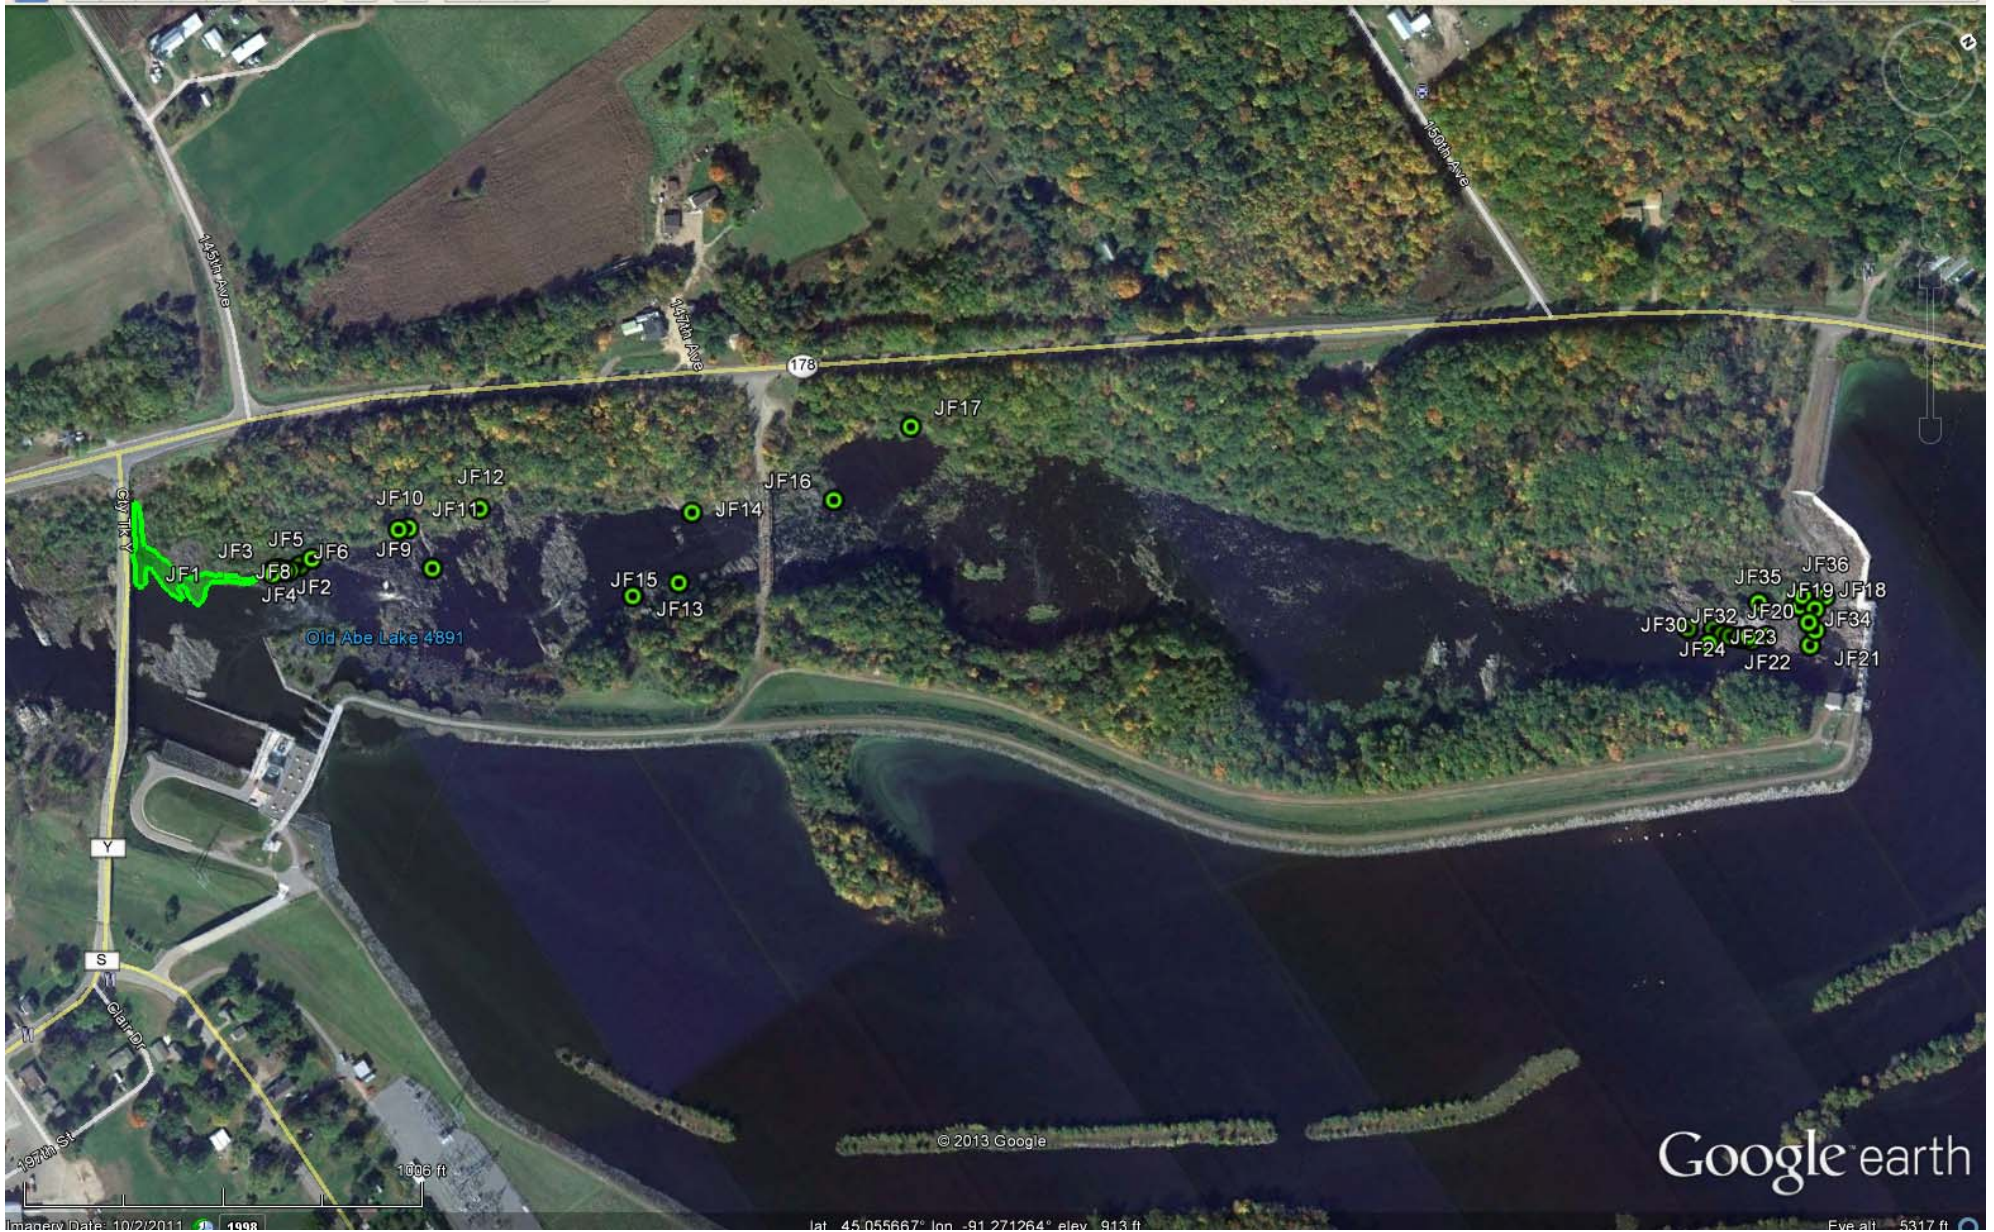
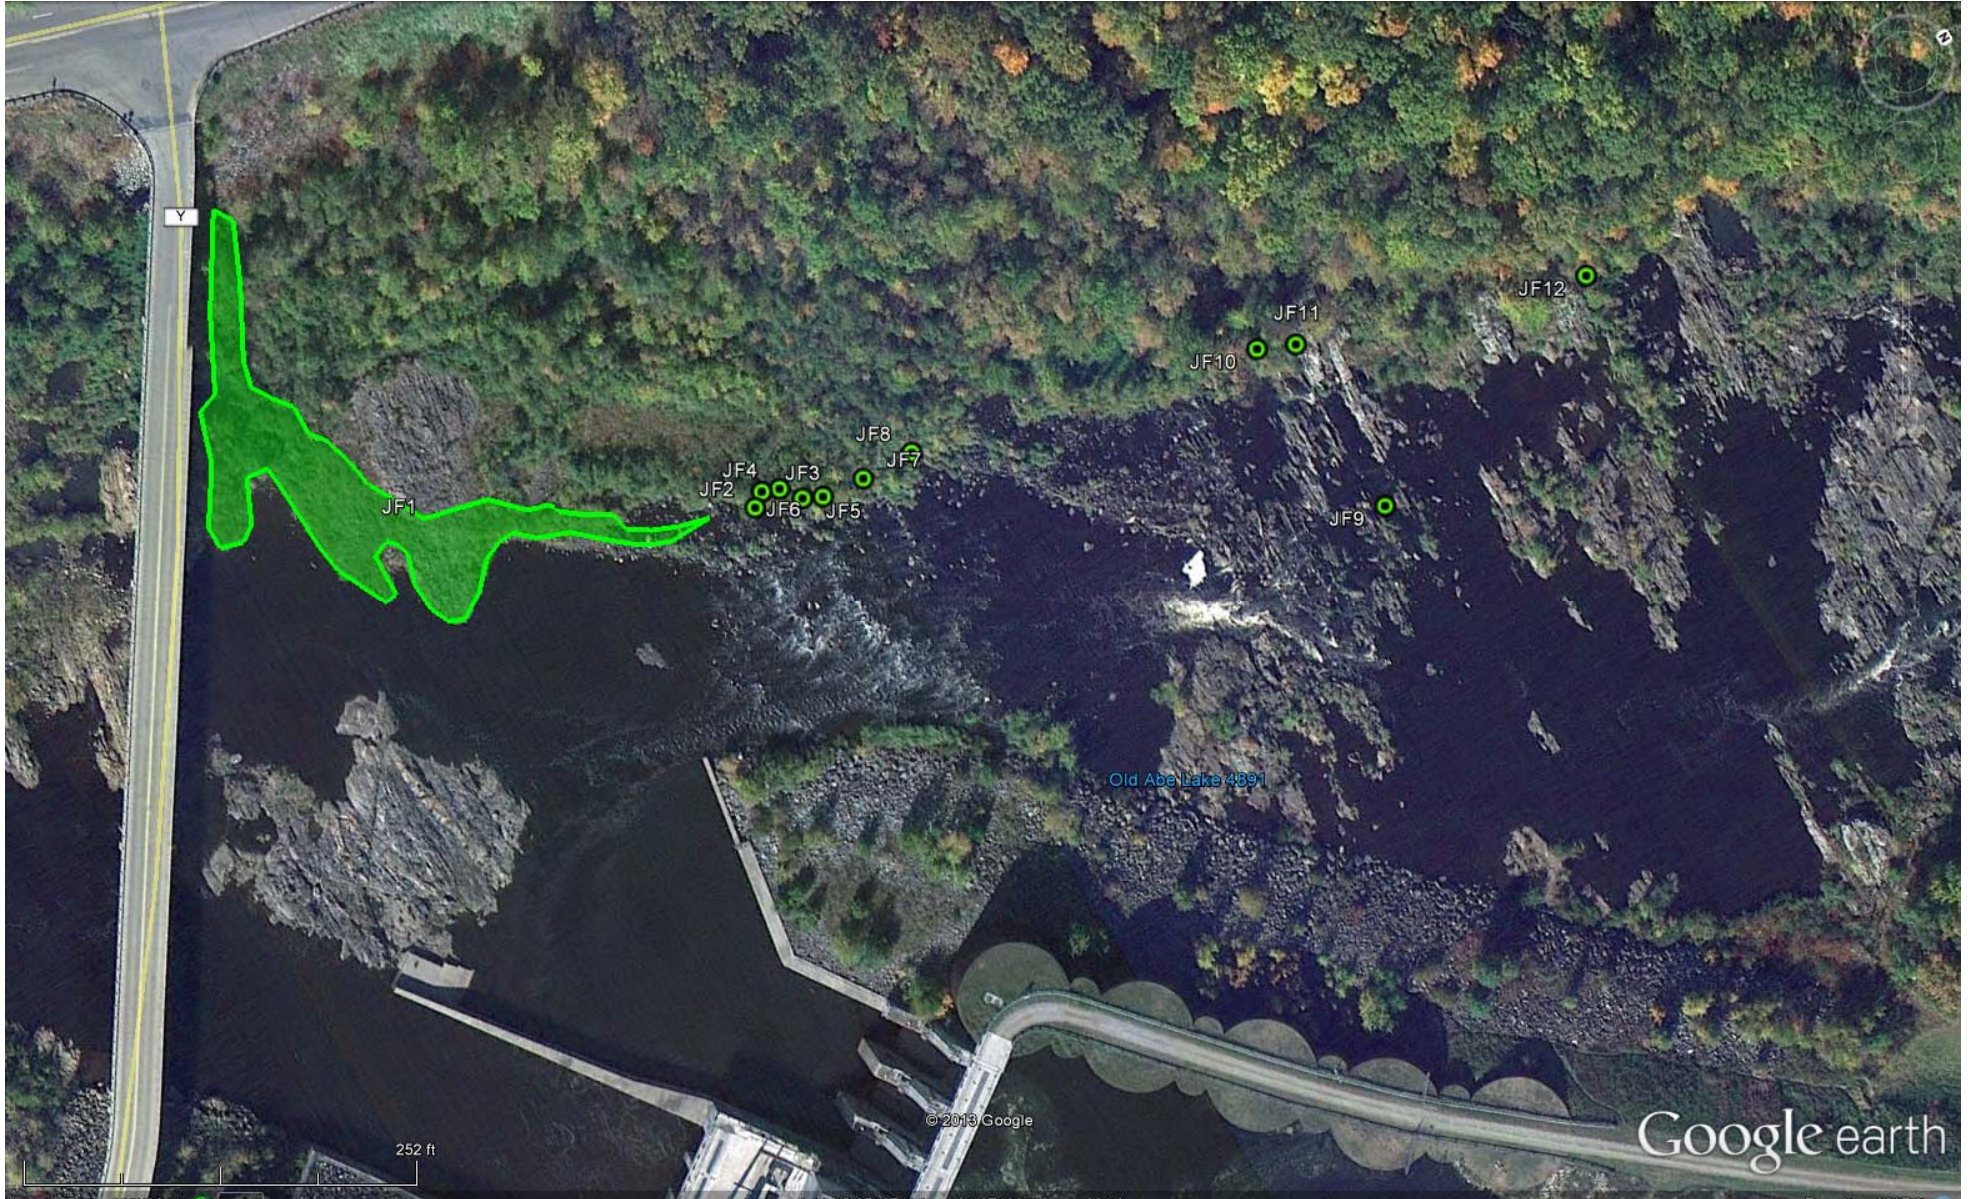
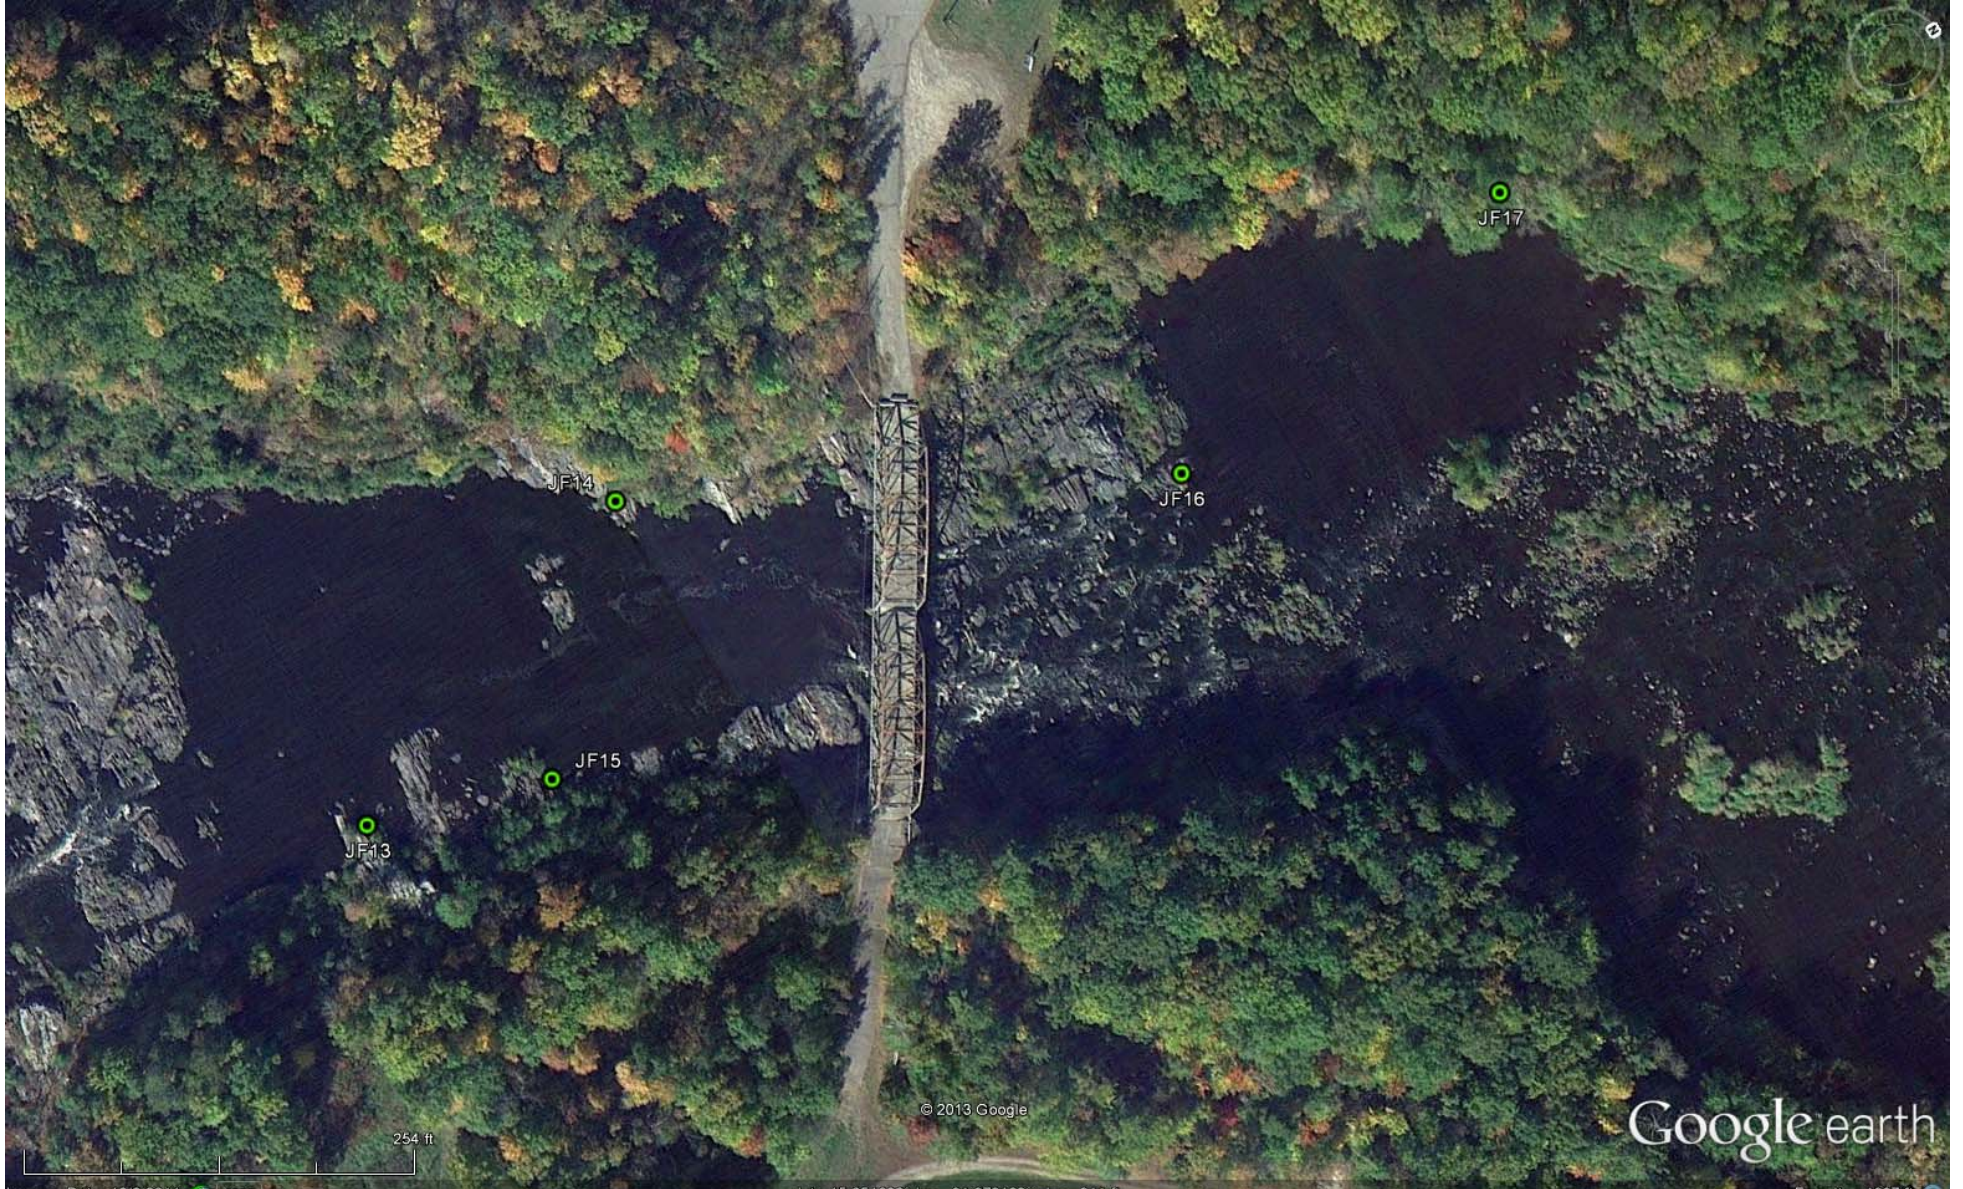
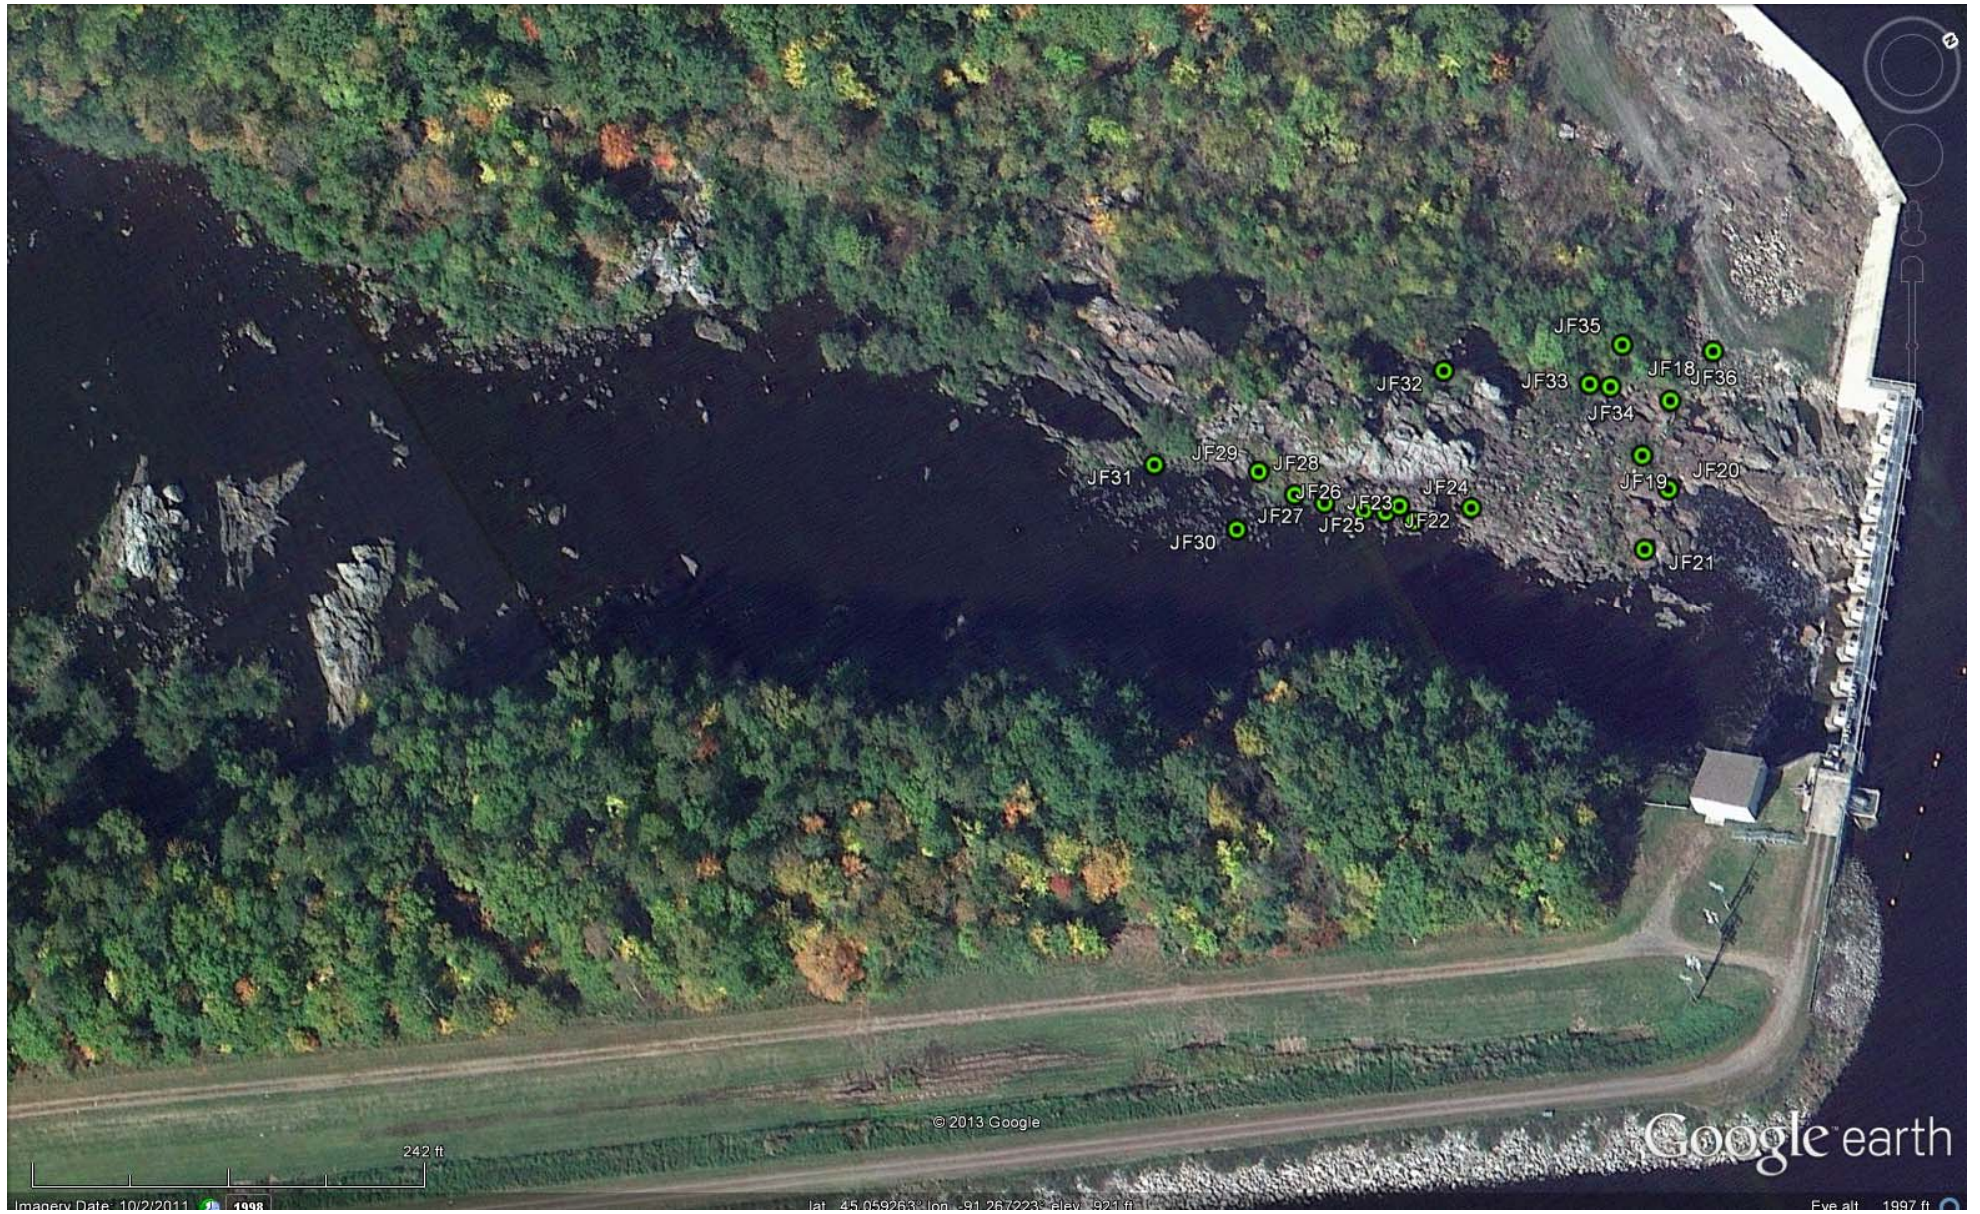
# Jim Falls Spillway Channel Purple Loosestrife Assessment – 2013 (Map 1 of 4)

The minimum flow channel at Jim Falls Hydro remains an area with a relatively high concentration purple loosestrife plants. A significant decrease in the number of plants was noted in 2012; however, plant numbers have rebounded somewhat this year (Table 3). Loosestrife was found scattered throughout the channel, with the lower third of the channel being moderately infested (see maps of Jim Falls Spillway Channel). The area of greatest concentration occurs in the area just upstream from the County Highway Y Bridge (see Jim Falls Spillway map 2). This area covers approximately 16,165 square feet (Table 4); however, the loosestrife is scattered throughout the area and therefore is not classified as abundant. The number of loosestrife locations increased from 19 in 2012 to 36 in 2013. Collectively, these amounted to 153 feet of infested shoreline versus 52 feet in 2012. Each of these locations was comprised of small plant clumps infesting between one and five feet of shoreline. Three years have passed since the introduction of the bio-control beetles. While it

is too early to make a determination as to their success, the fact that loosestrife levels have remained below those seen in 2011 and in previous years is encouraging.
