ANNUAL INSPECTION REPORT

BARRETT LANDFILL

New Berlin, Waukesha County, Wisconsin

January 18, 2018

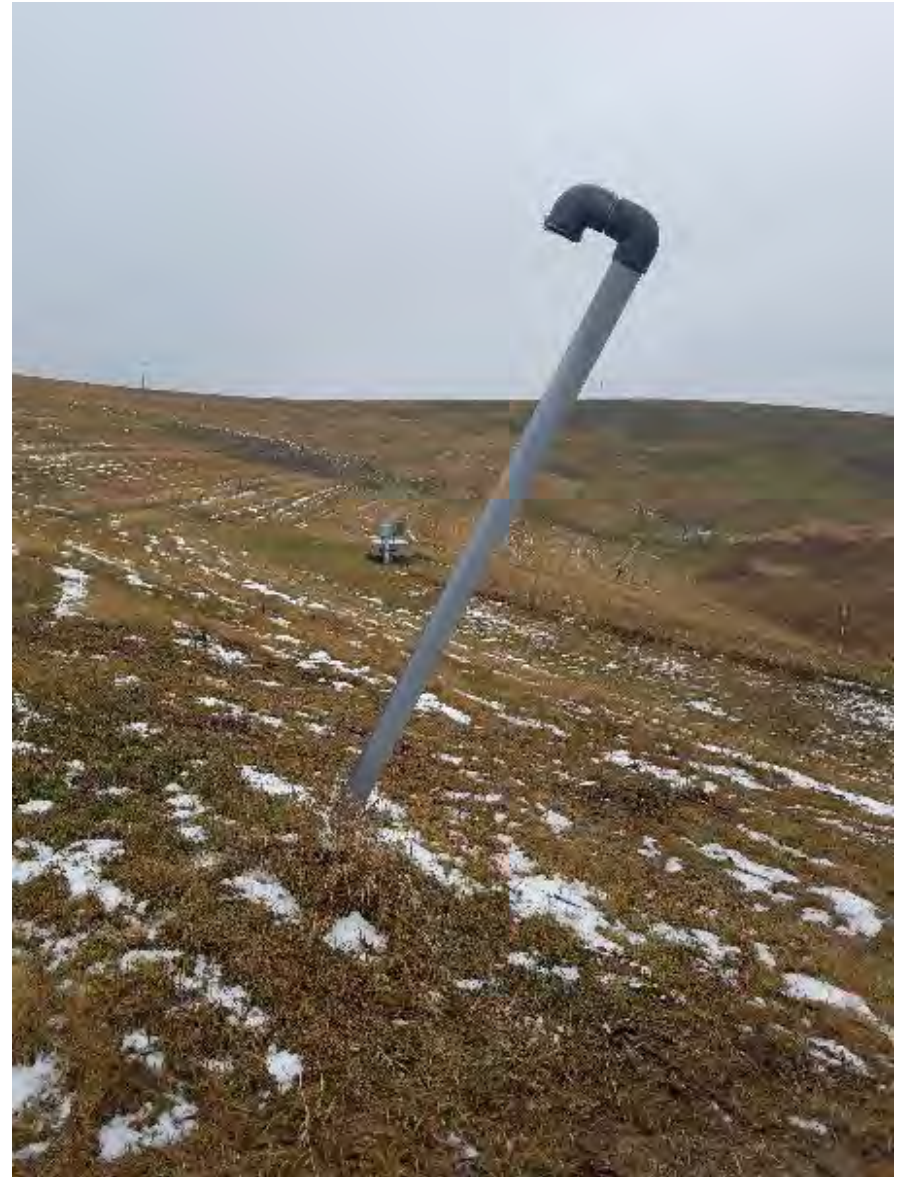
2. GV-2 tilting NE, looking

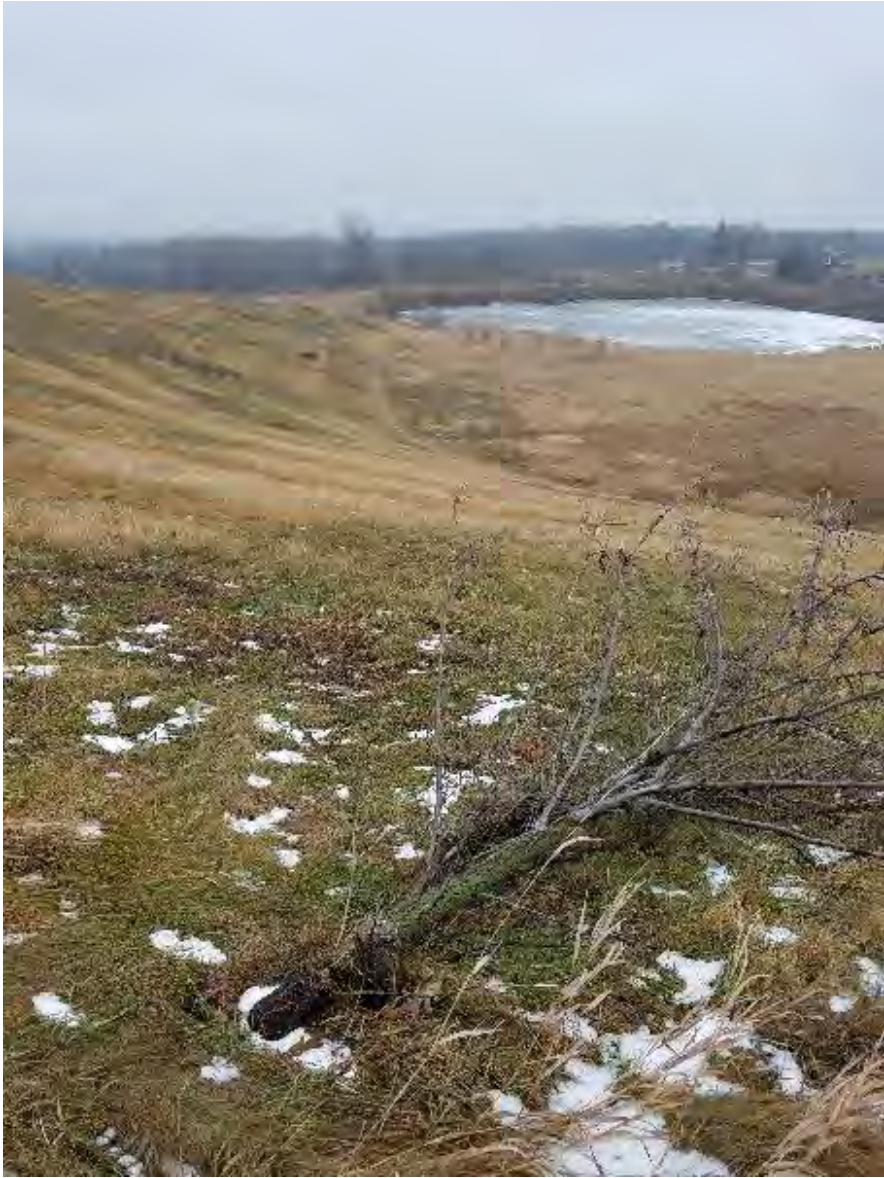
5. Tree/stump NW of GV-4, looking N

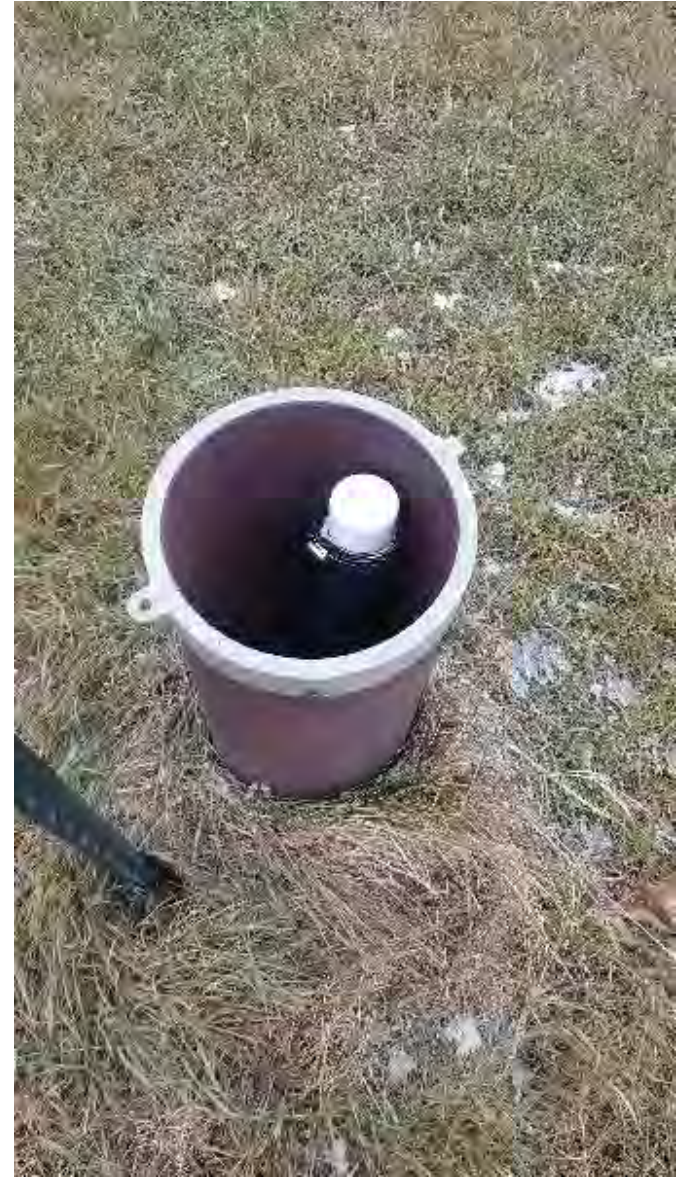
6. LHW on top of hill, SE of GV-17

- Leachate head wells (LHW) and unknown pipes will be identified or renumbered and placed on a revised Site Map.
- One LHW (near GV-46) had a hole/tear in the boot that will need to be repaired.
- If the protective casing is lockable, locks will need to be added. If the protective casing cannot be locked, a cap or plug that can be locked will need to be installed.

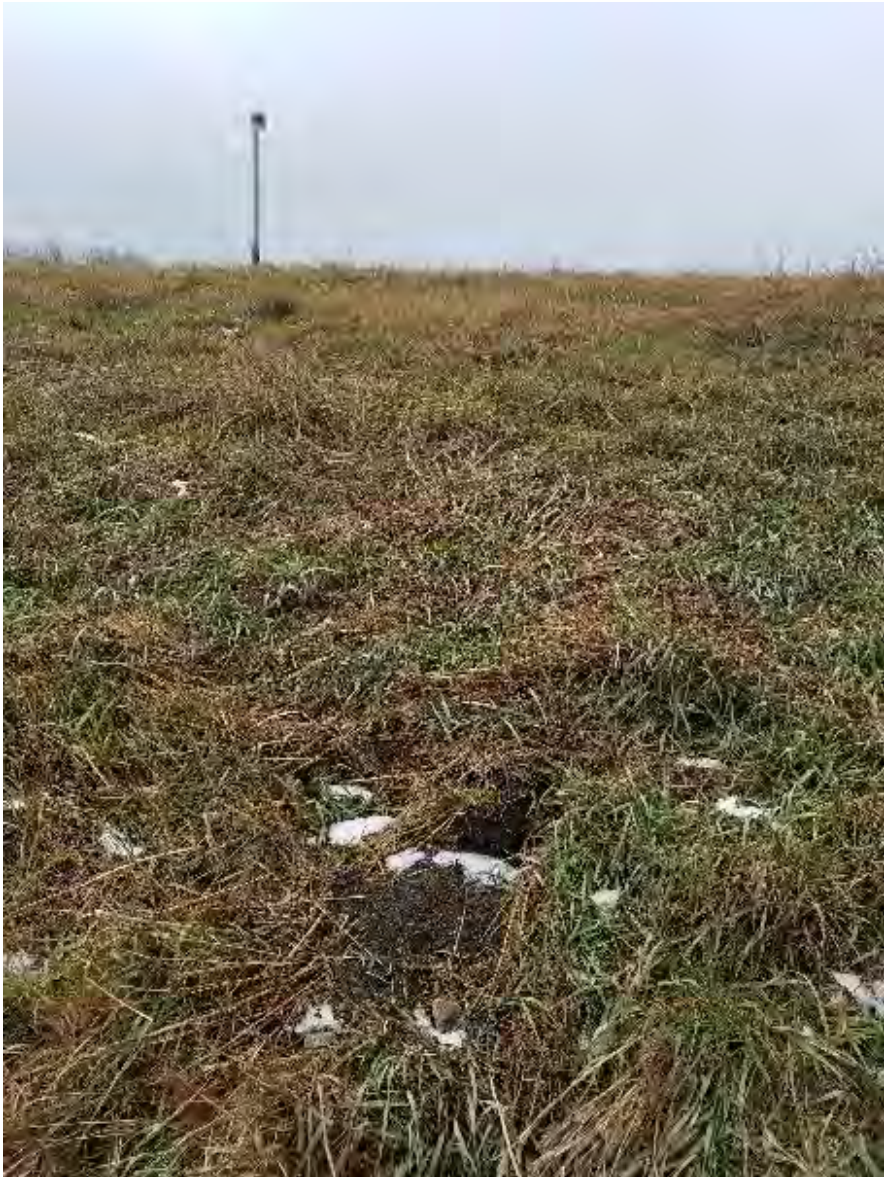
9. Animal burrow, looking SE towards GV-6

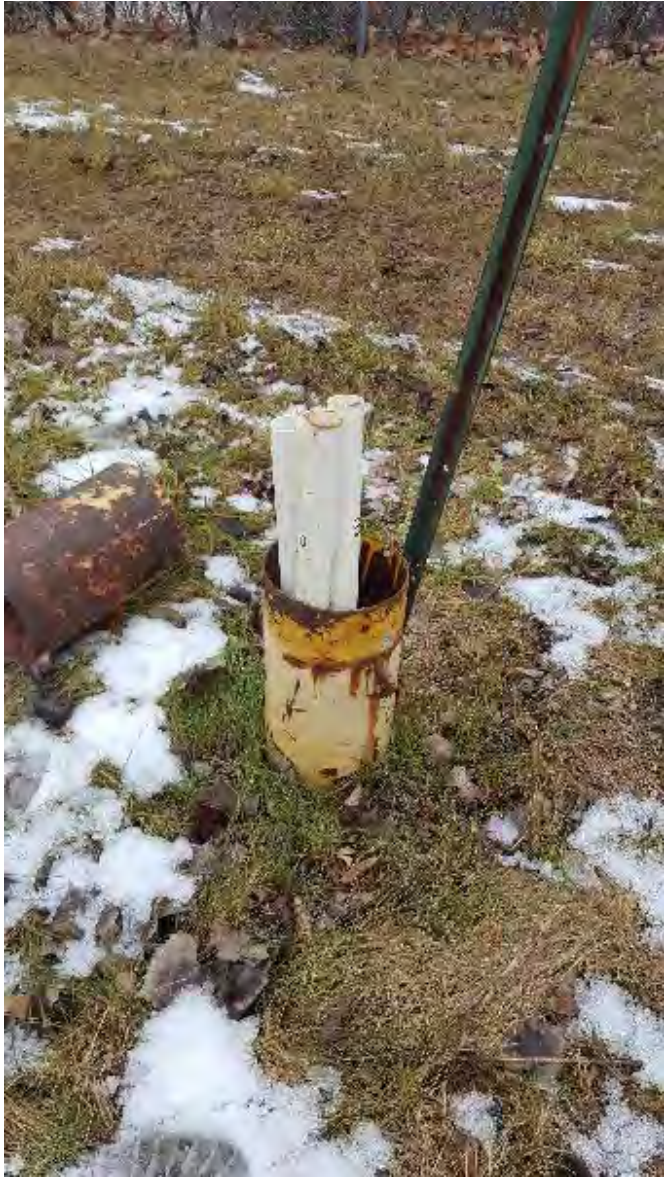
29. GP-9, looking E, no caps on individual probes

- Gas vents need to be renumbered. Some vents are not assigned a number and others are assigned duplicate numbers. The newly numbered vents will be placed on a revised Site Map.
- Five gas vents (GV-3, GV-11, GV-18, GV-50, and an unmarked gas vent near GP-9) had holes or tears in the boots at the base of the vent. Hose clamps need to be replaced on GV-17 (a duplicate number) and GV-26. Screens need to be replaced on GV-1 and GV-33, and screens need to be cleared (not fully blocking screen) at GV-2 and GV-50.
- Gas probes GP-3, GP-5 and GP-12 need locks as there are none on these protective casings. GP-1, GP-2S/D, GP-5S/M/D, GP-6S/M/D, GP-9S/M/D and GP-10S/M/D need caps on the individual probes; the vented caps that were present on gas probes were plugged with mud and should all be replaced (27 caps in total).

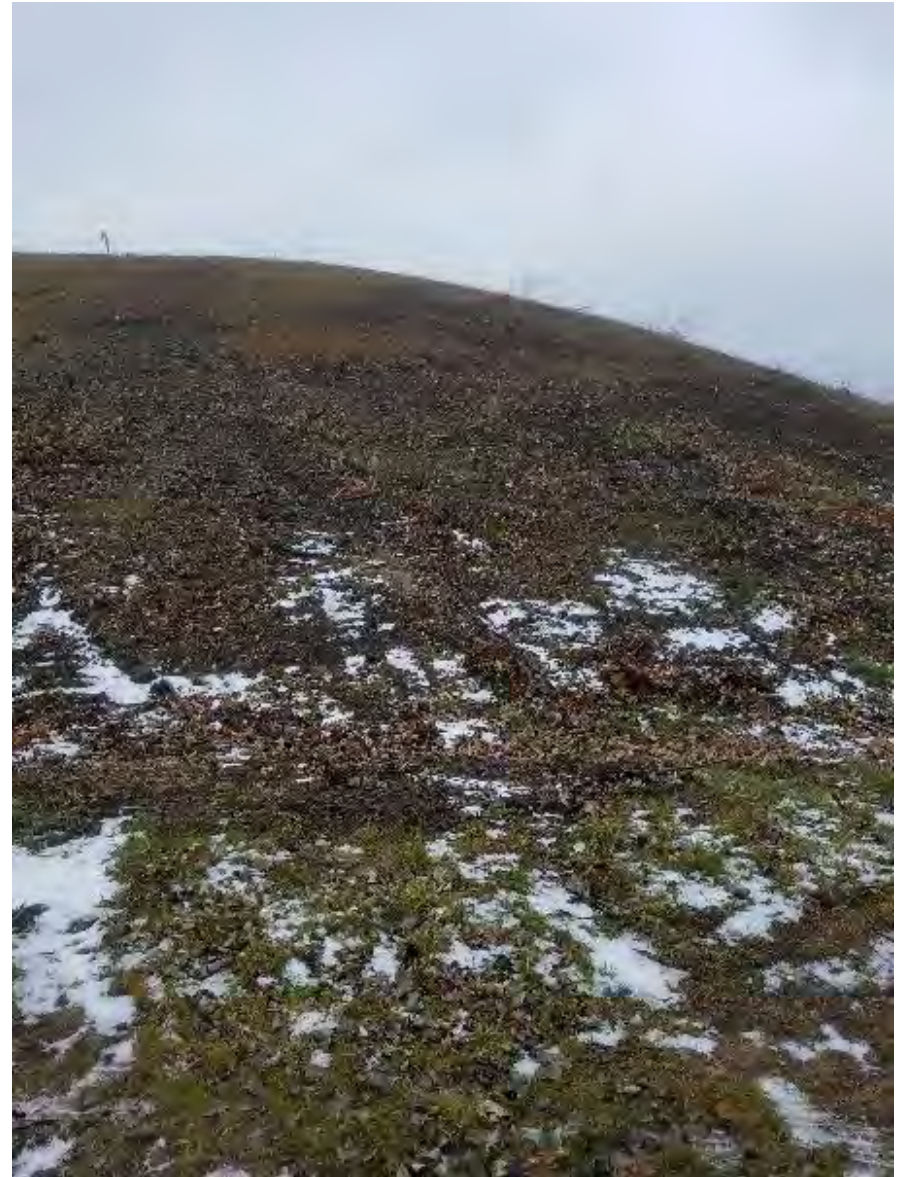
34. SE corner of LF, looking N towards GV-3

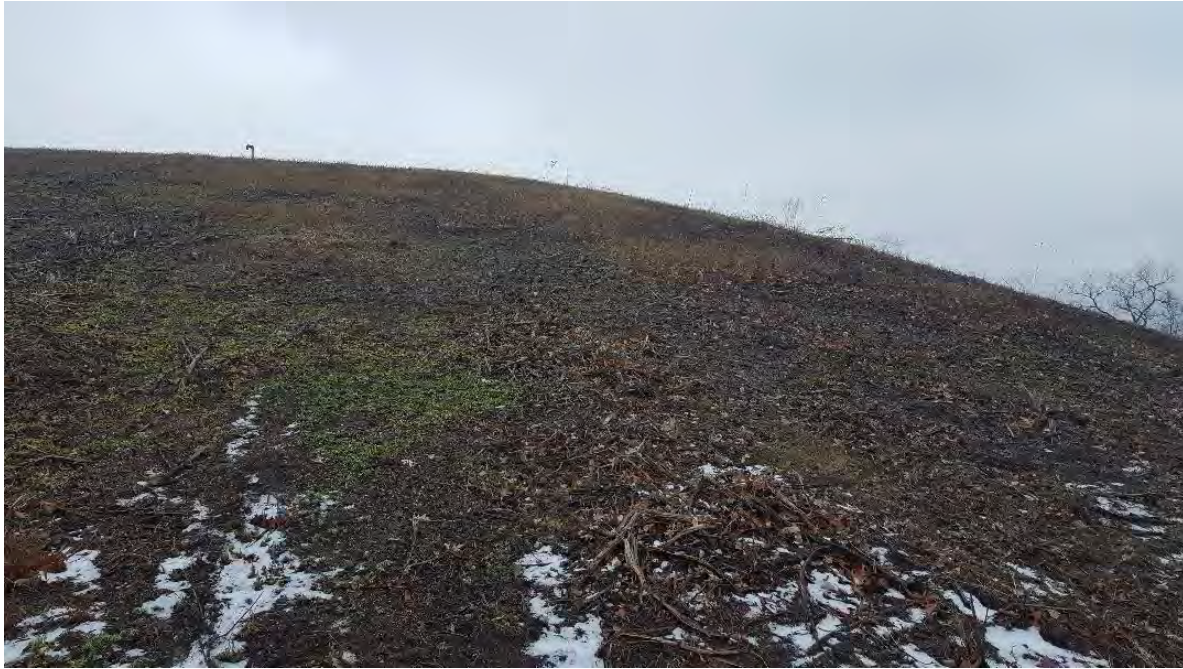
35. SE corner of LF, looking N towards GV-3

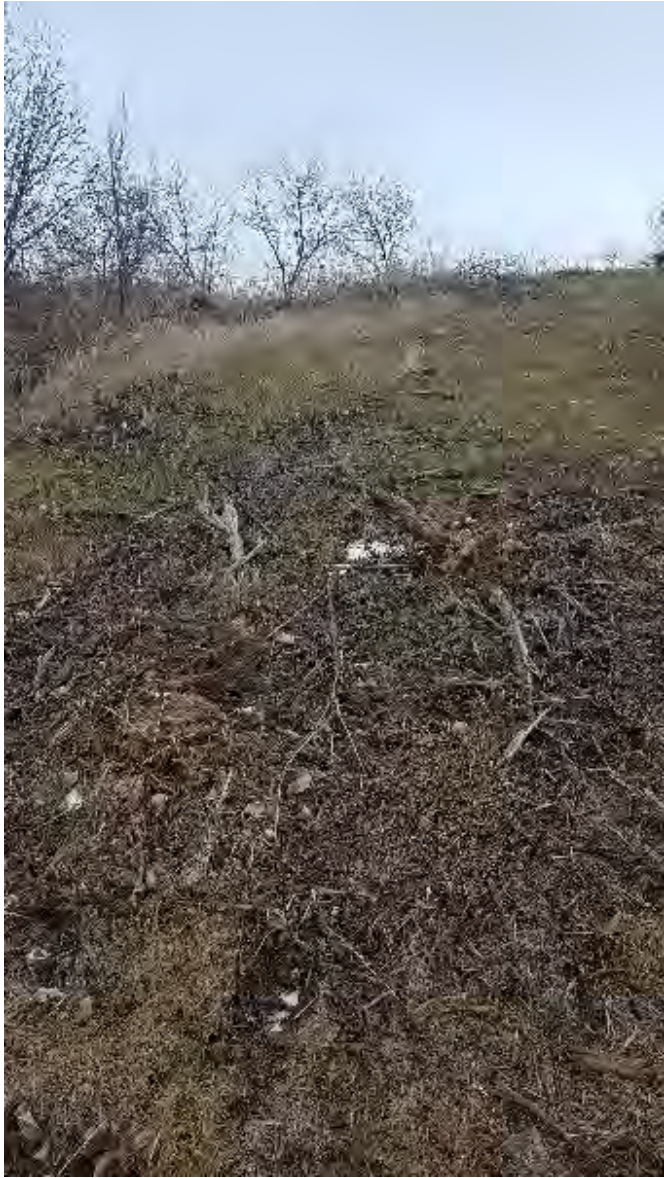
37. Southern edge of hill, looking W

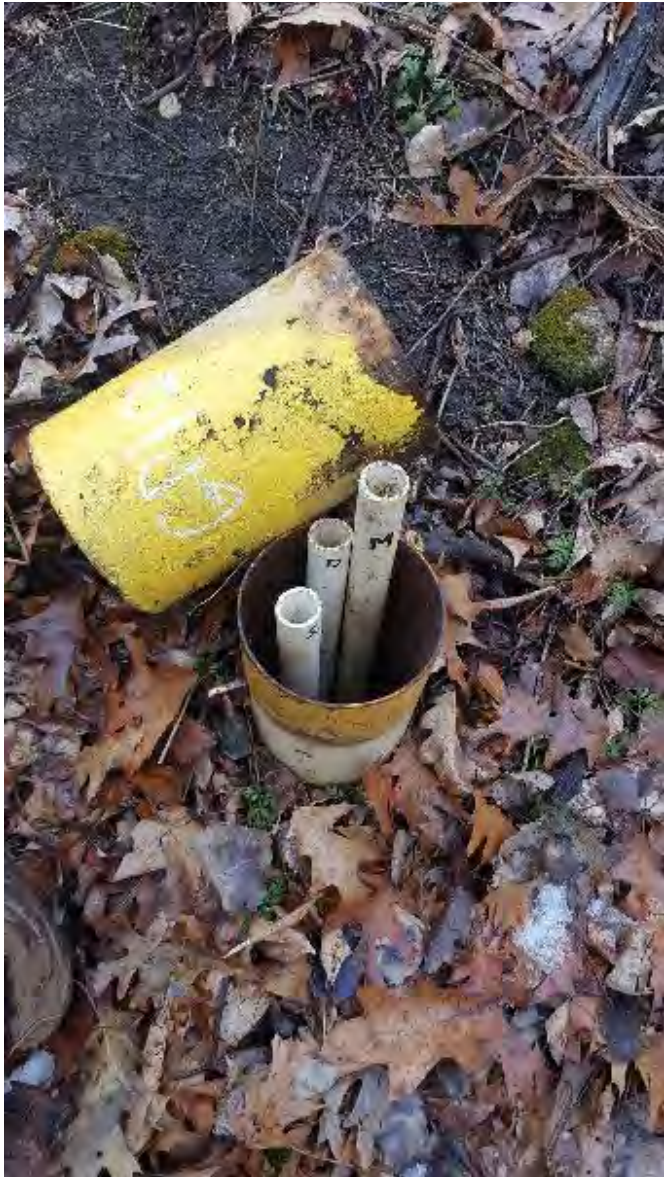
39. GP-10, no caps on individual probes

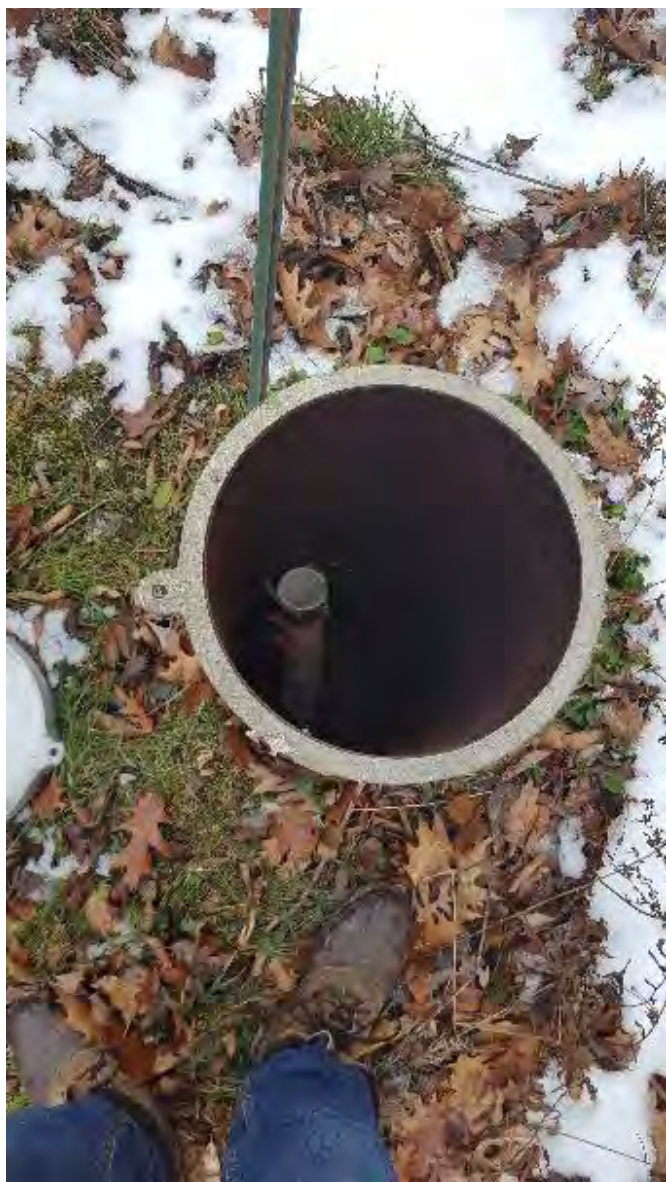
43. B-94-26, no cap

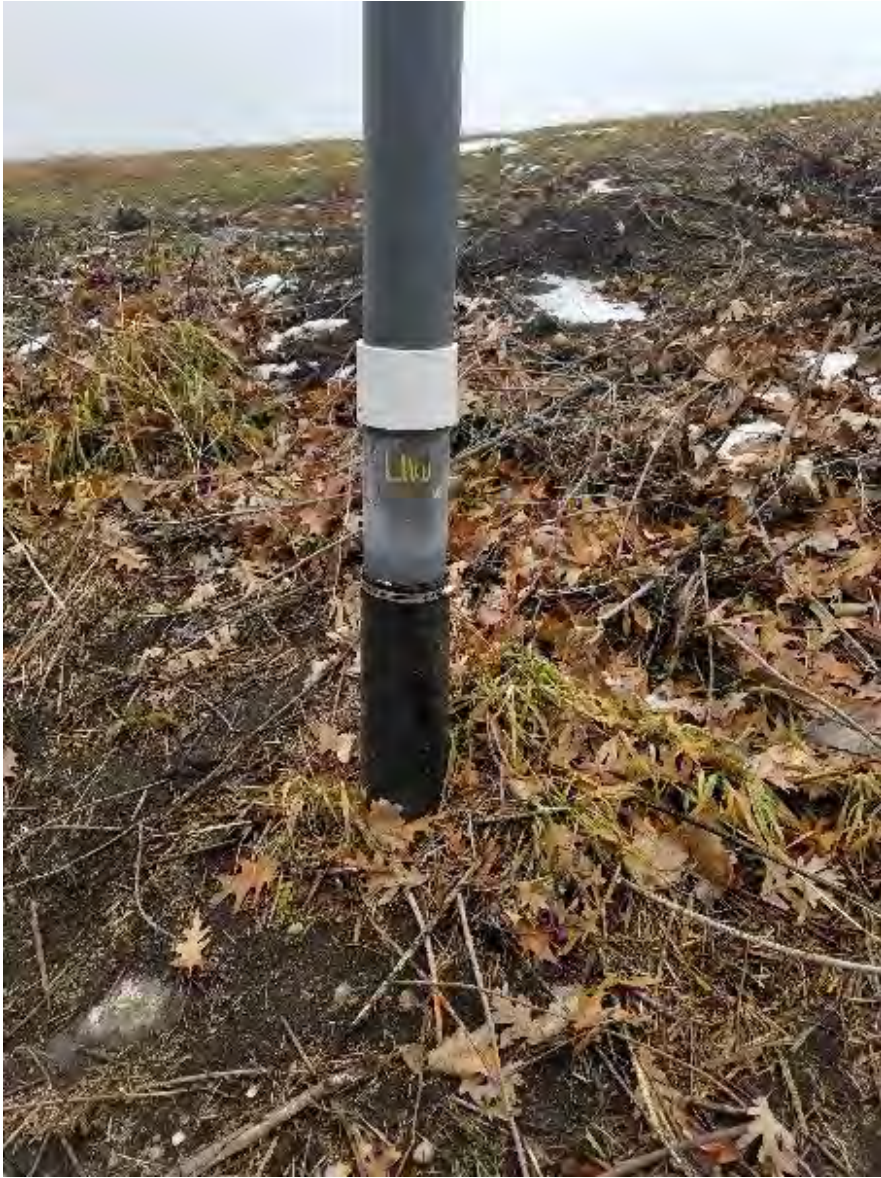
45. Un-numbered LHW N of GP-11, looking N, bare spots in vegetation

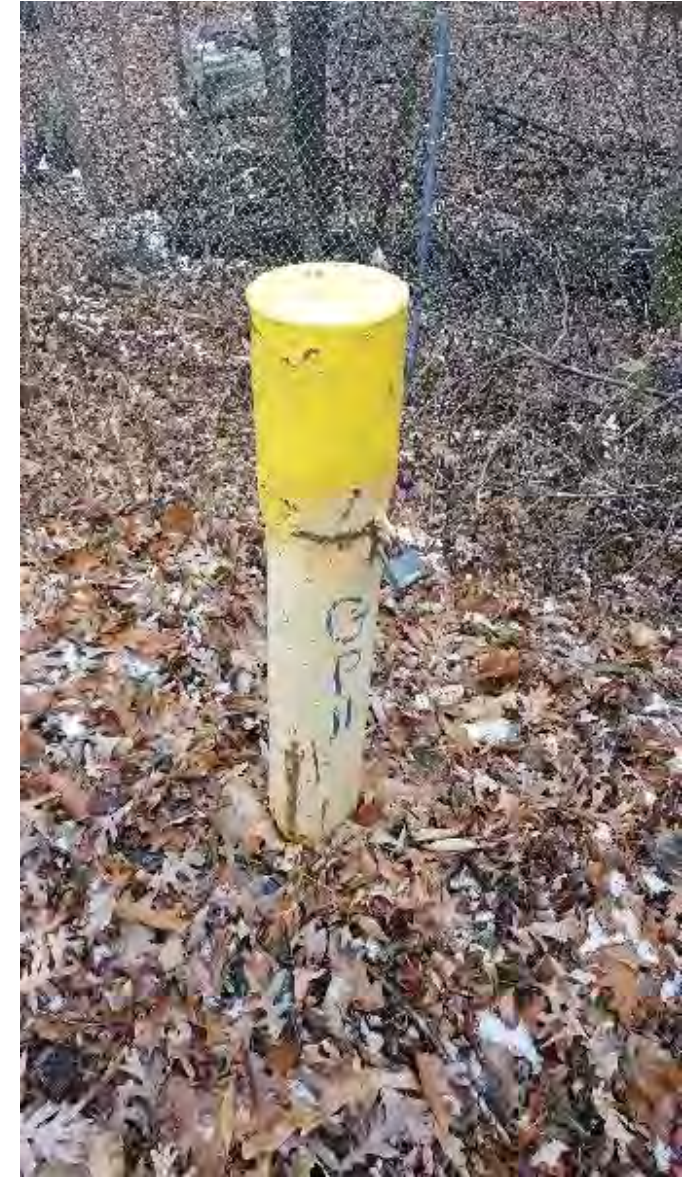
46. GP-11, looking SE

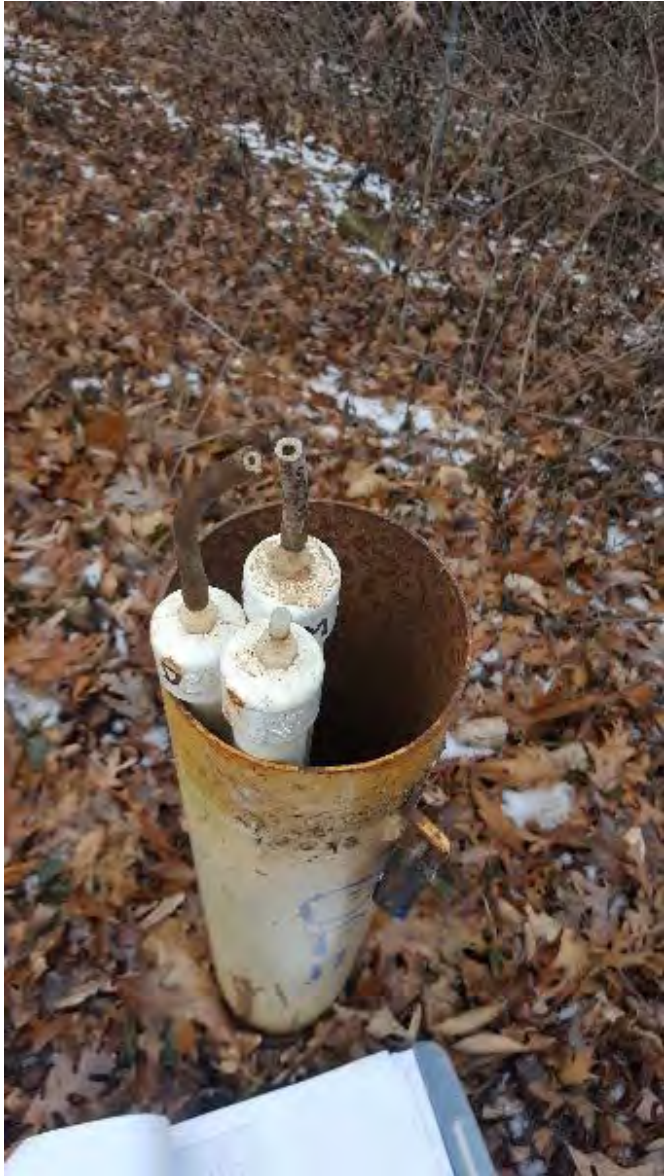
47. GP-11, looking SE

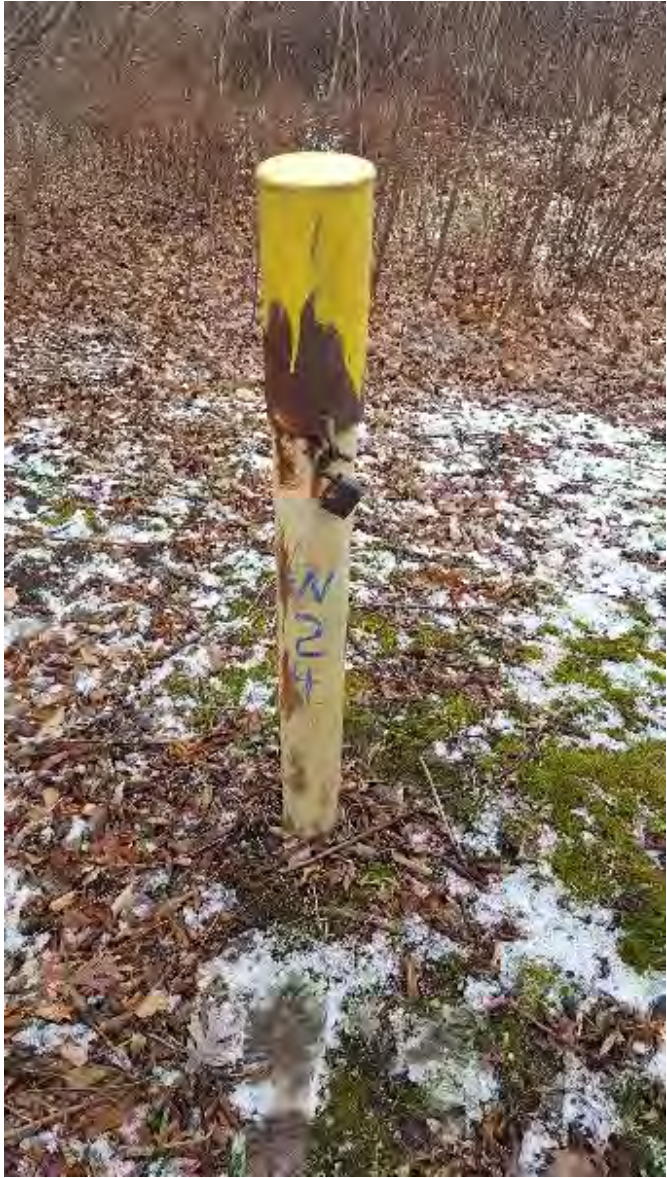
49. W-24, looking NW

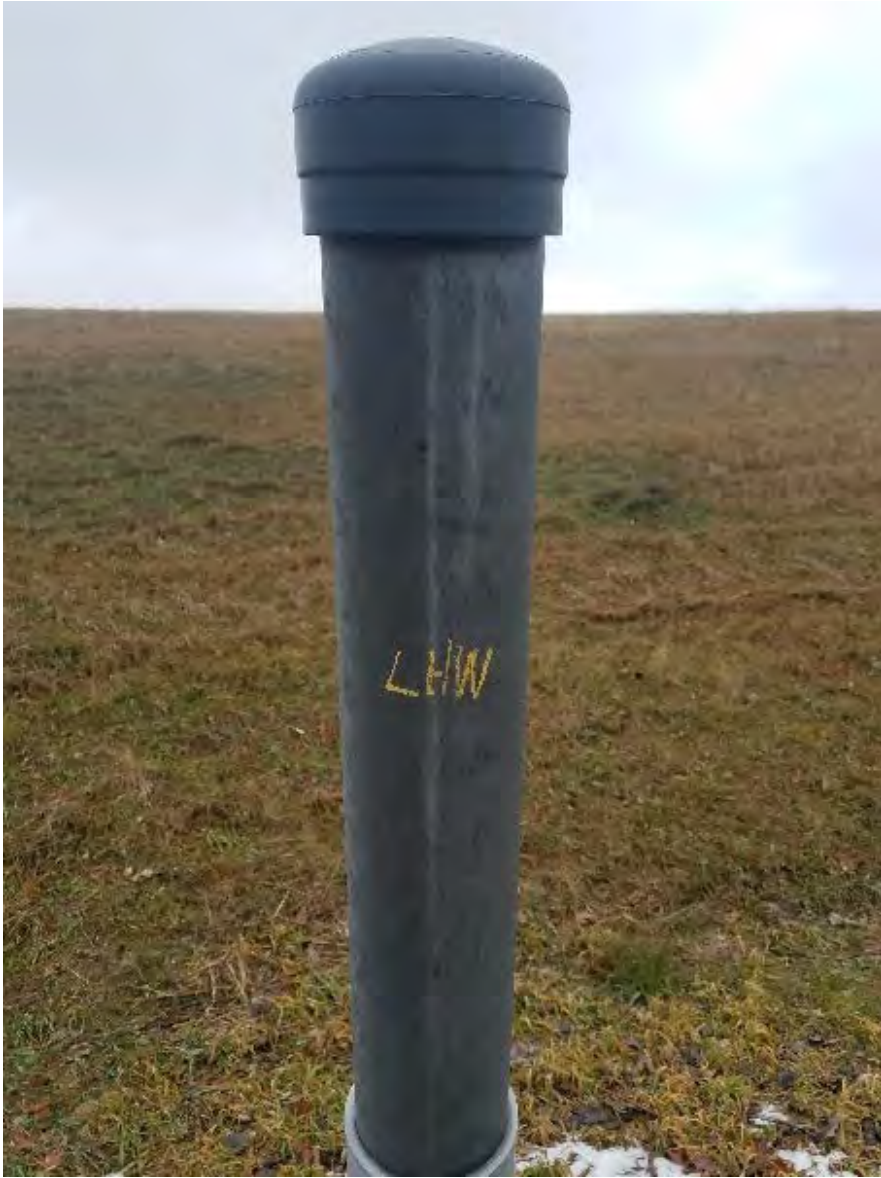
51. Un-numbered LHW by GV-46

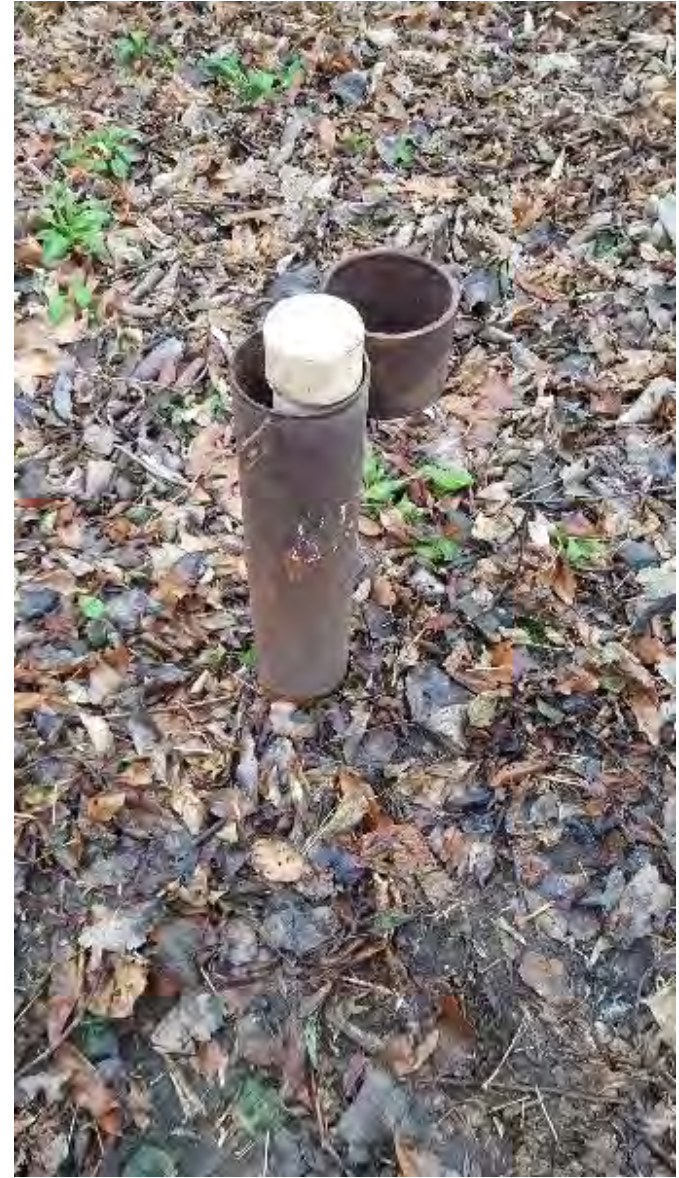
60. B-96-17, looking W

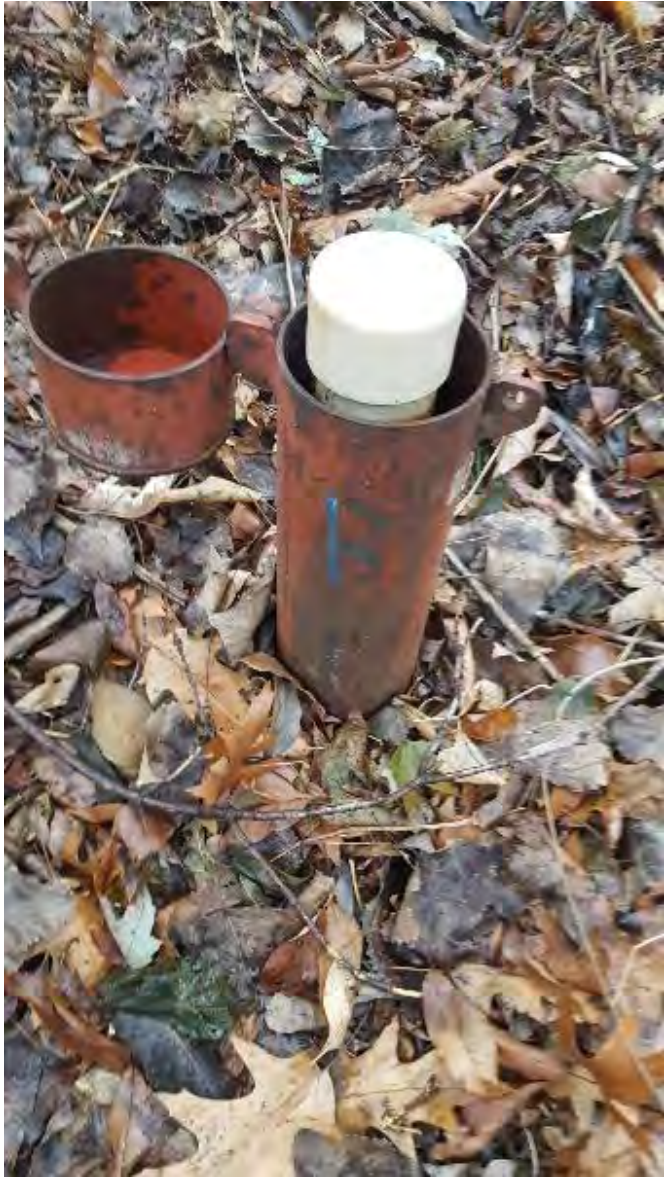
61. B-96-17A, with cap

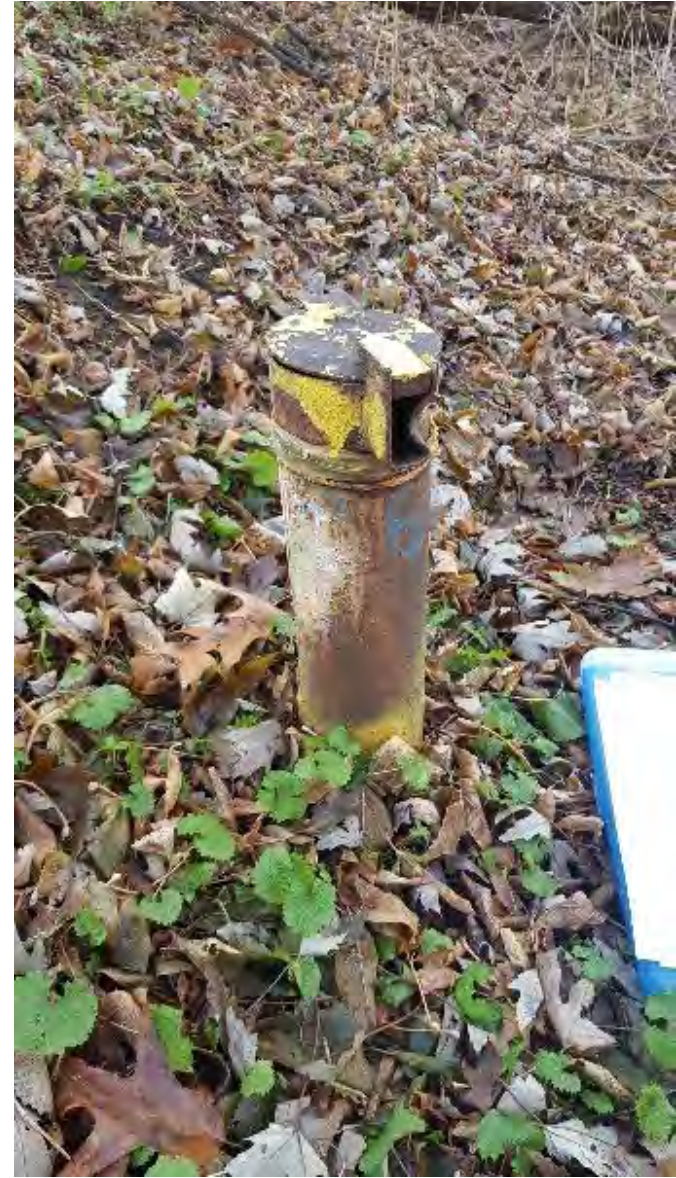
66. GP-6, looking S

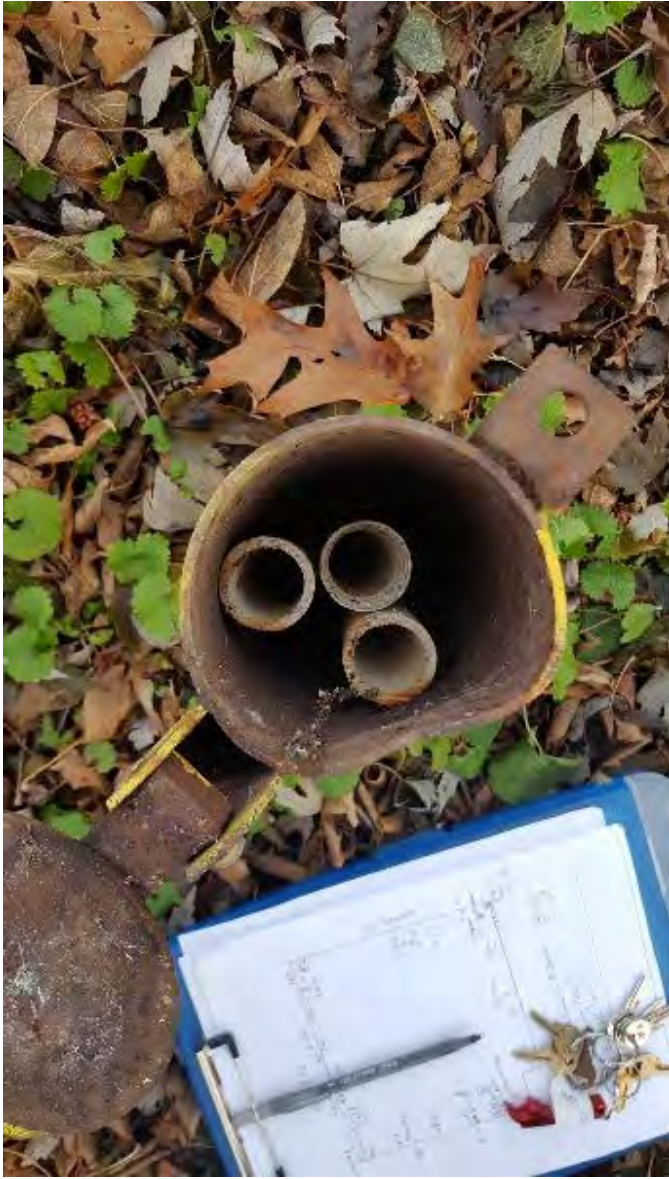
67. GP-6, no caps

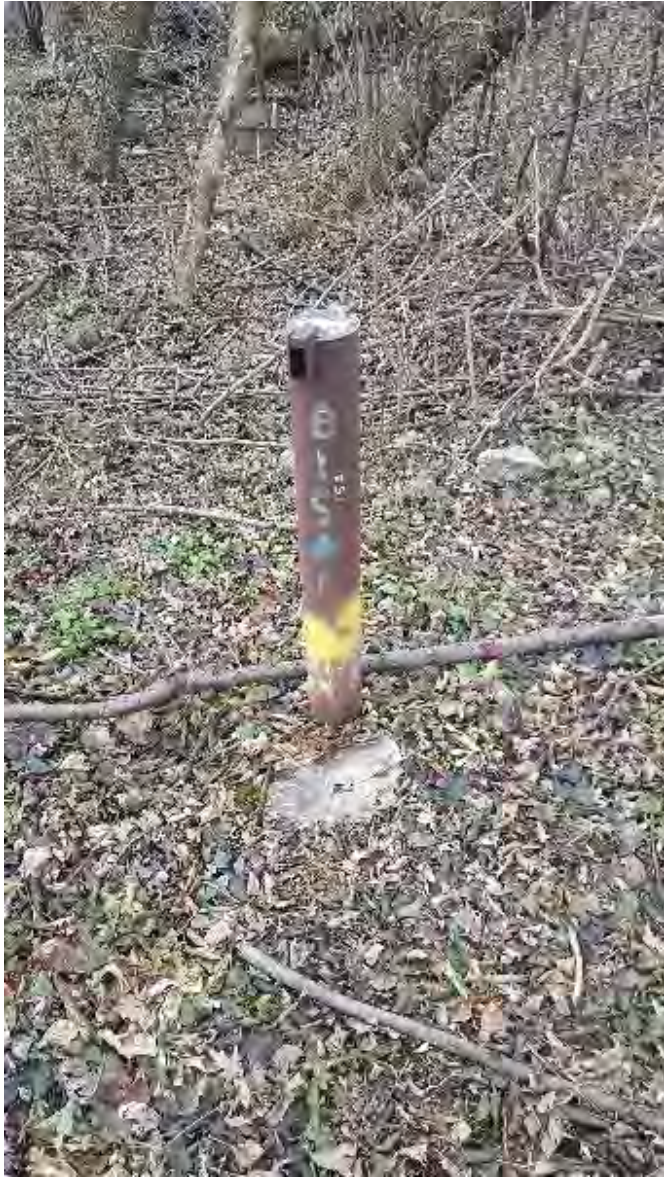
69. B-15A, looking N

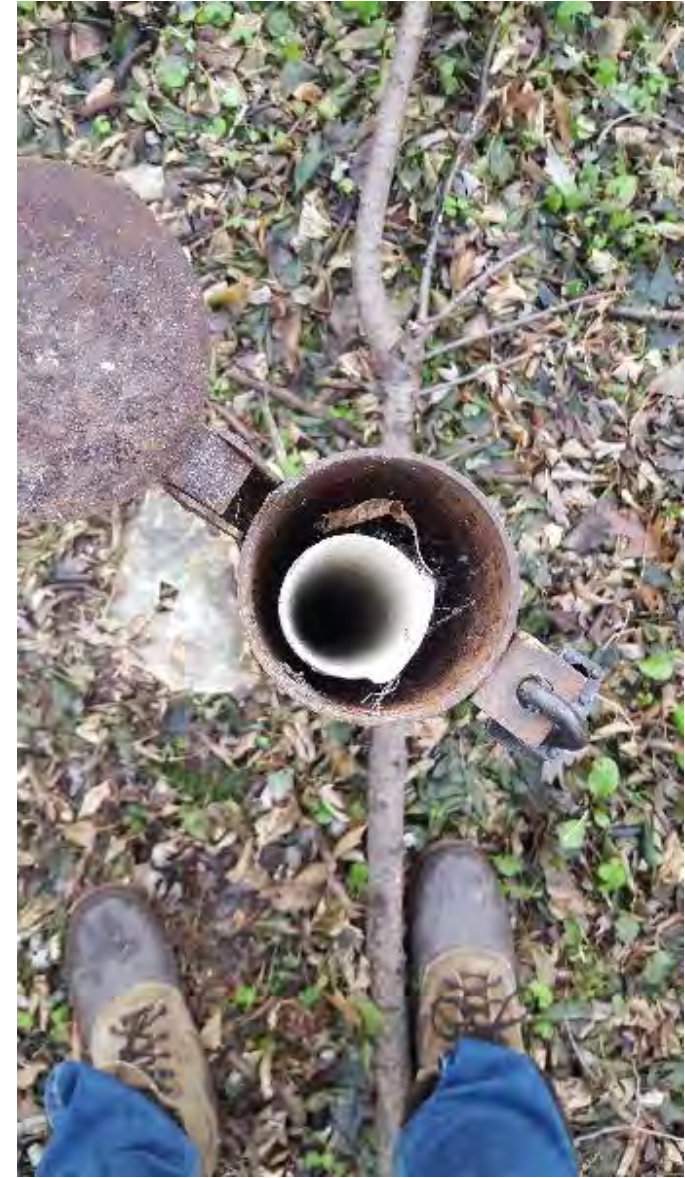
70. B-15A, no cap

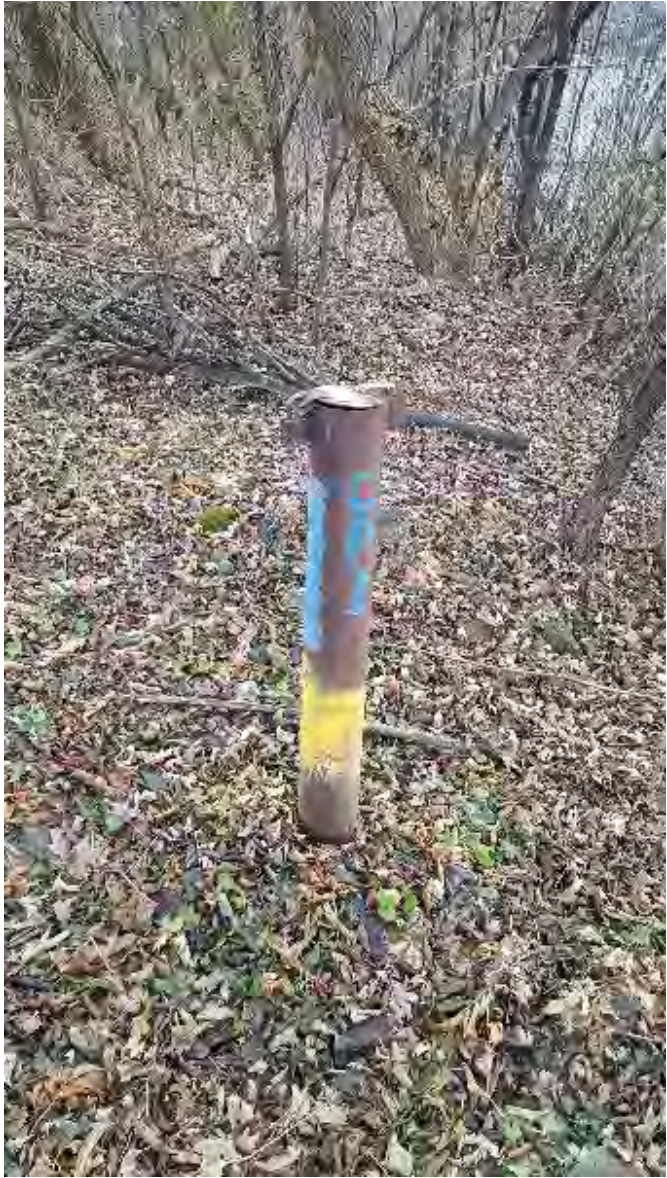
71. GP-1, looking S

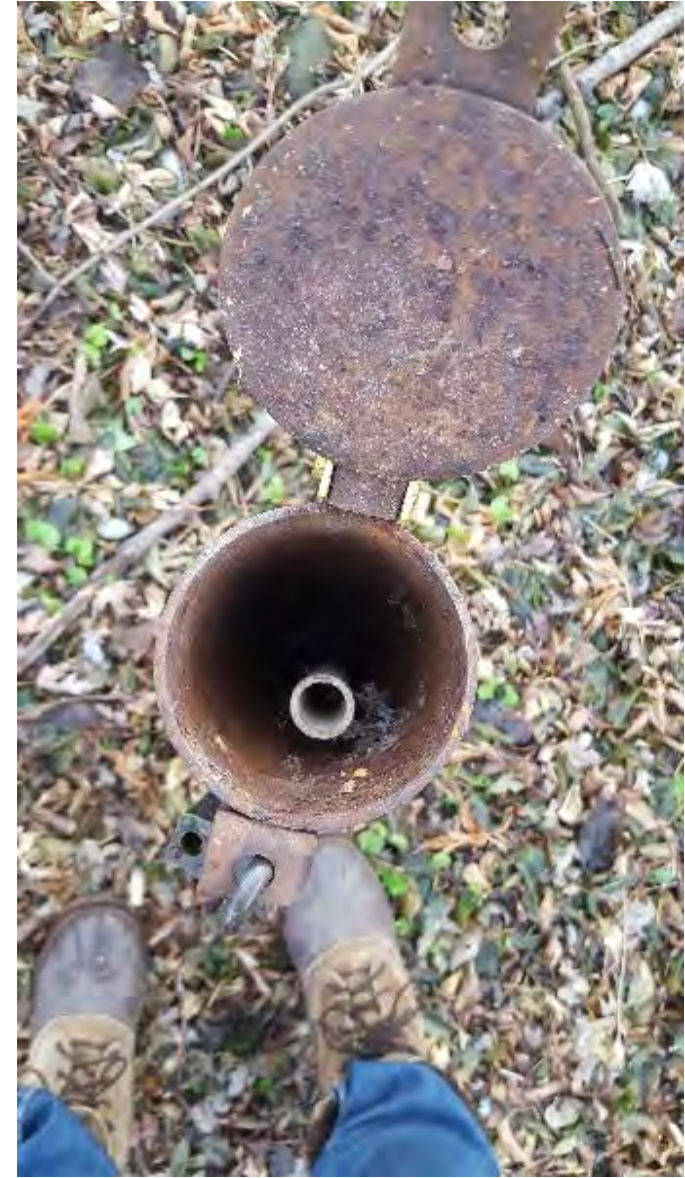
72. GP-1, no cap

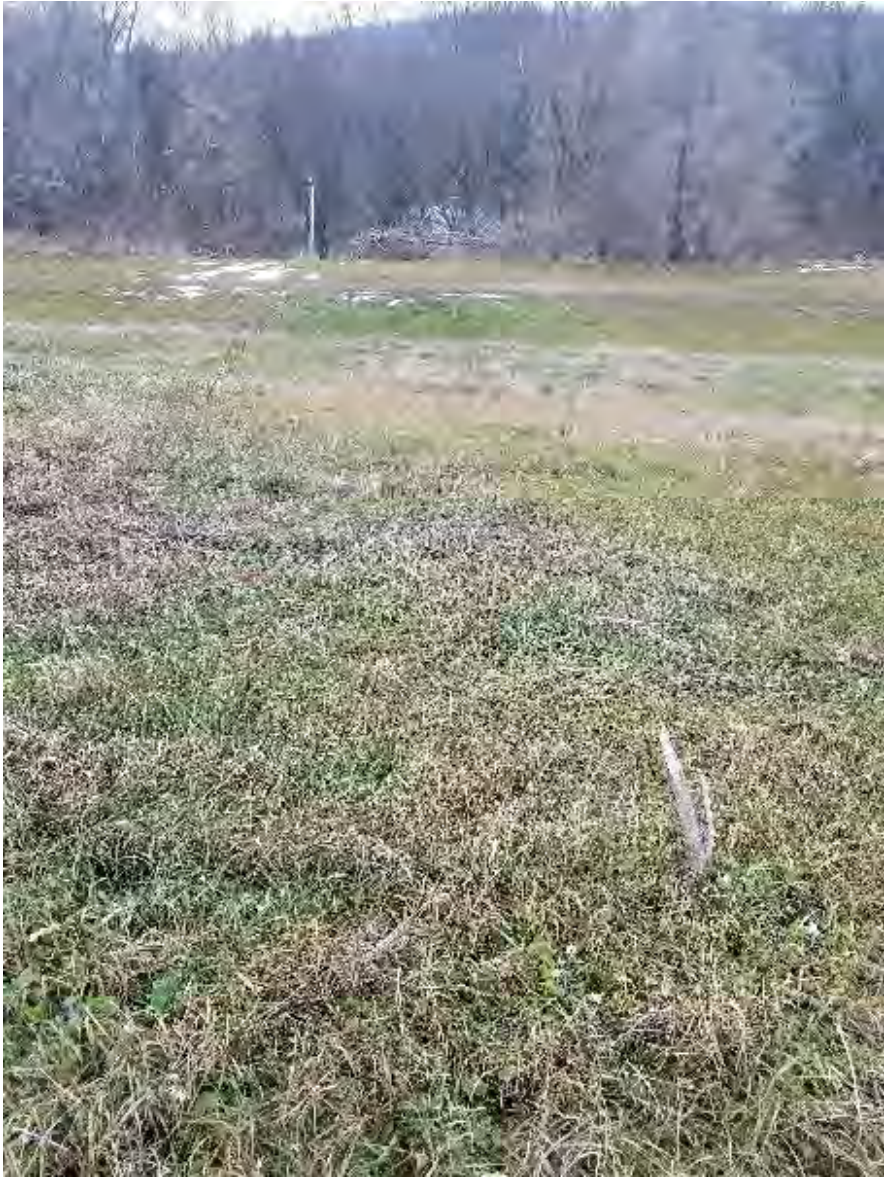
79. Small tree stumps along west hill face, looking W

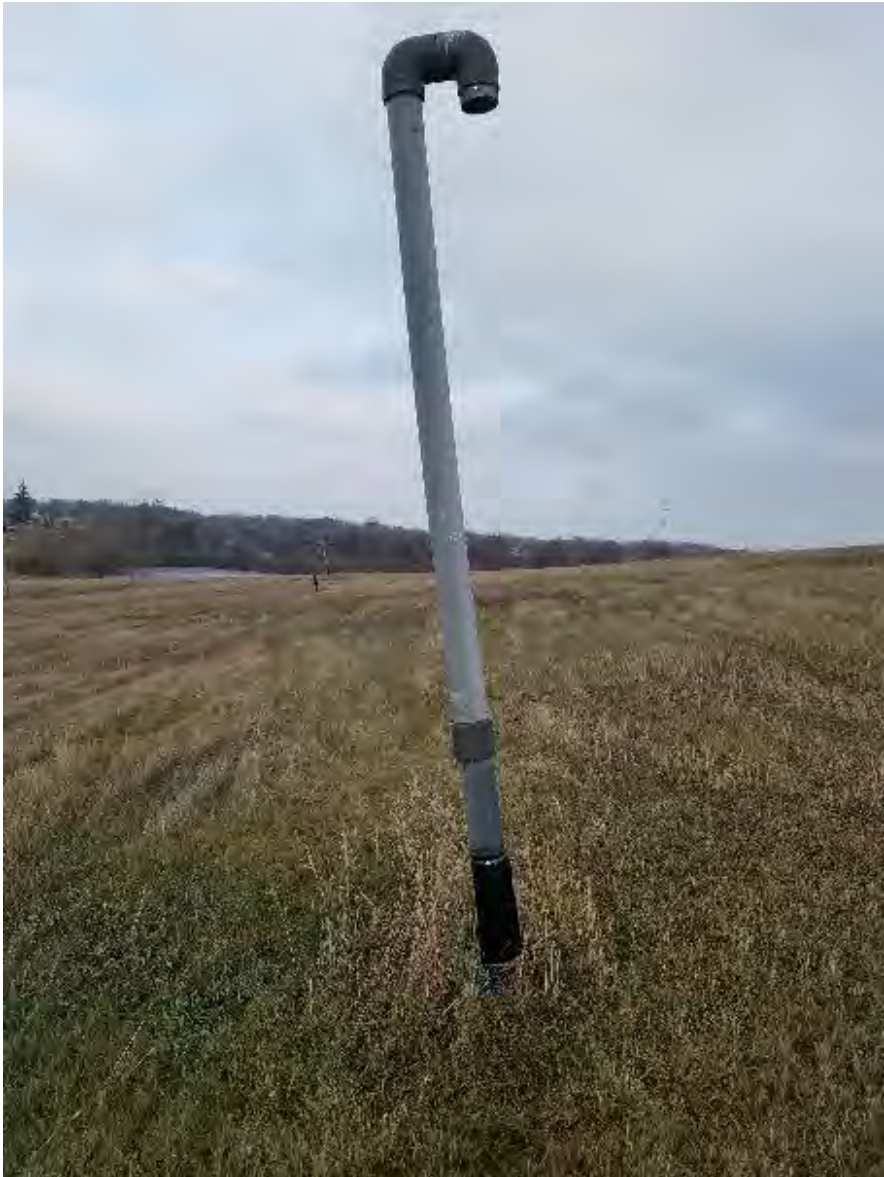
81. GV-14 tilting slightly N, looking E

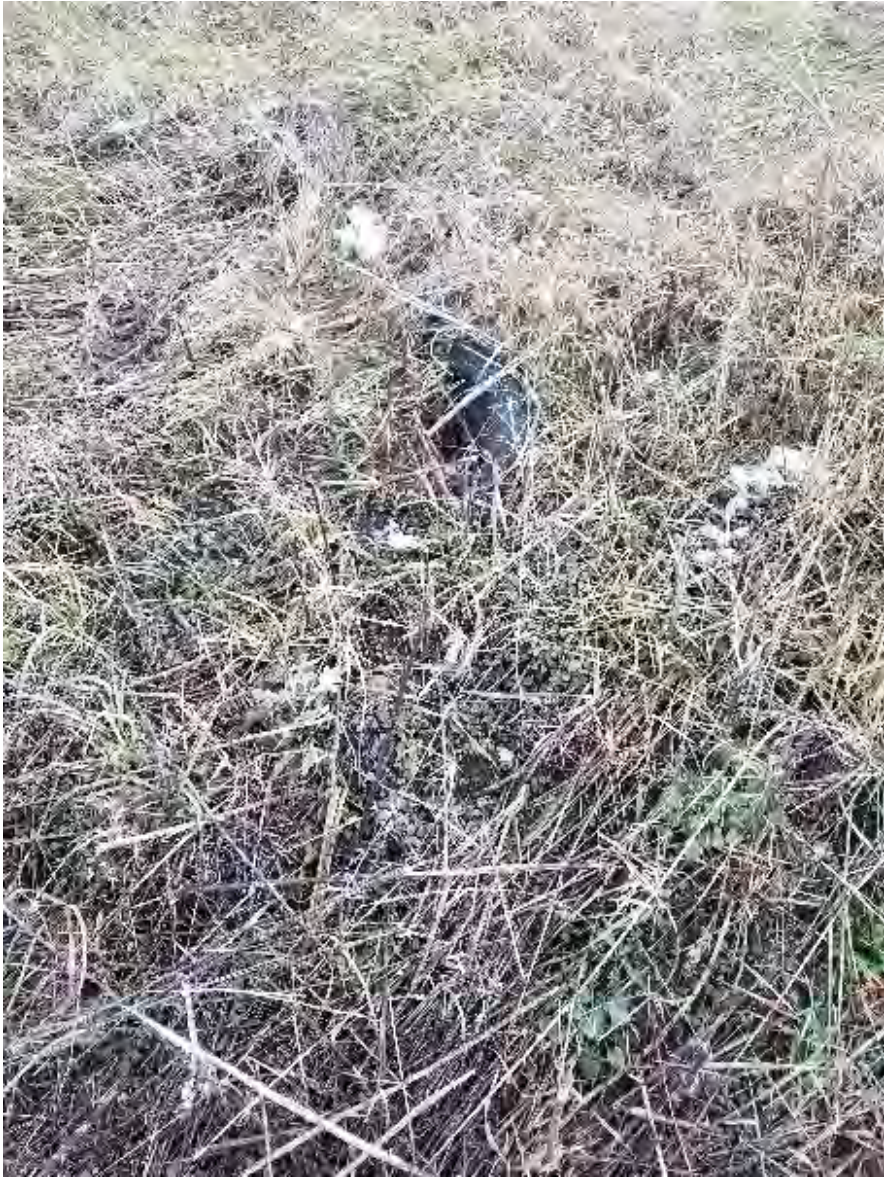
83. Tire on ground by GV-11
