ANNUAL INSPECTION REPORT

BARRETT LANDFILL

New Berlin, Waukesha County, Wisconsin

January 18, 2018

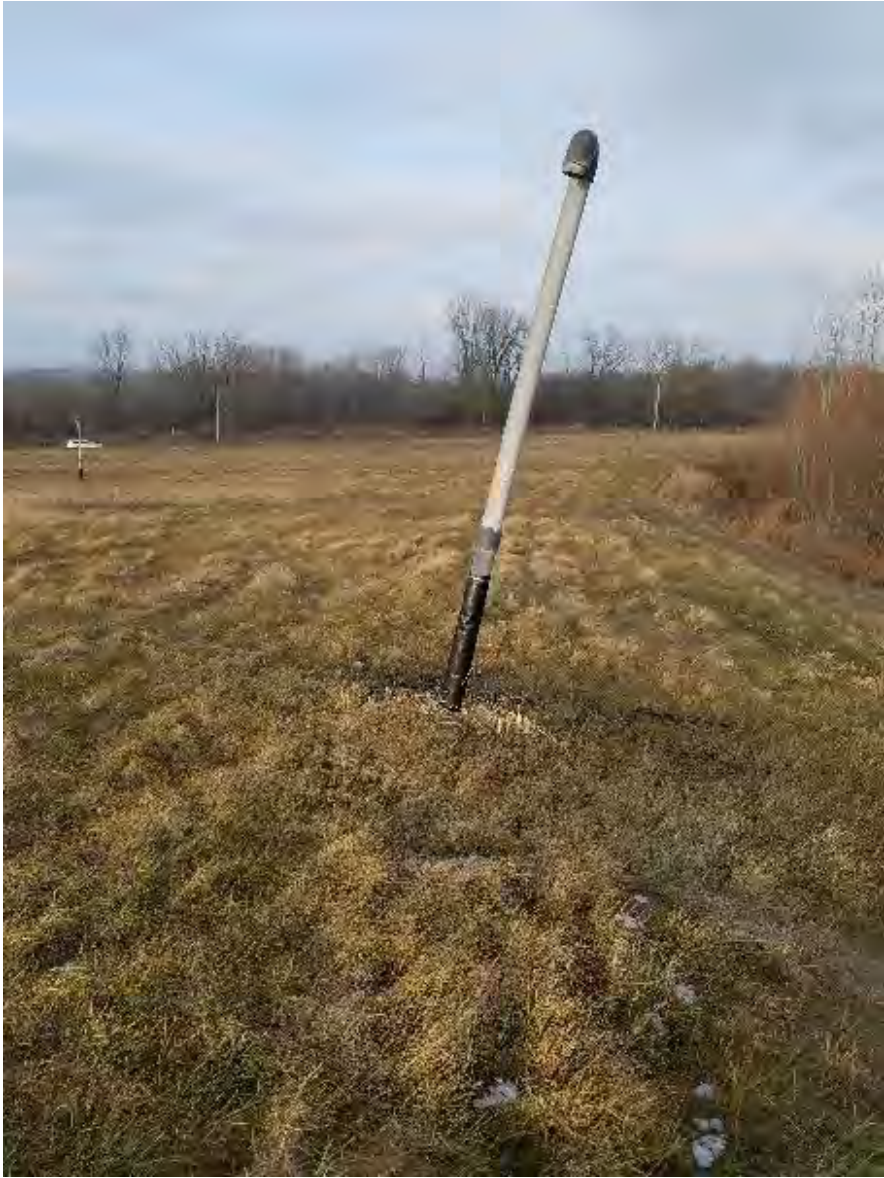
85. GV-27 tilting E, looking N

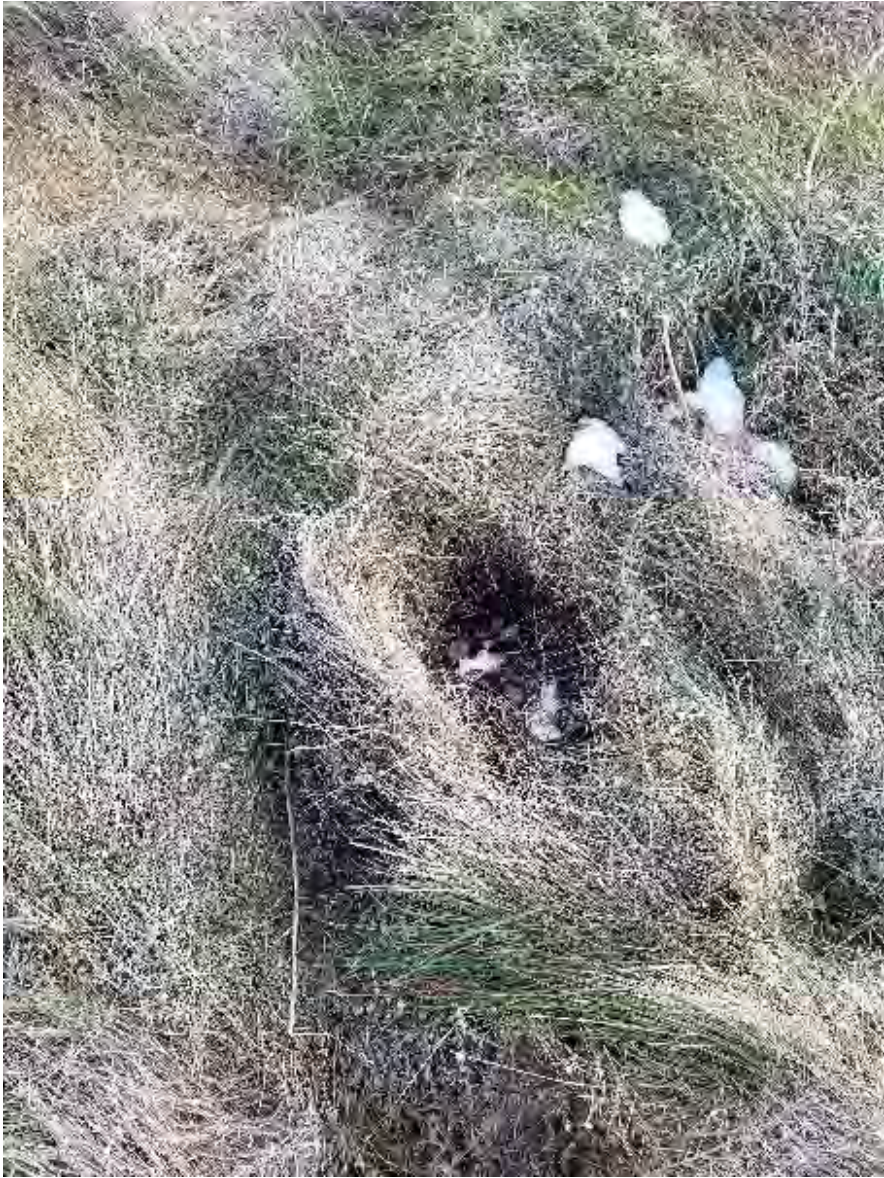
87. Animal burrow W of GV-10

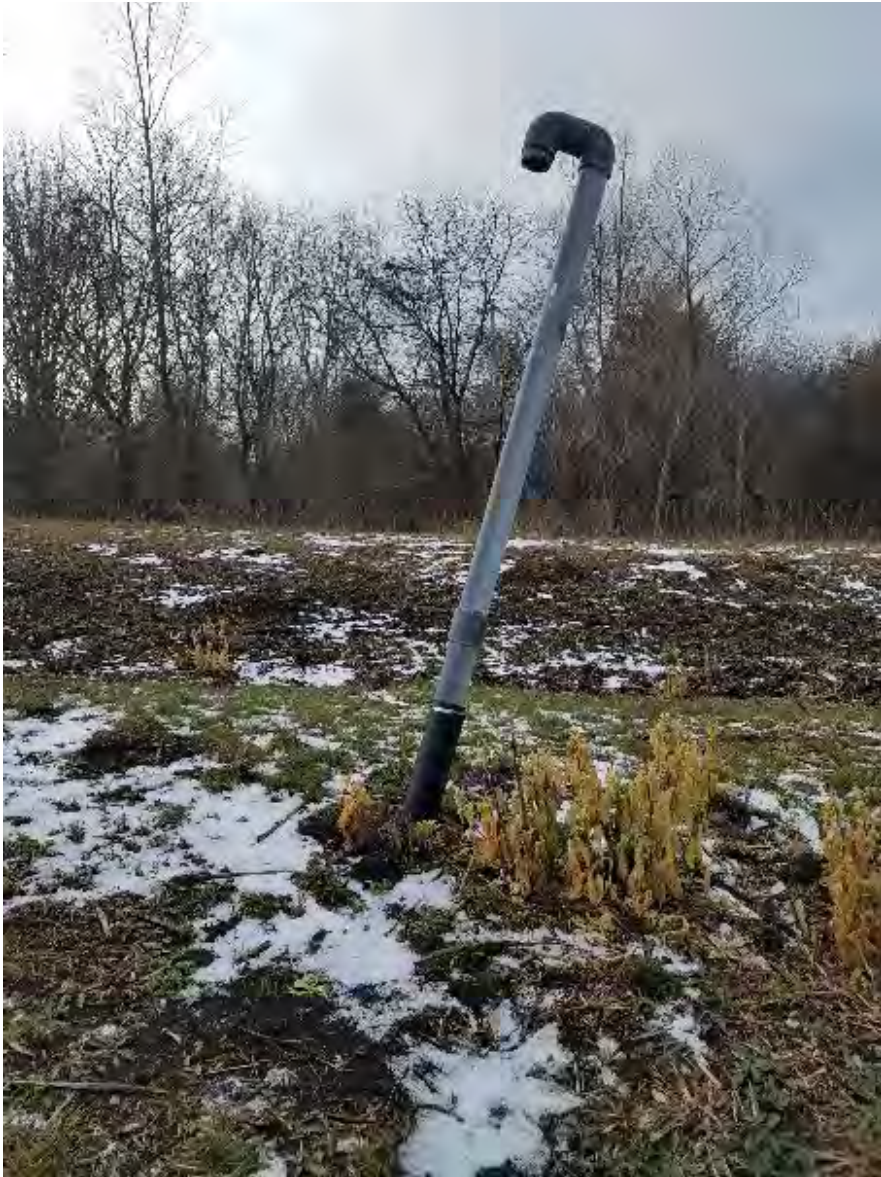
97. GV-38 tilting W, looking W

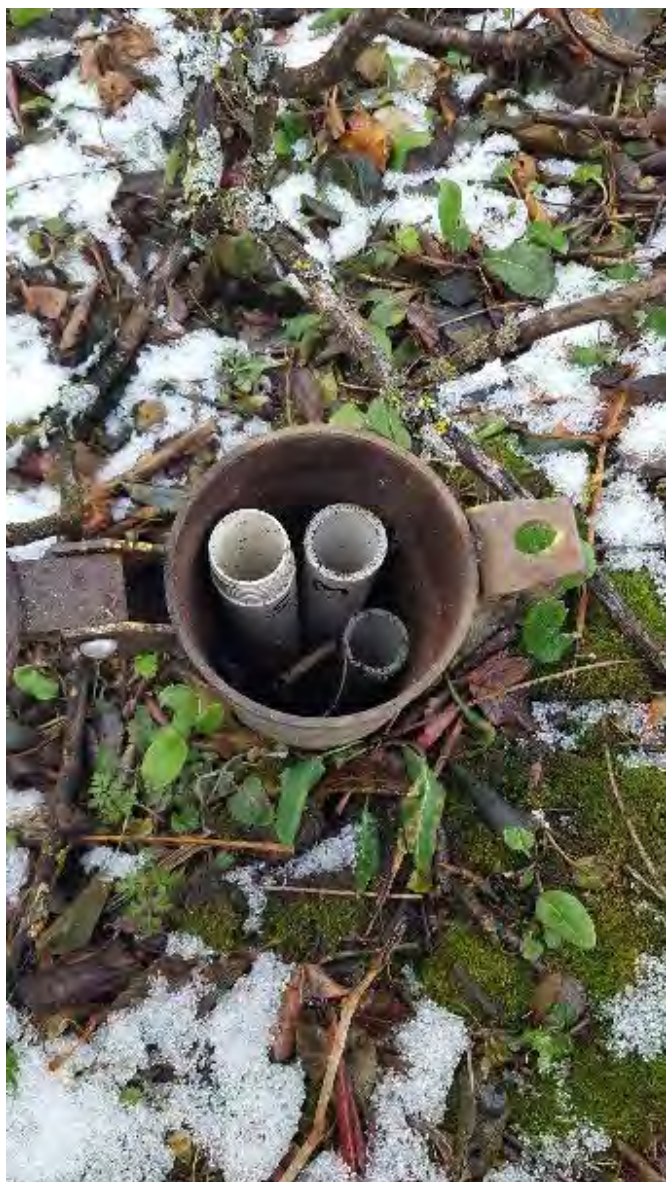
99. GP-5, no cap

8. Gas Probes		X		Locks and caps need to be installed where missing.
9. Gas vents				Need to be renumbered
10. Leachate Head Wells (LHW) and unidentified pipes			X	Need to be labeled, caps and locks installed where missing, fix any broken or missing covers

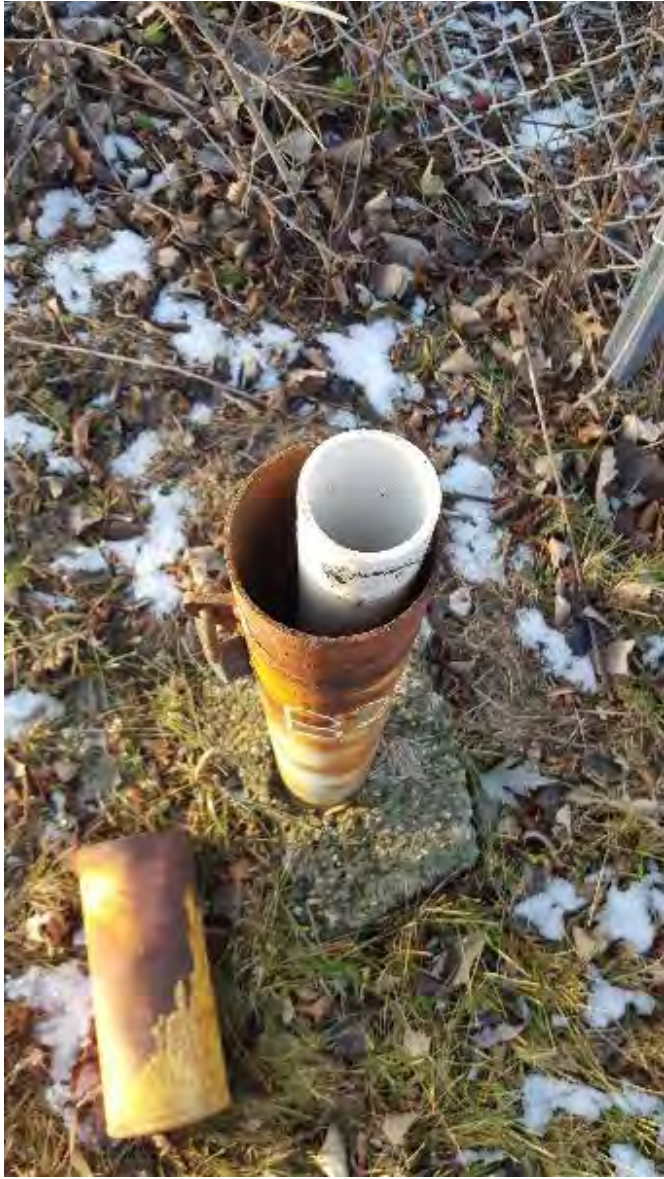
105. B-94-25A, no cap

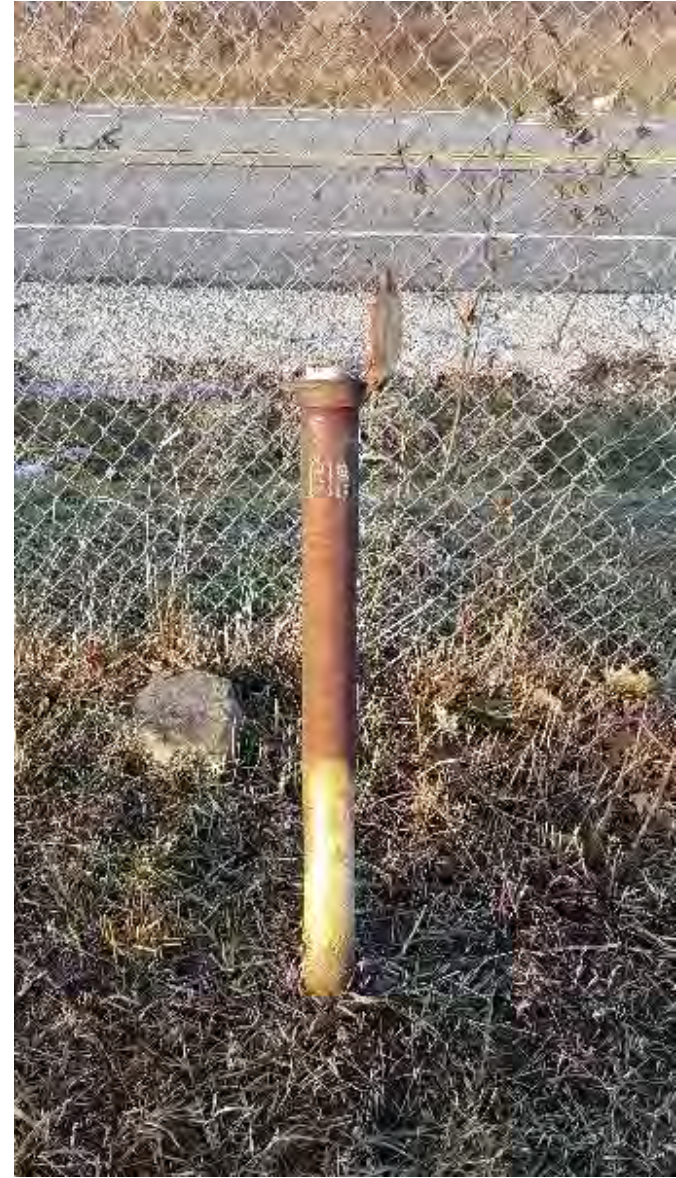
112. B-19, bent towards the N, looking N

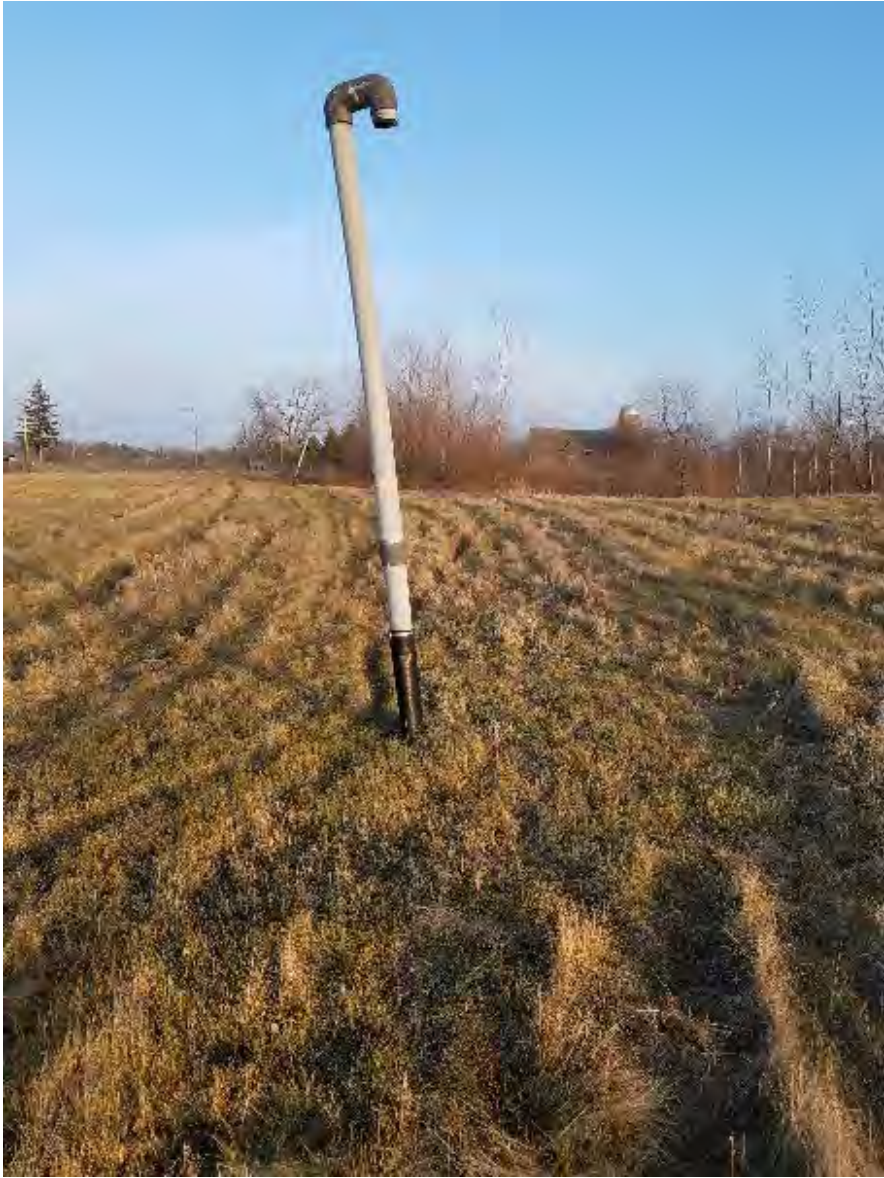
117. GV-32 tilting N to NE, looking E

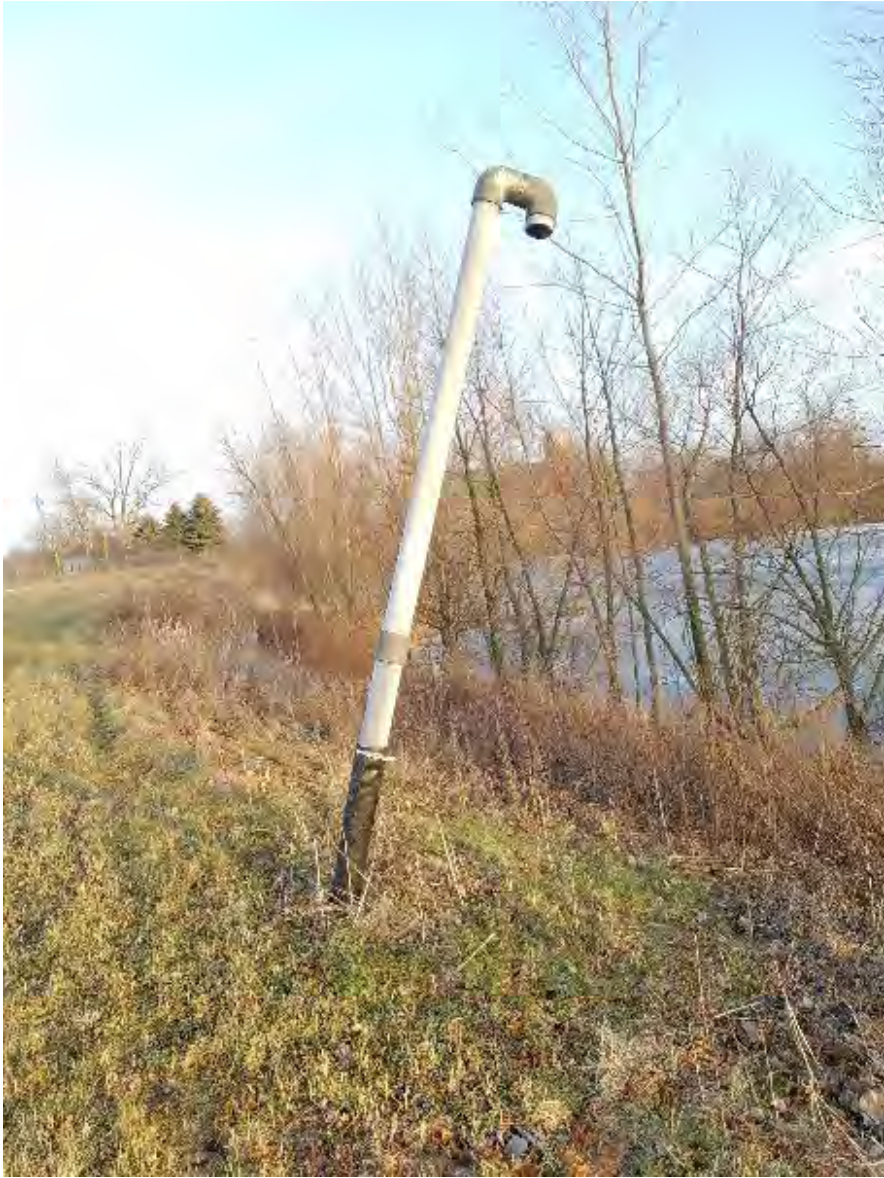
119. GV-30 tilting S, looking E

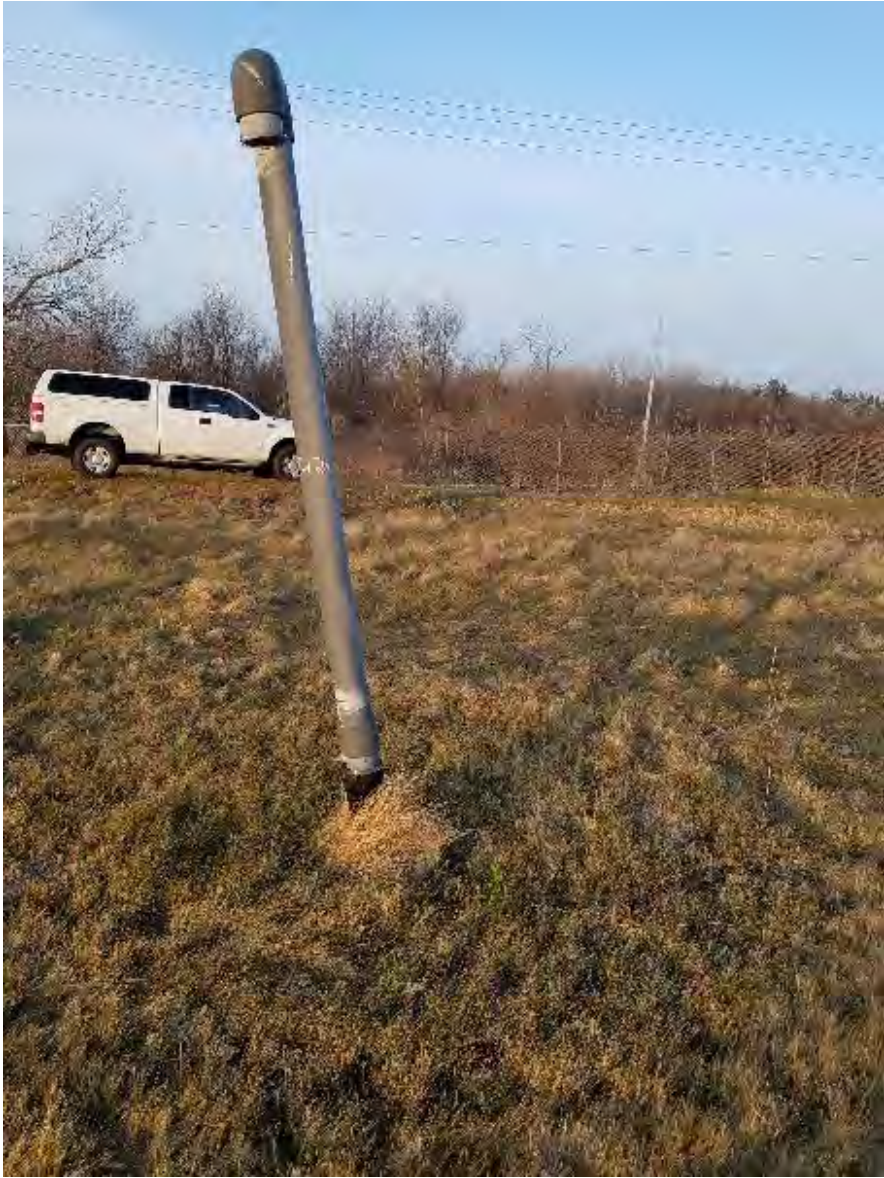
121. GV-28 tilting W, looking N

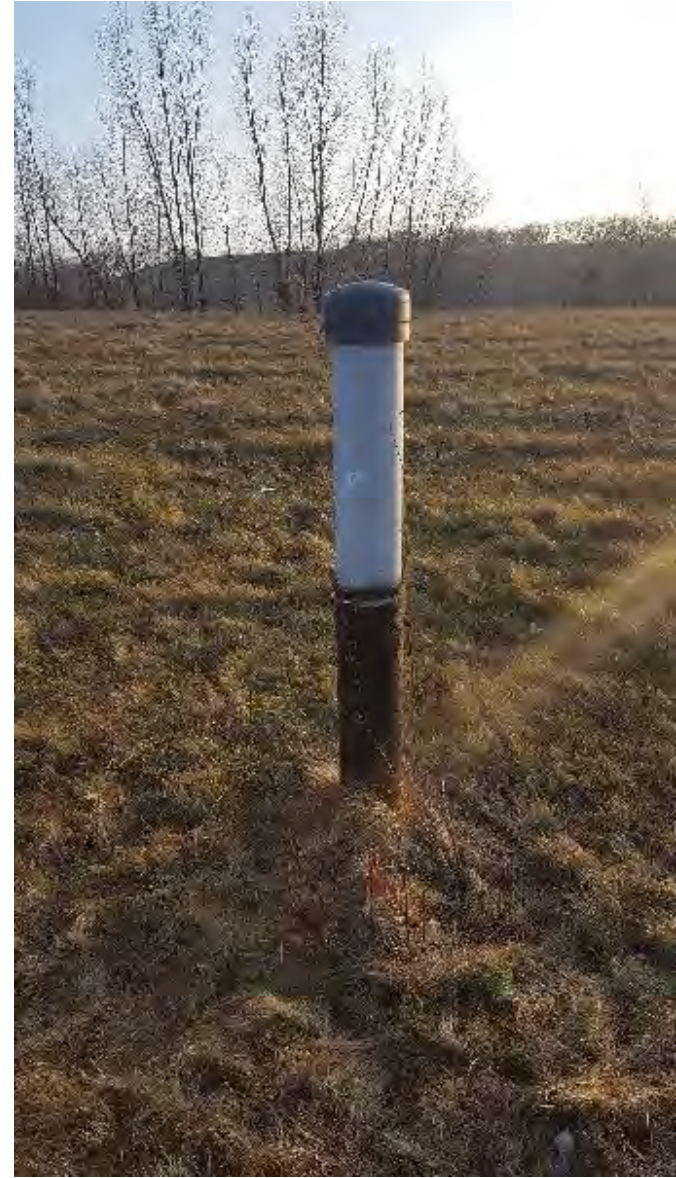
124. B-96-13A, not lockable, looking S

- B-96-13A and B-96-13 have unlockable PVC protective casings: we recommend installation of protective casings consisting of lockable steel; alternatively, both well casings are of considerable height (approximately 4.5 feet above ground surface) and if not switched to steel could be cut down to a workable height, and a lockable cap or plug installed. B-96-13 is damaged at a depth of approximately 8 ft bgs; this will be further investigated and repaired or replaced as needed.
- B-94-19 is bent and needs to be repaired. During sampling of B-94-19A, it was difficult to get a bailer down the well at approximately 7.5 ft bgs; this will be further investigated and repaired if appropriate.
- B-94-14A is located near the edge of a slope and there is erosion around the cement pad that should be addressed by clean fill or repair.

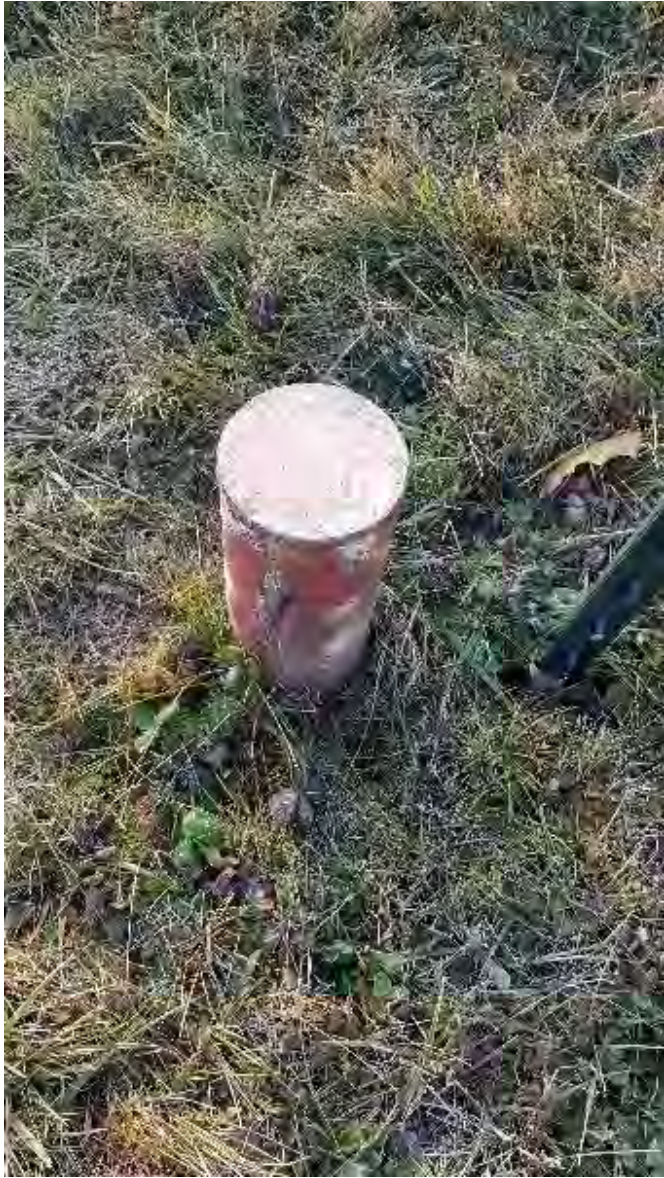
129. W-23, looking W, no lock

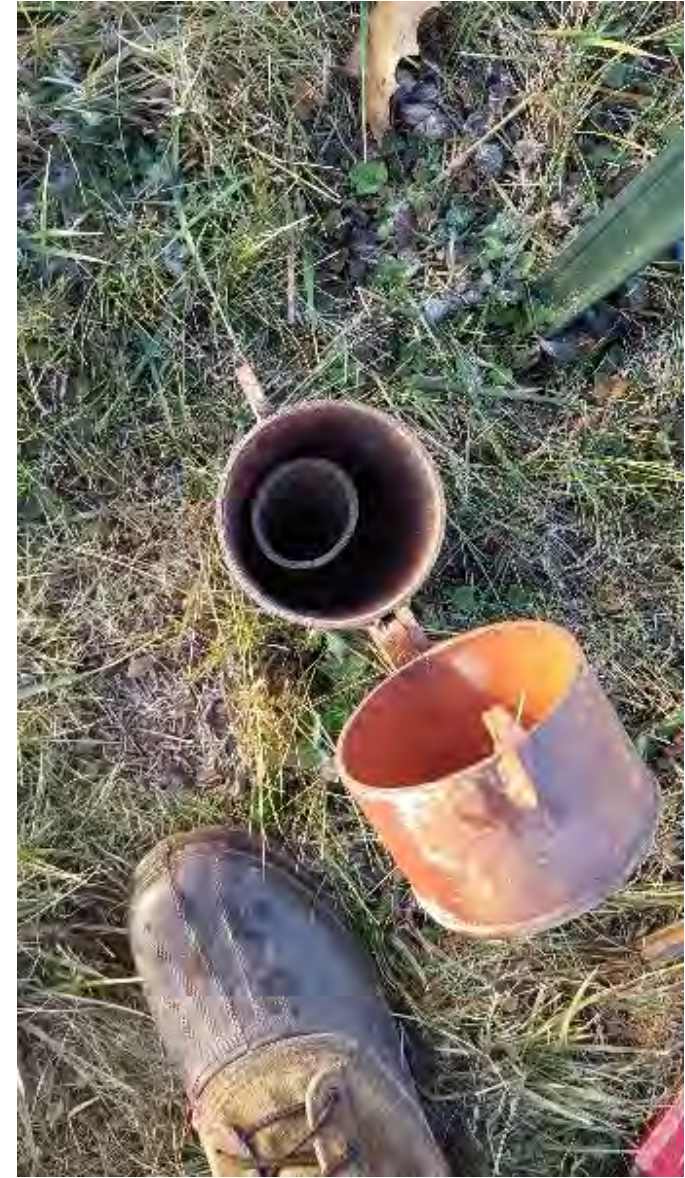
130. W-23, no cap

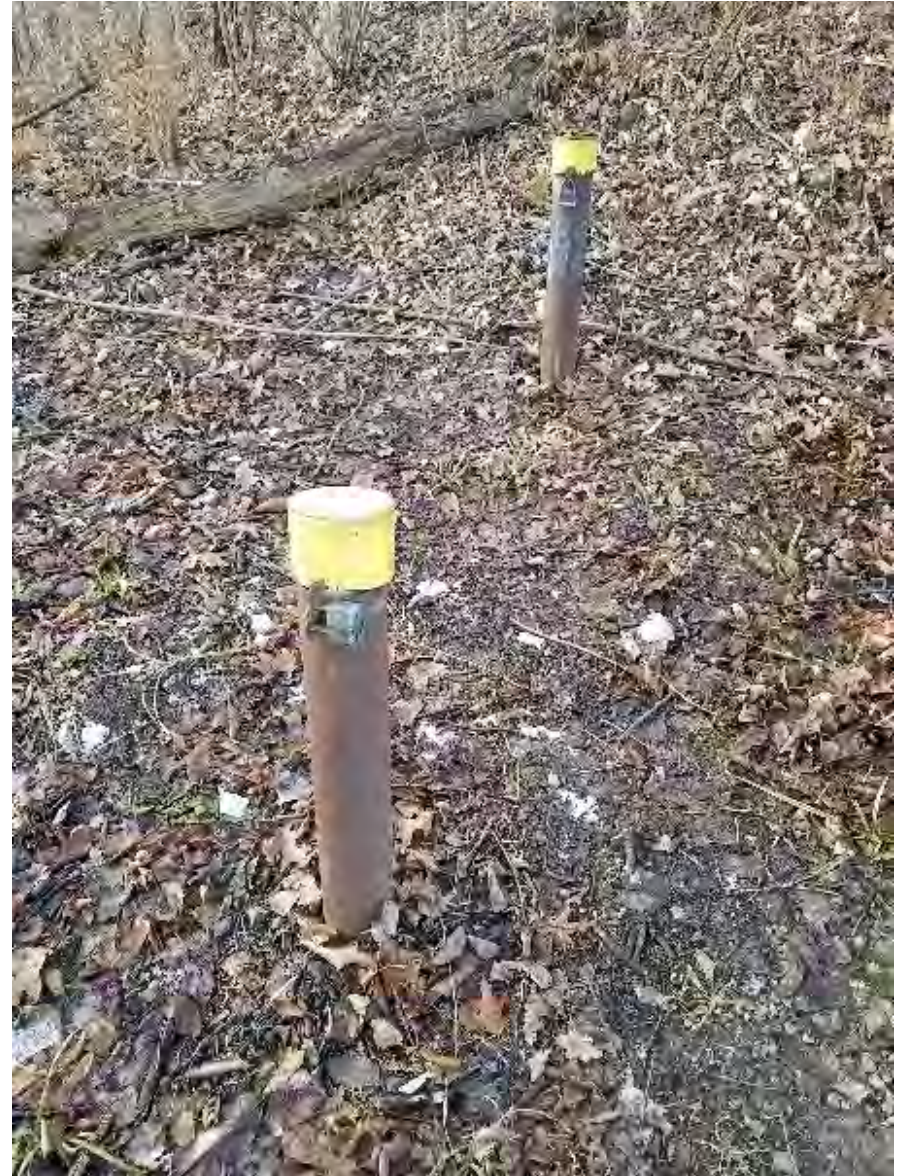
140. B-96-18A and B-96-18B, looking W

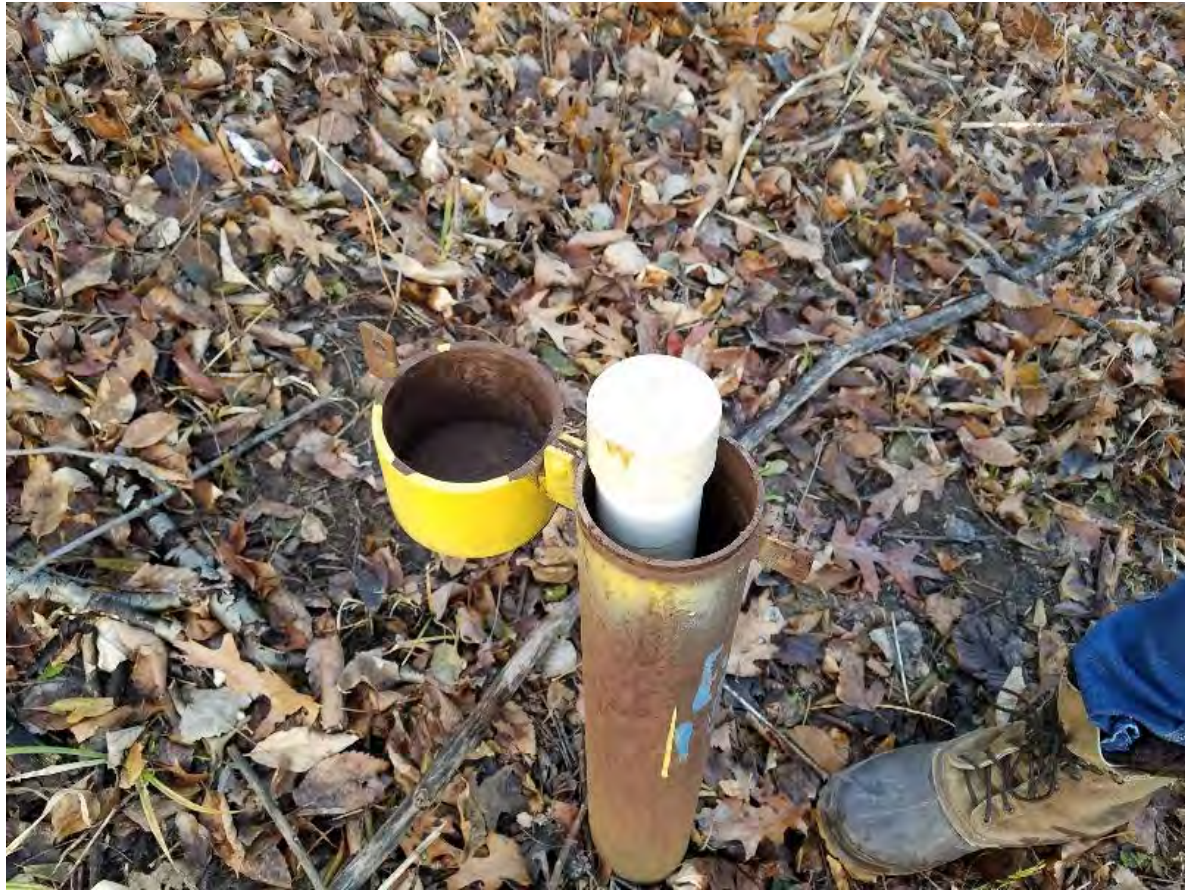
141. B-96-18B inside cap

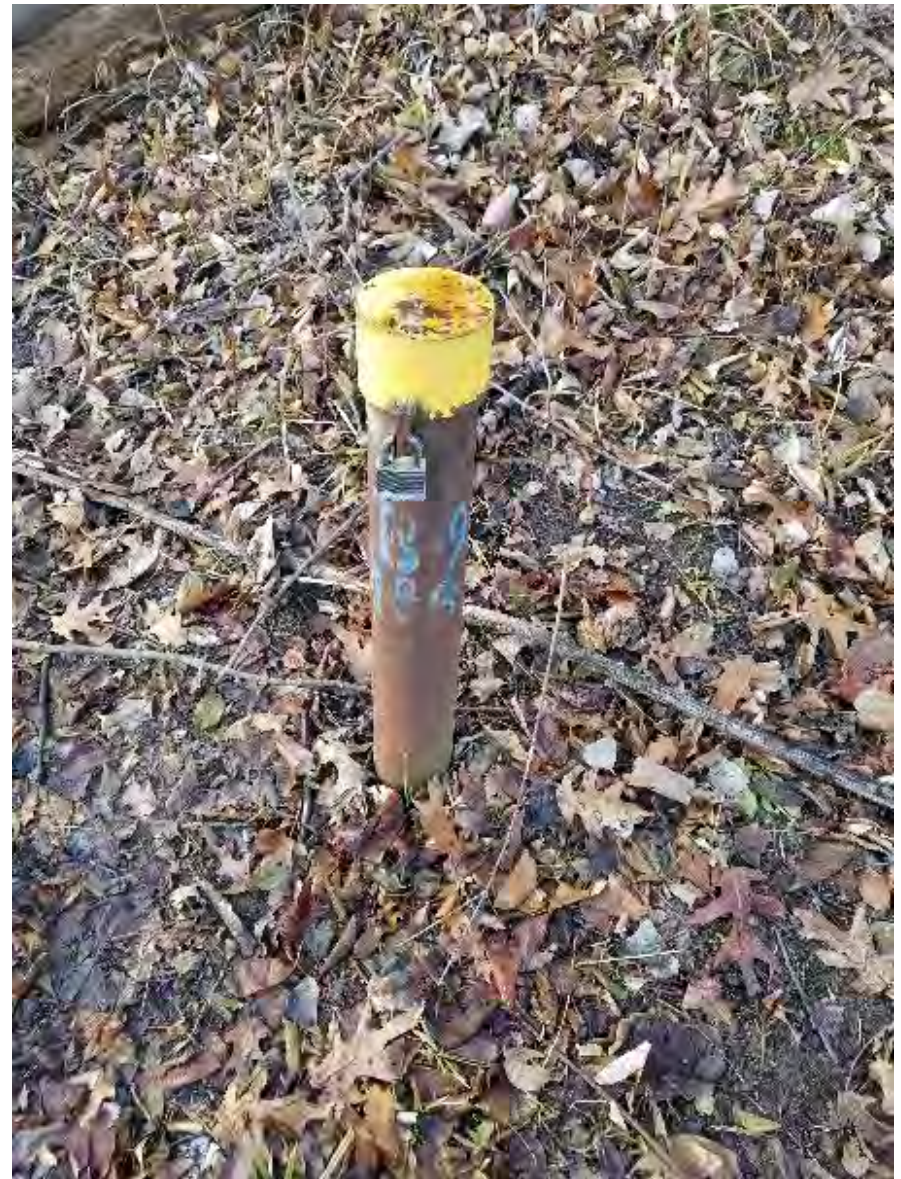
142. B-96-18B

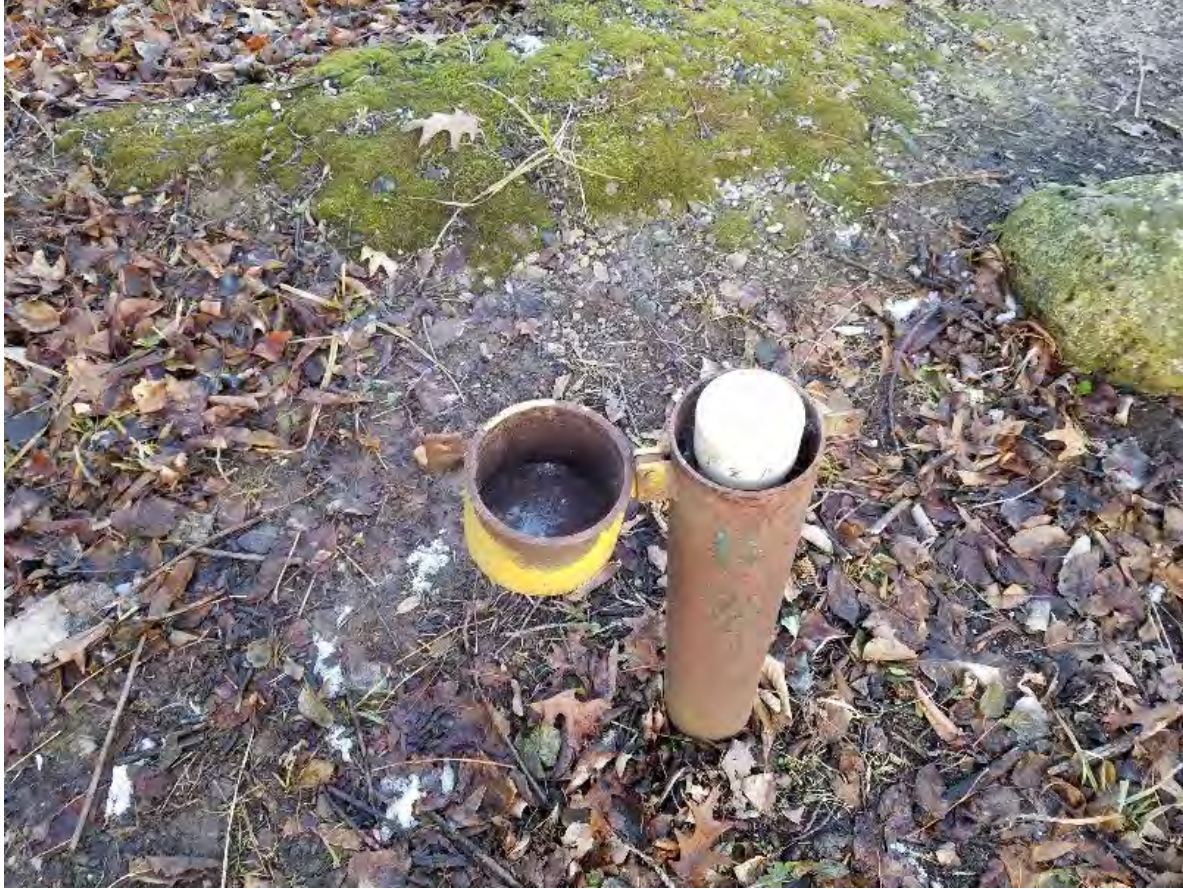
143. B-96-18A inside cap
