Appendix D

HYDROLOGY AND DRAINAGE

Hooker Lake Drainage Meeting MEETING MINUTES DECEMBER 12, 2008

Survey Results Bryzek and Hooker Lake Dams (Field File # 30.02)

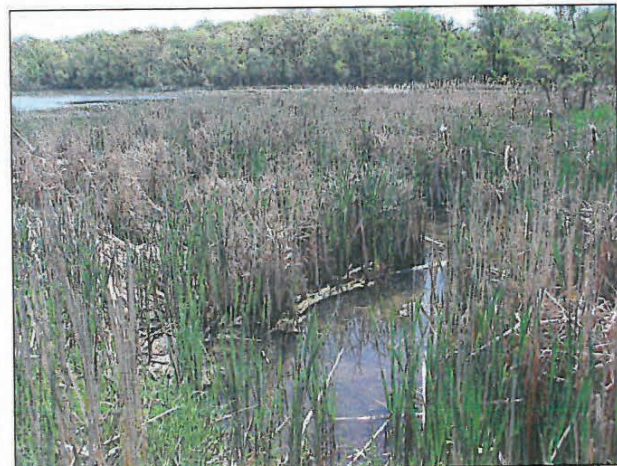
Photo #13 – Cattails
(May 20, 2009)
