## Menomonee Fish Passage Barrier Survey

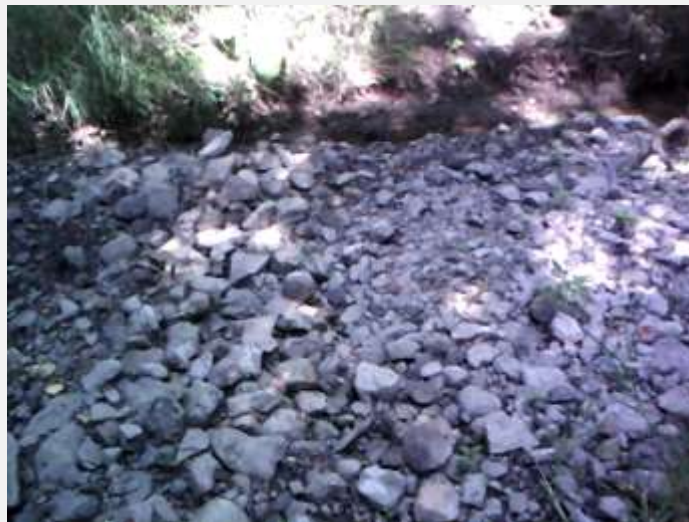
Rocky debris jam major.

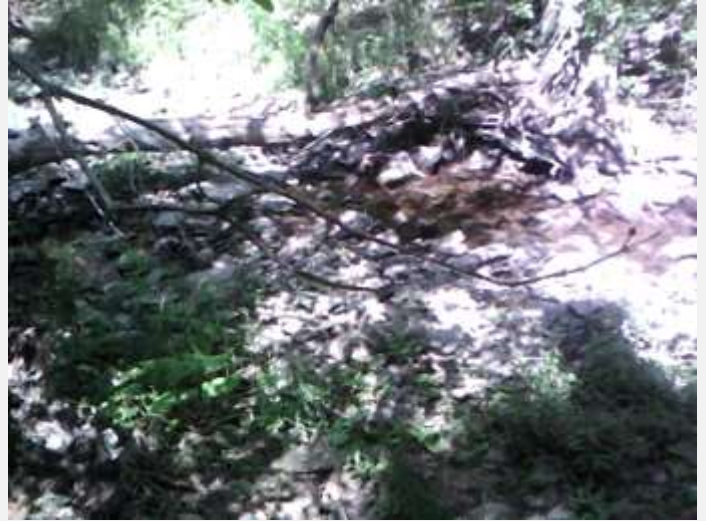
Rocky debris jam major.

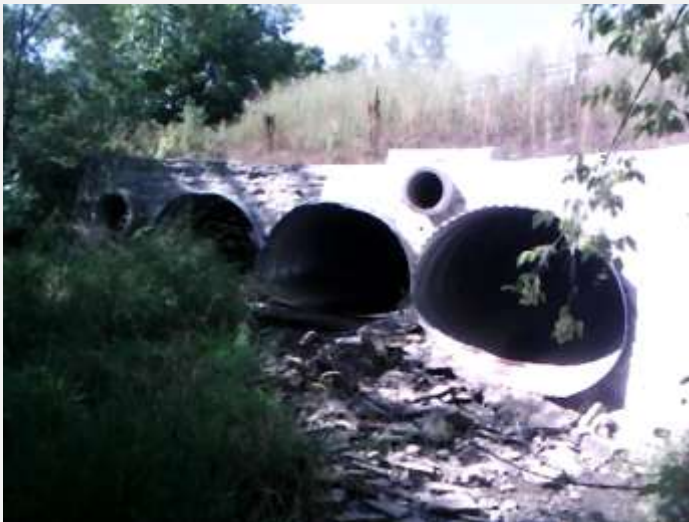
[Photo Outlet](#)

Shape Ellipse Drop Freefall into pool  
Condition New Material Metal  
Drop 0.2 Slope 0.009 Plugged 1%  
Length 144.4 Width 11 Height 7.1

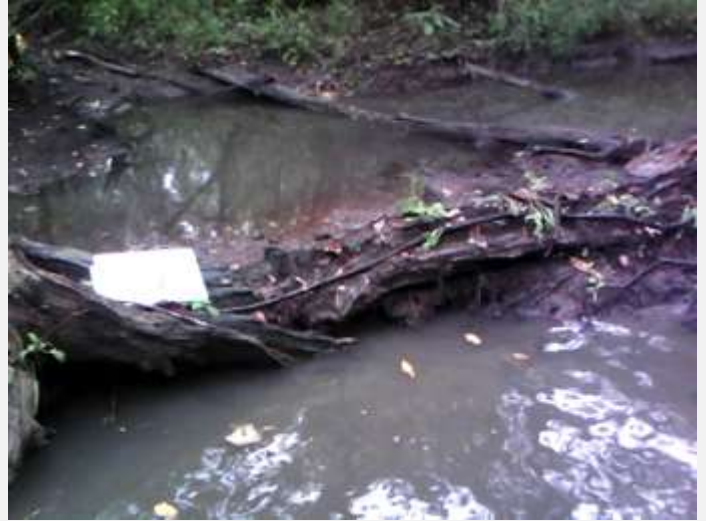
Fallen tree impeding stream/changing its course, new course is just a trickle, blockage 13 ft in width.

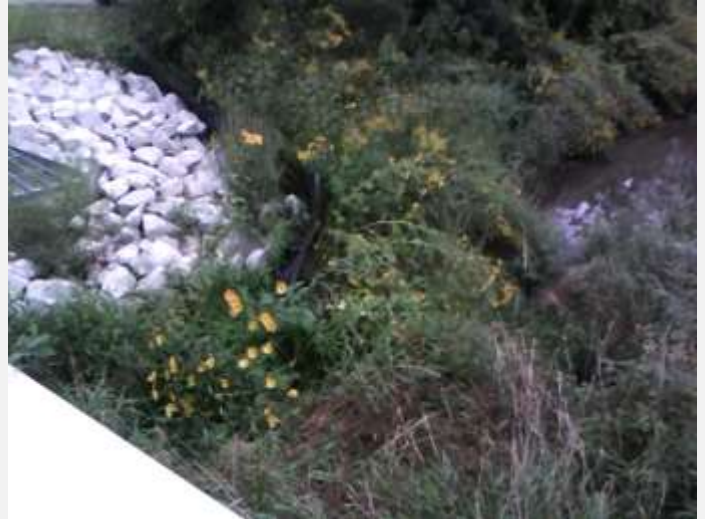
Free spanning bridge, but big blockage at outlet impeding stream, stream width about 16 ft across; bank slump into stream causing blockage across entire width.

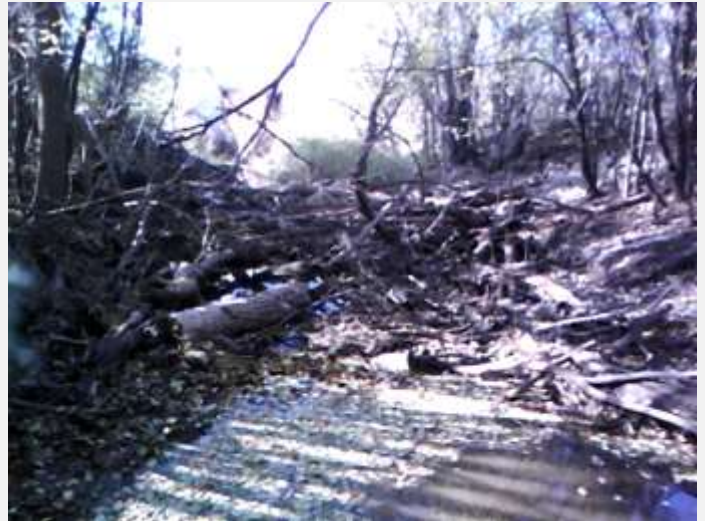
Major debris jam impeding stream.

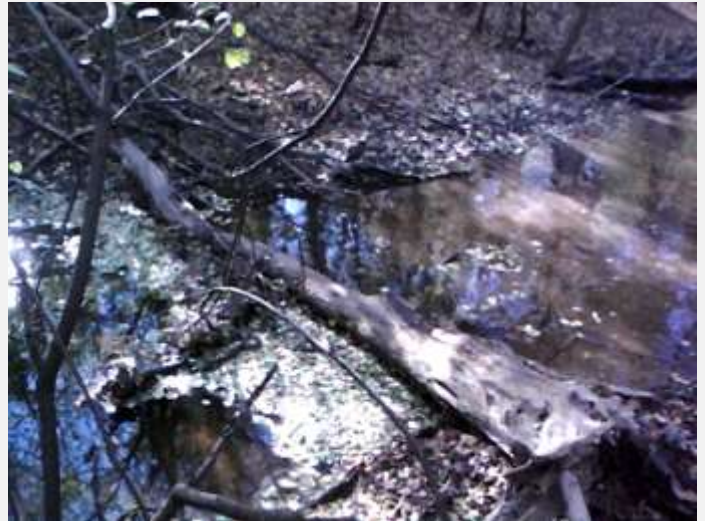
Log spanning stream, minor impediment.

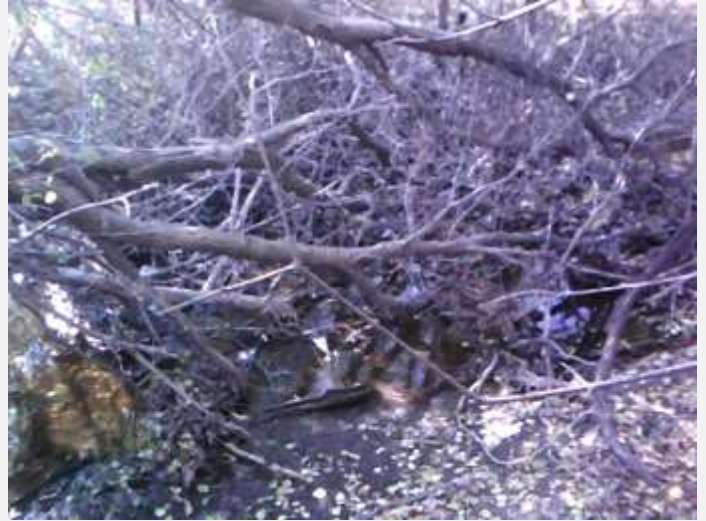
Minor debris jam.

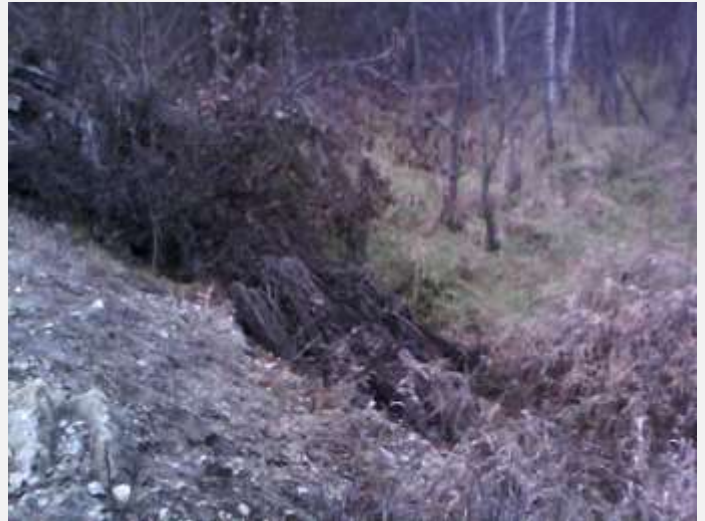
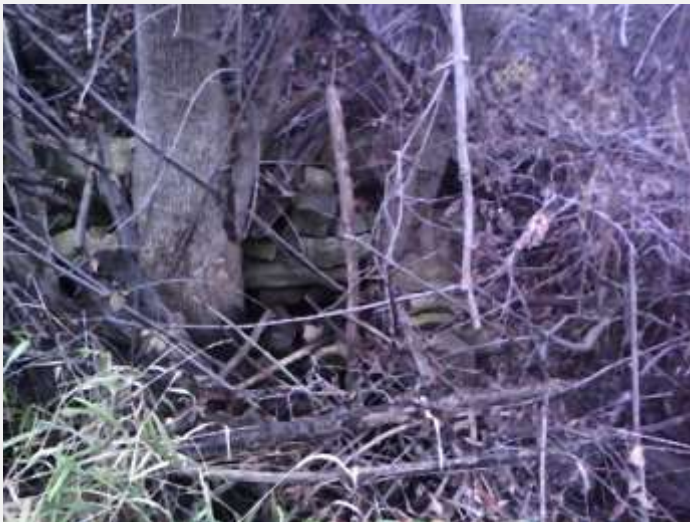
Collapsed railroad bridge culvert; water still getting through but defintie impediment. Inlet blocked by railroad debris

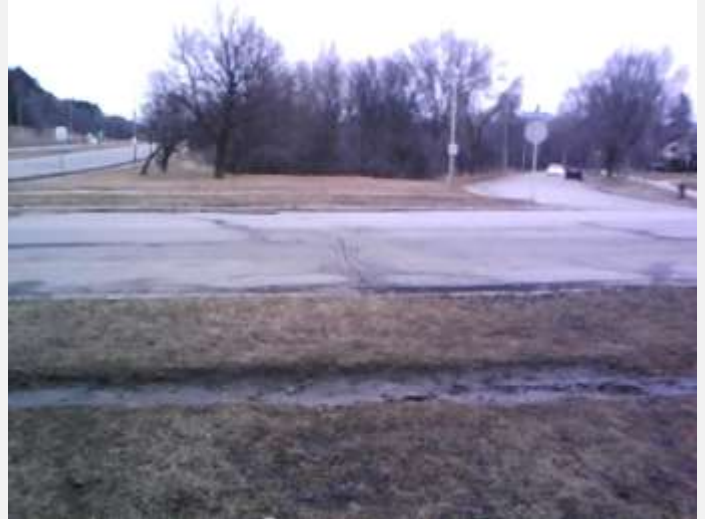
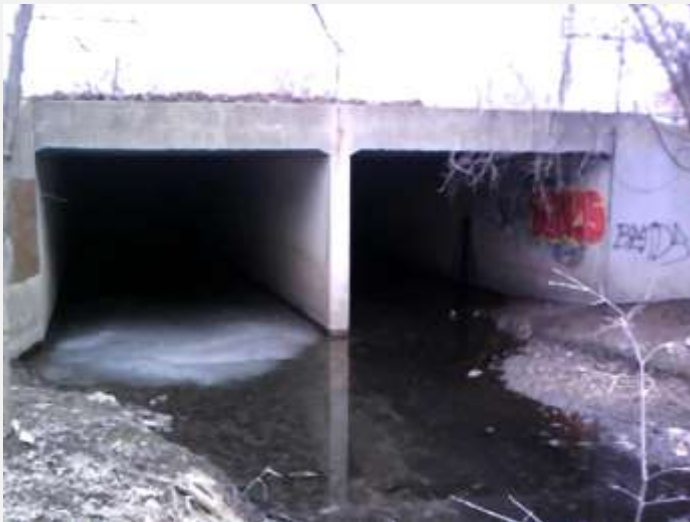
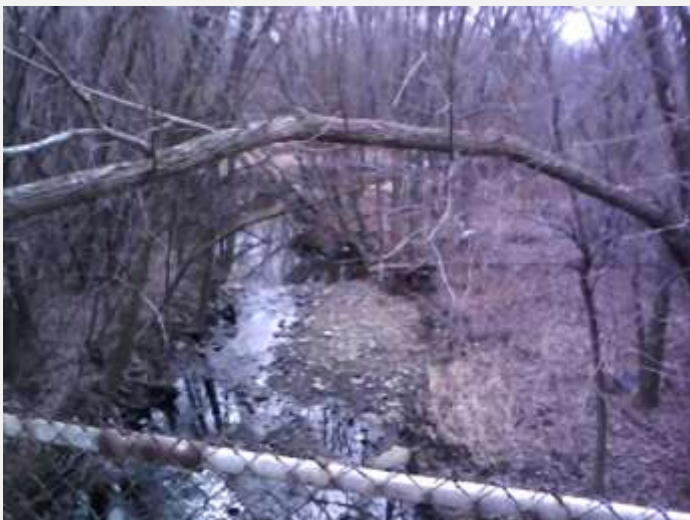
On south side of mayfair rd. flows underground approximately 100 yds underneath menomonee river parkway. debris clogging up inlet.

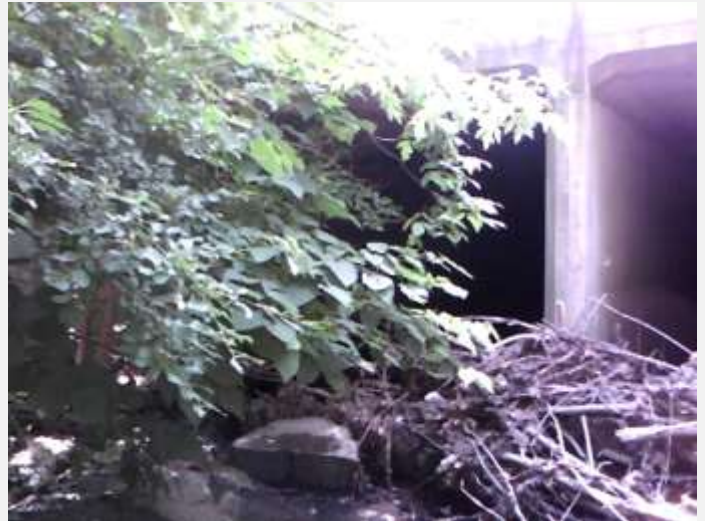
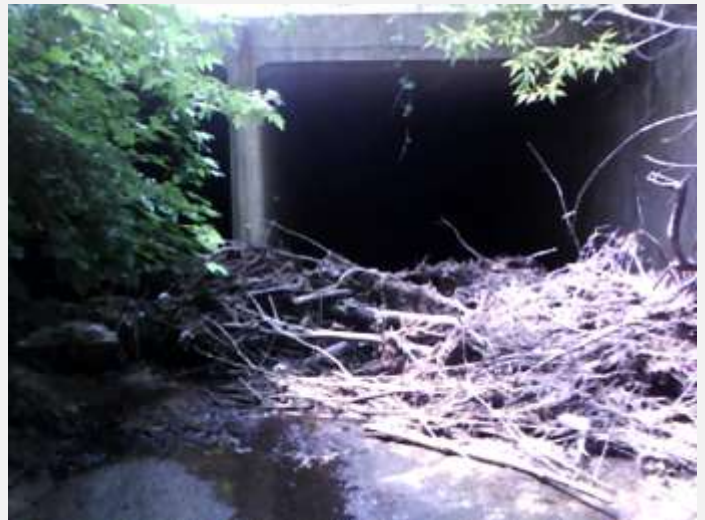
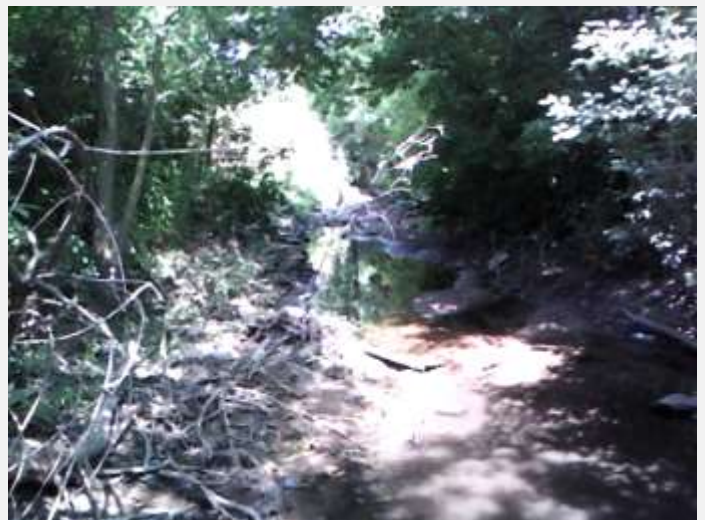
Inlets both blocked with substantial debris.

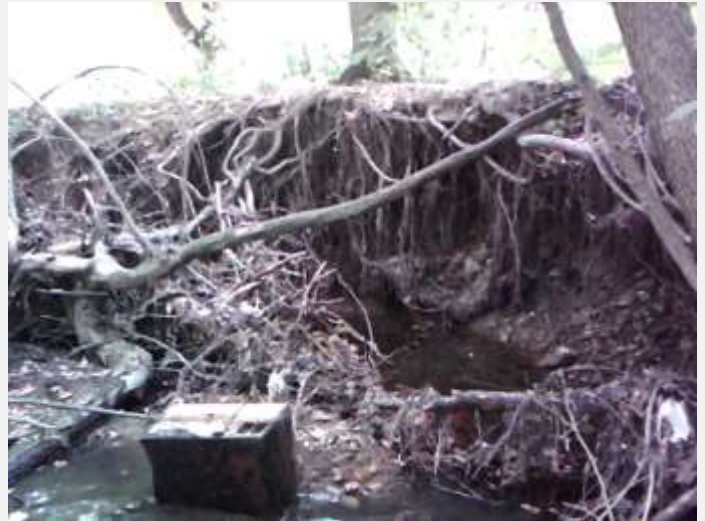
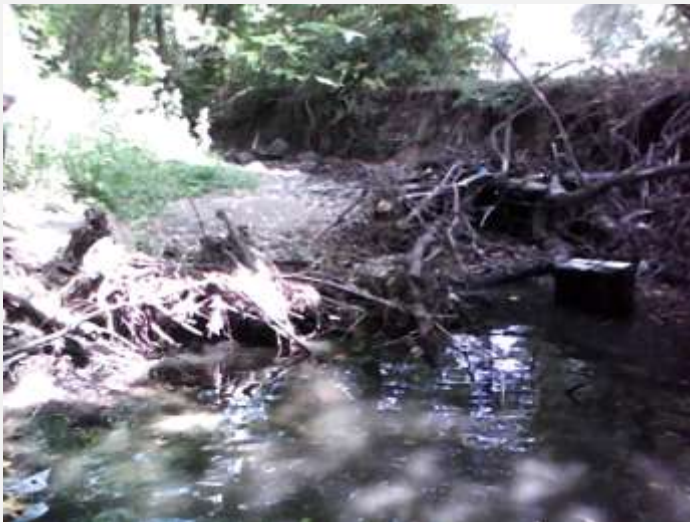
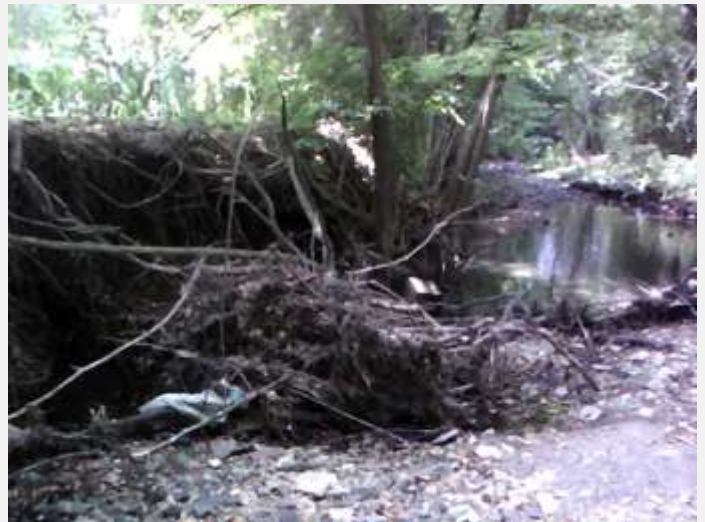
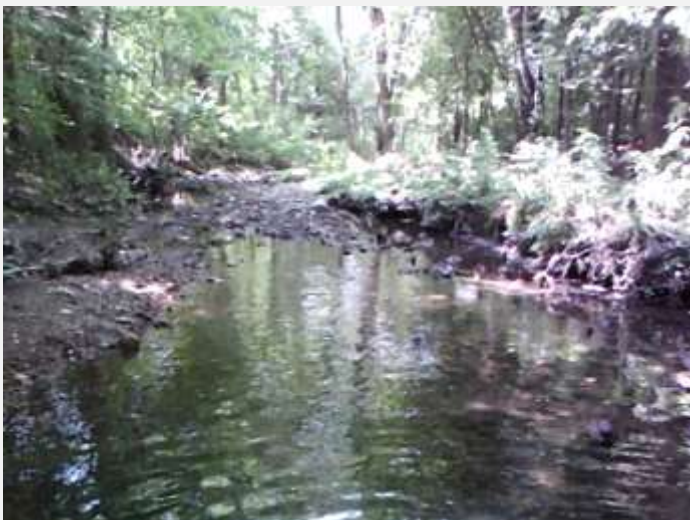
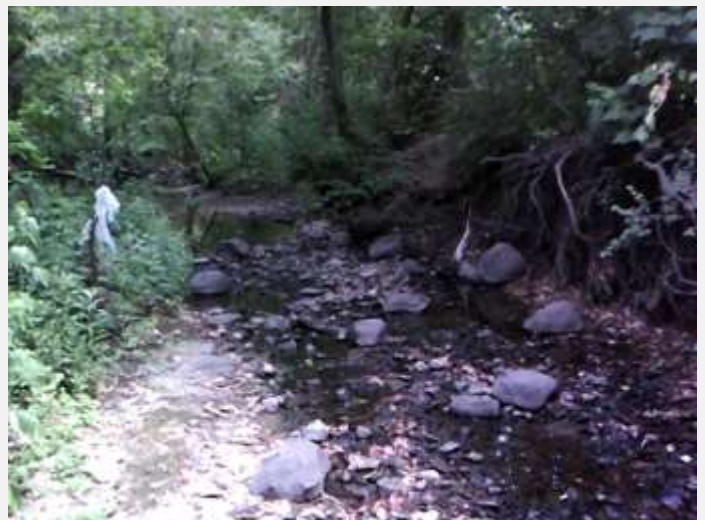
Fallen tree blocking stream causing severe erosion.

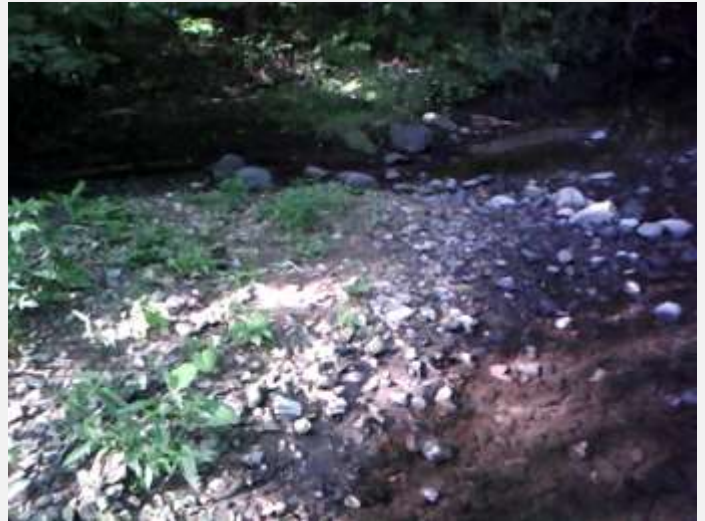
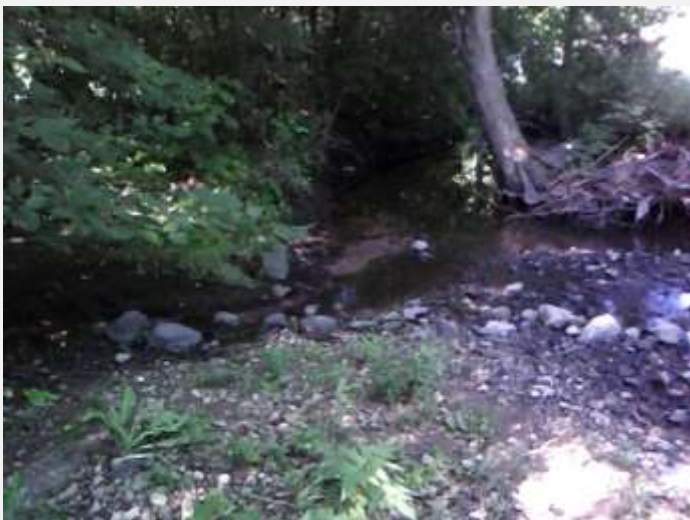
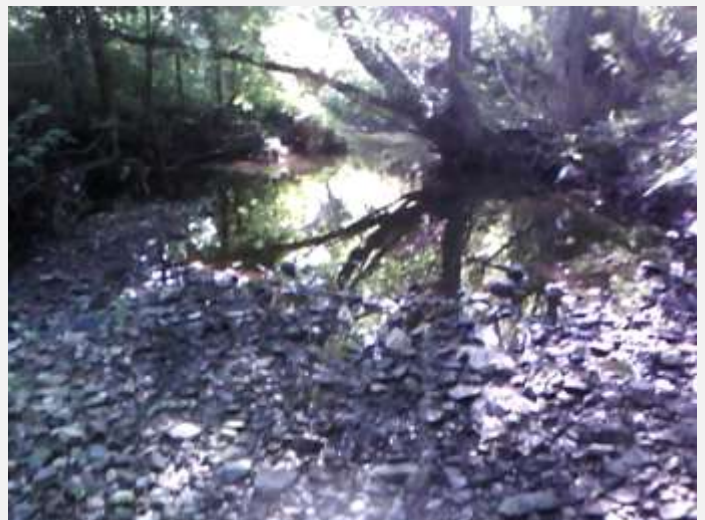
Large rock pile. Deep upstream and downstream.

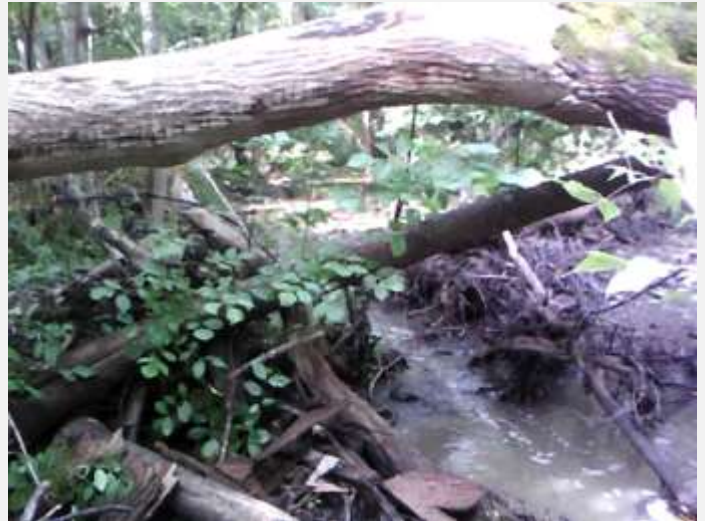
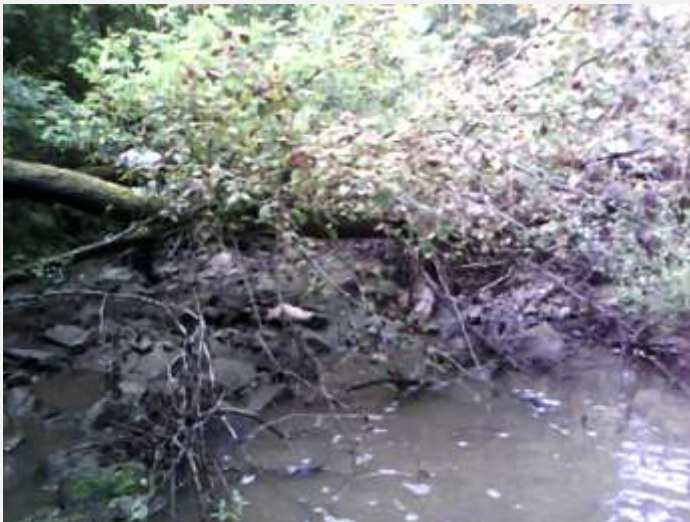
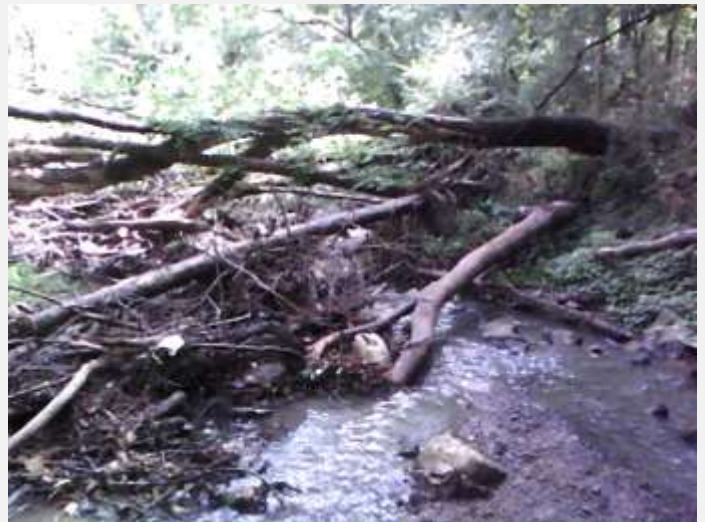
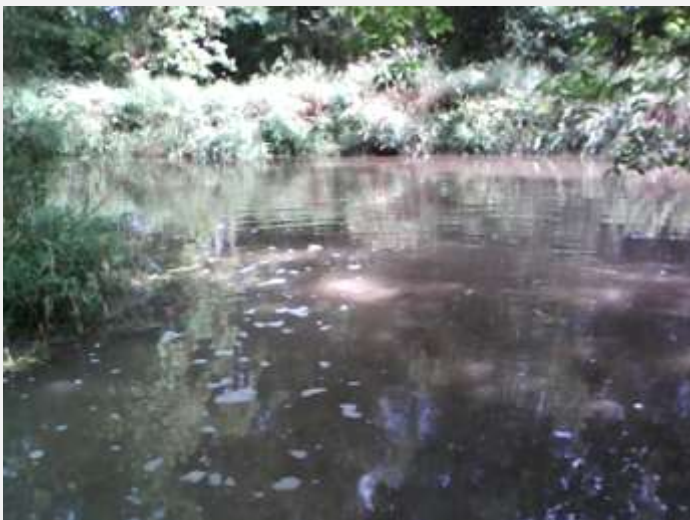
Large debris jam at mouth of Lily Creek; but somewhat passable.

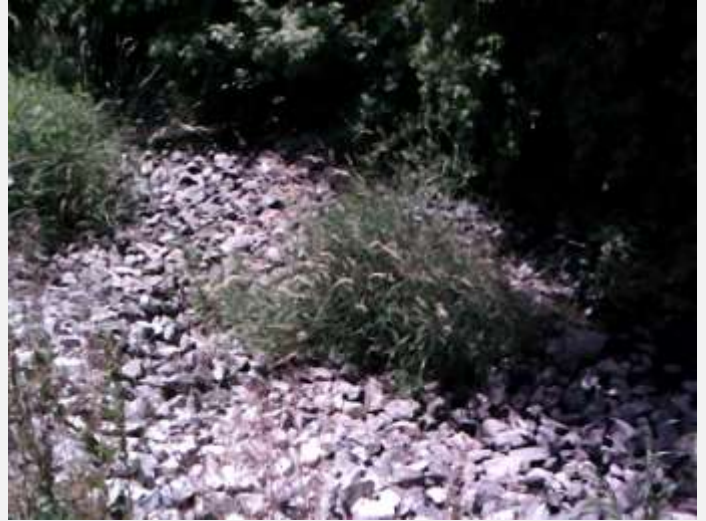
Photo Outlet

Rock field impediment impeding flow.

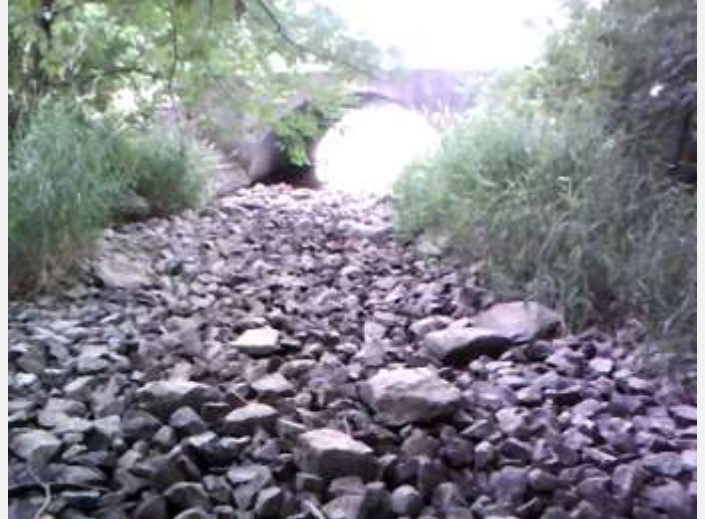
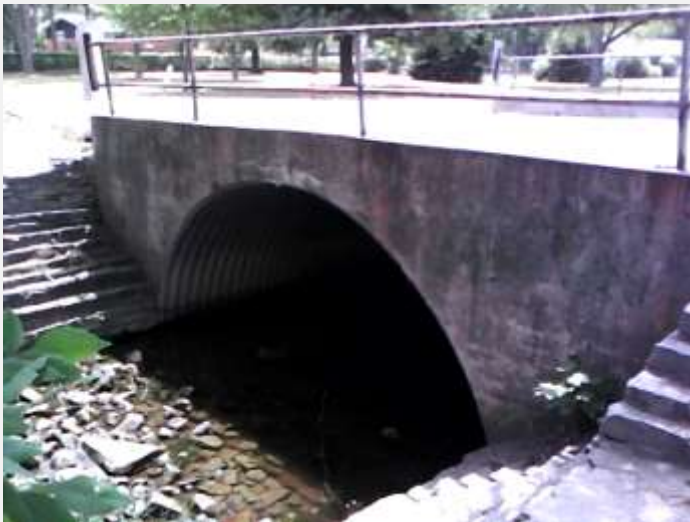
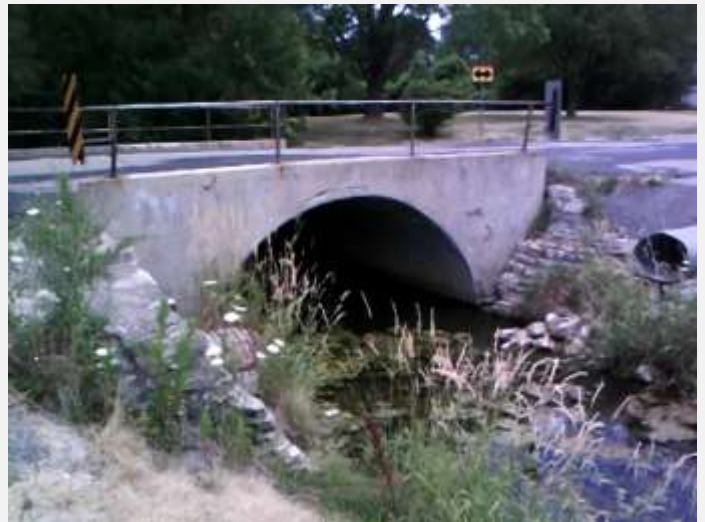
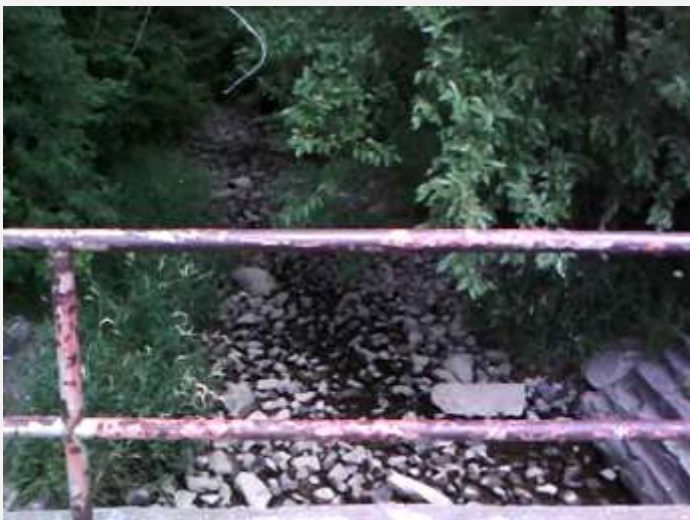
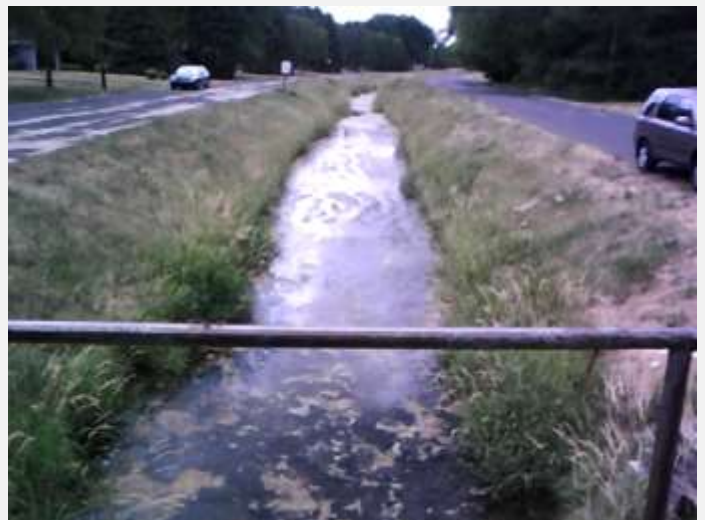
Bridge with culvert lining, stagnant water, rock field just beyond outlet impeding the flow; school of small bass.

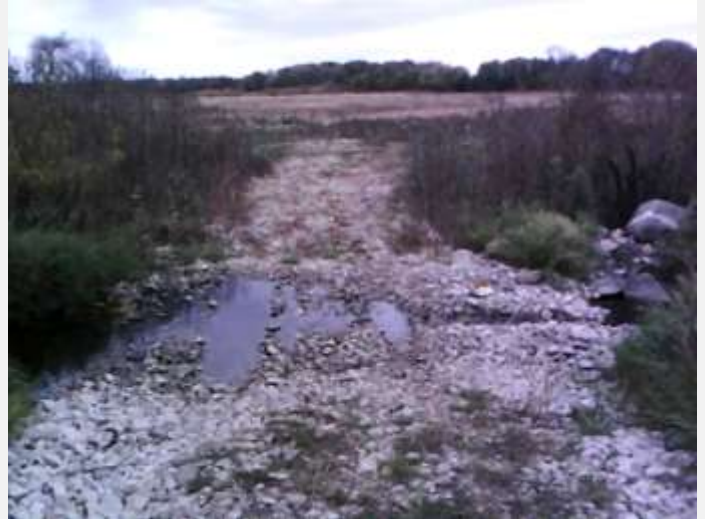
Low water crossing for farm vehicles.

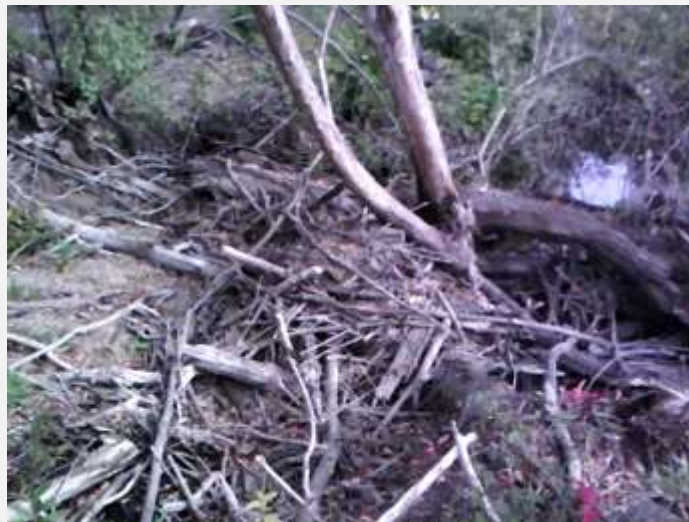
Big debris jam; definite impediment.

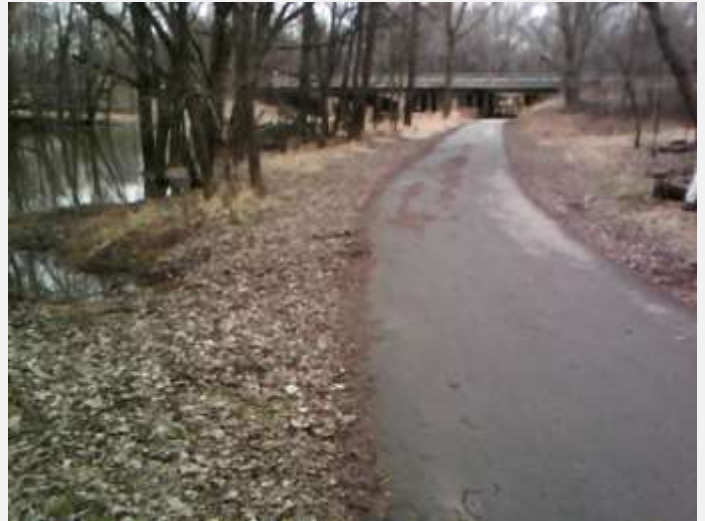
Culvert w apron oak leaf trail connecting wetland area to Little Menomonee.

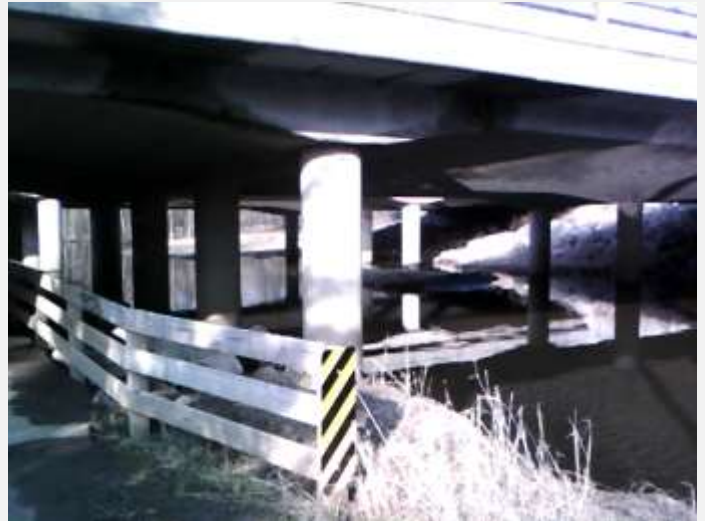
No impediment. Some sediment built up in channel.

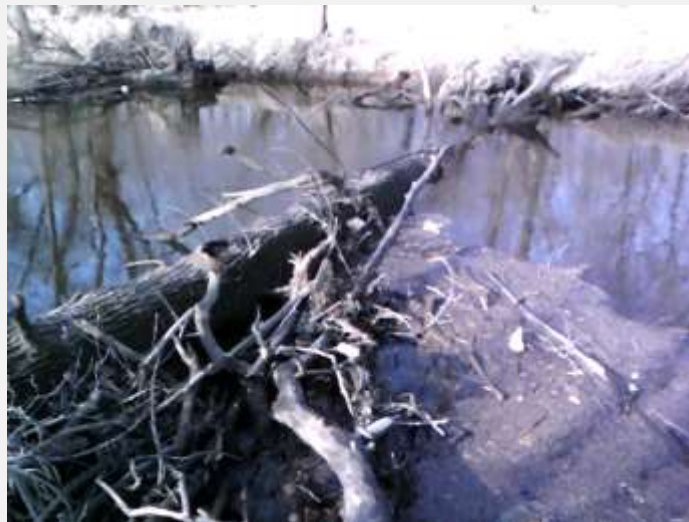
Log span entire stream; most likely impediment.

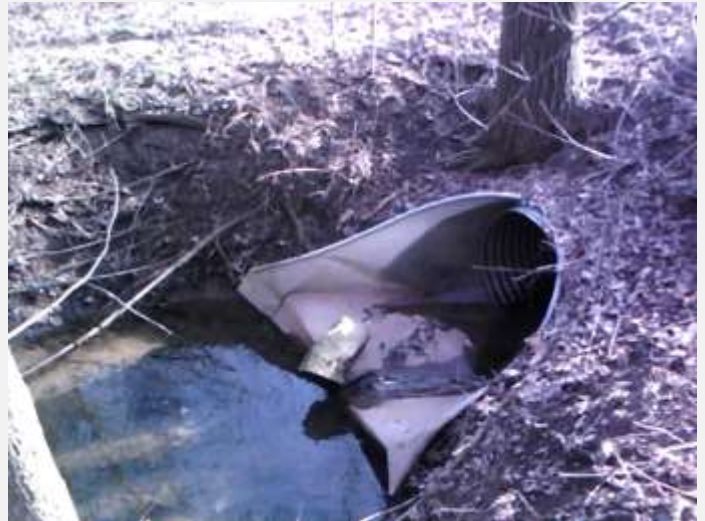
Stormwater outlet & ditch.

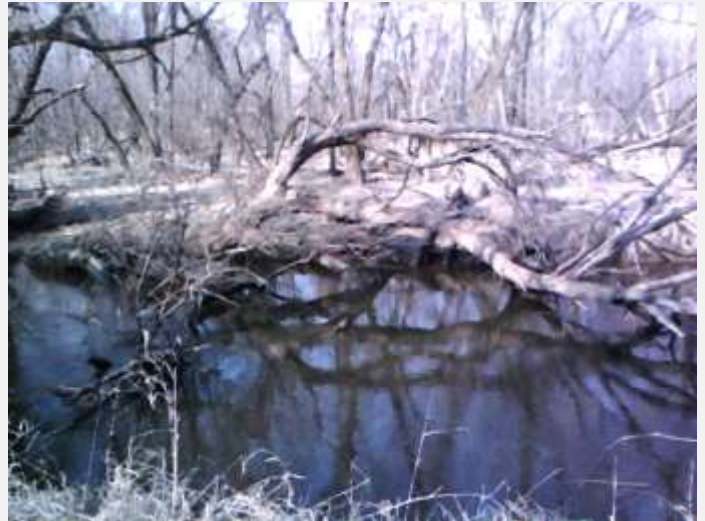
Debris jam, not major impediment.

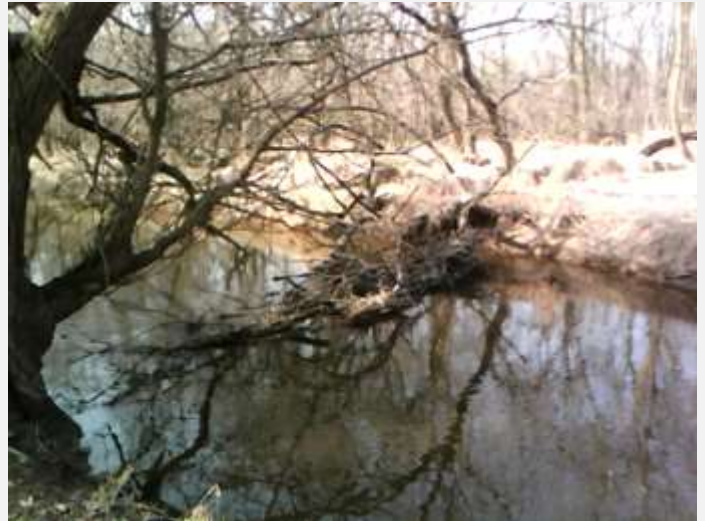
Minor debris jam.

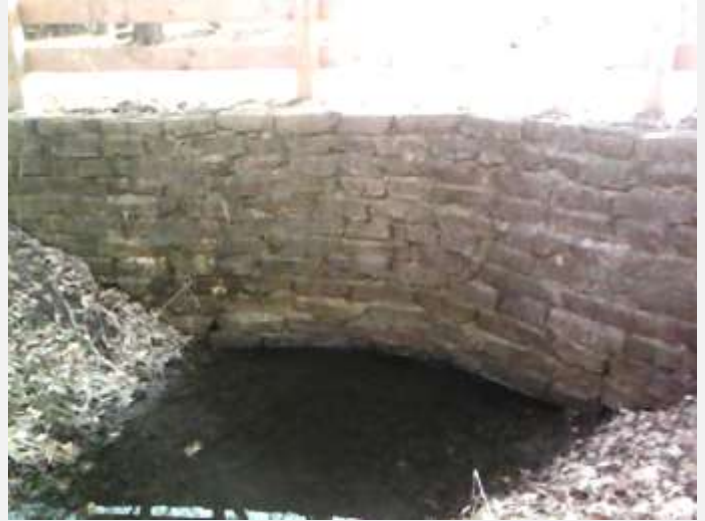
Stormwater outlet & ditch.

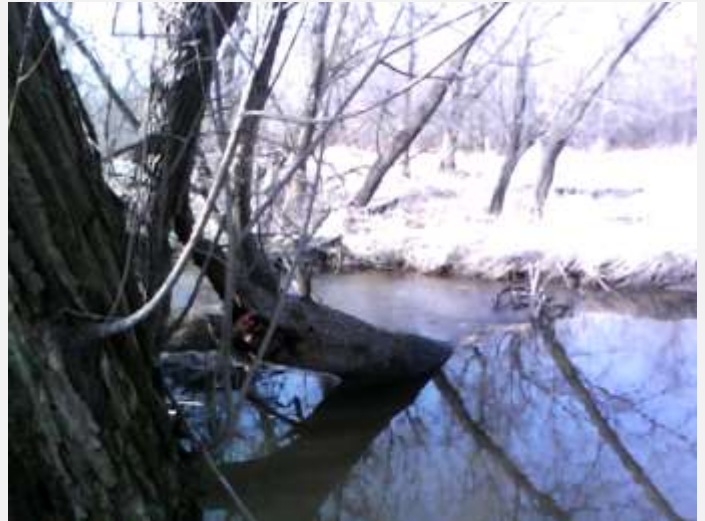
Minor debris jam.

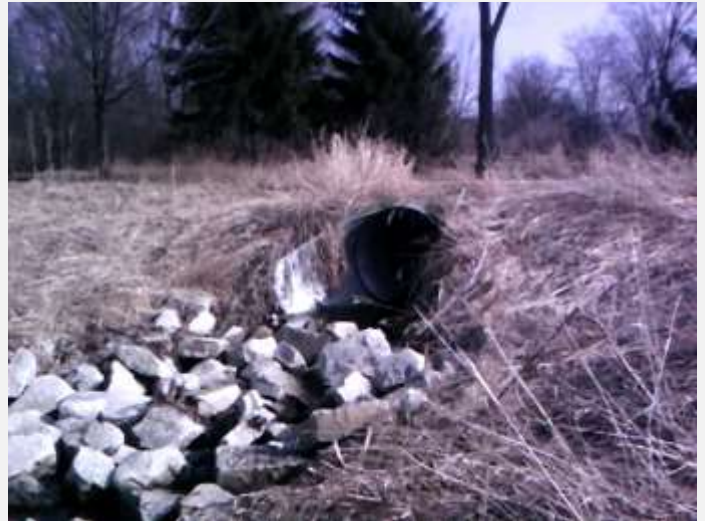
Stormwater outlet & ditch.

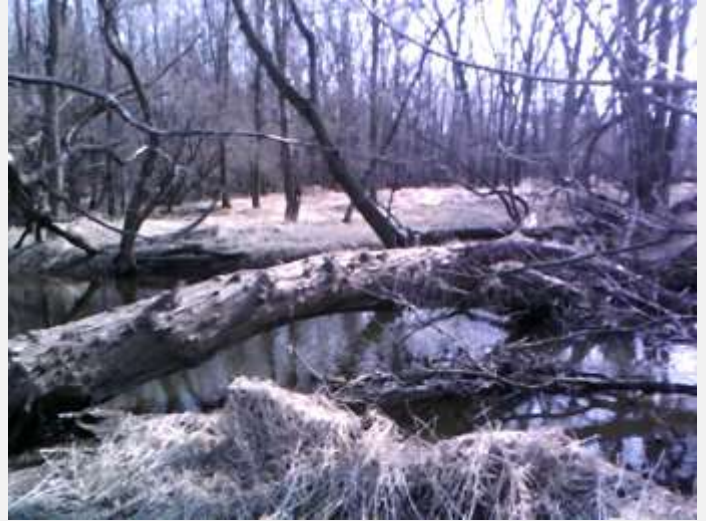
Minor debris jam.

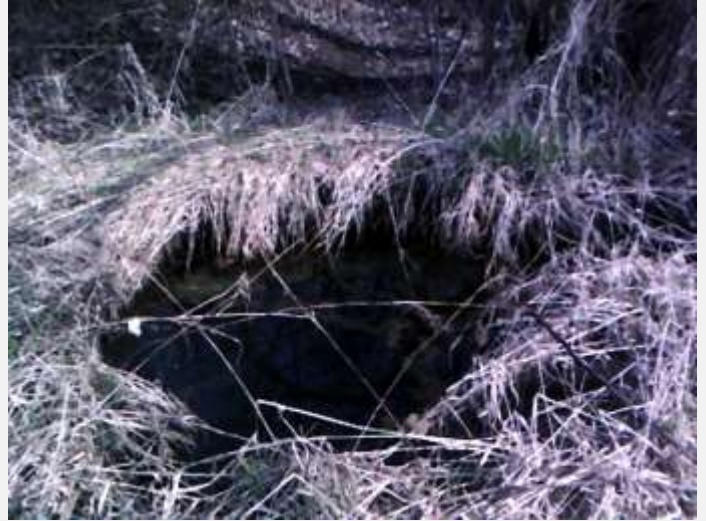
Stormwater outlet & ditch; 4 ft deep hole at outlet.

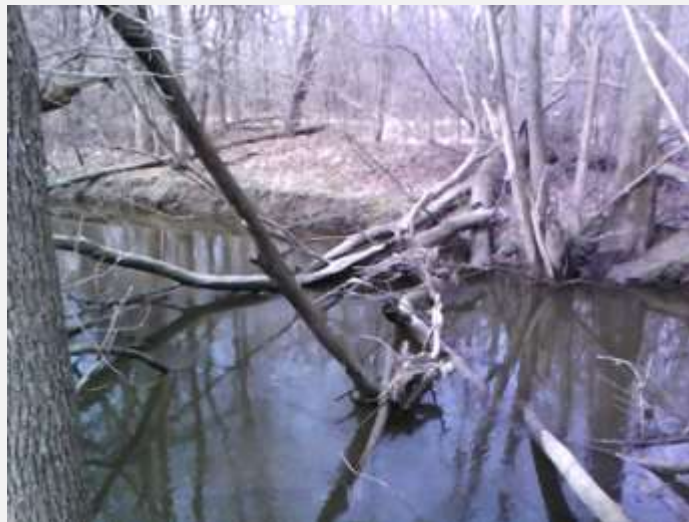
Minor debris jam.

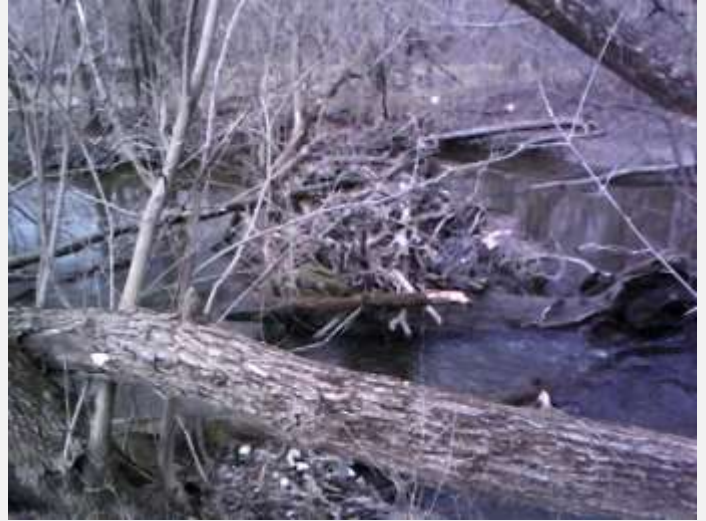
Major debris jam.

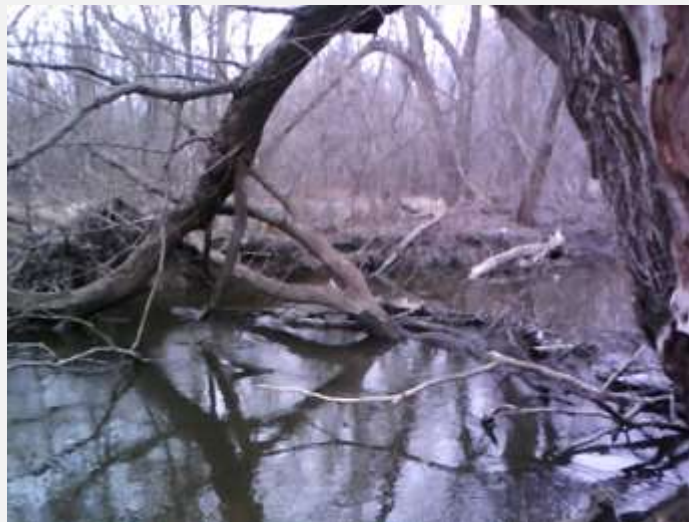
Major debris jam and impediment.

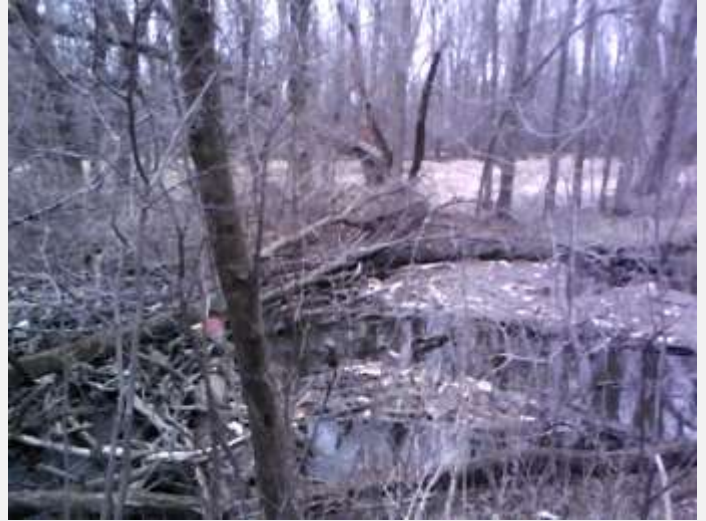
Major debris jam with sediment backed up.

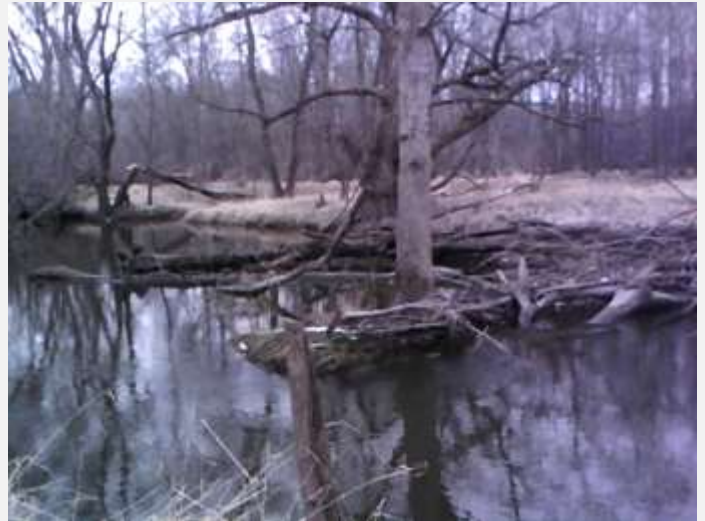
Series of minor debris jams.

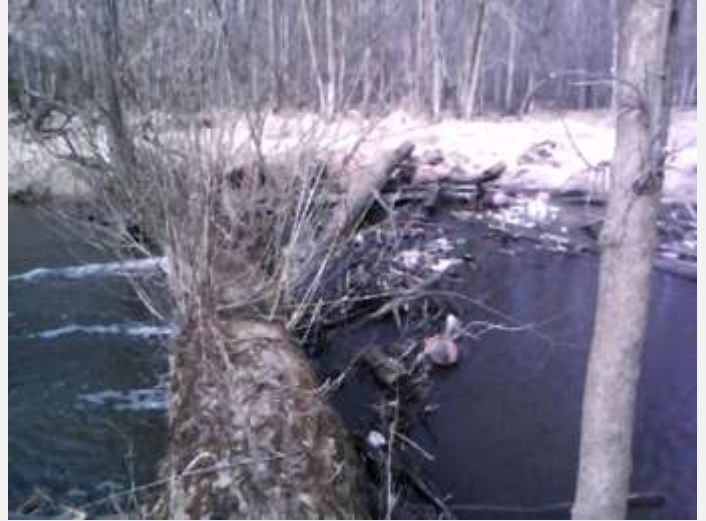
Major debris jam and impediment.

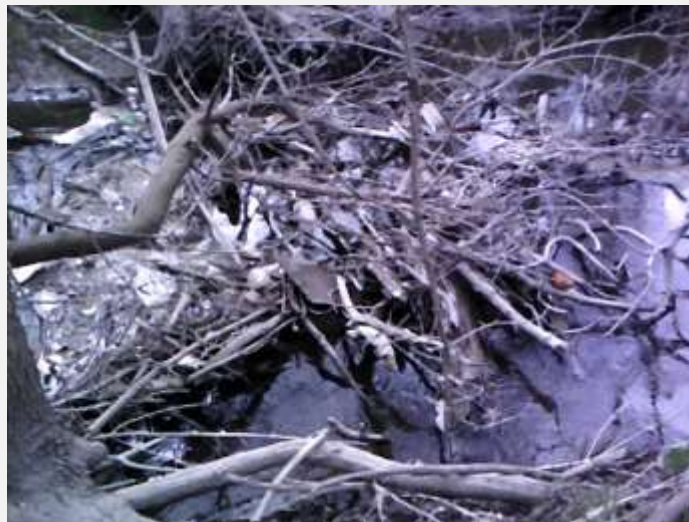
Major debris jam.

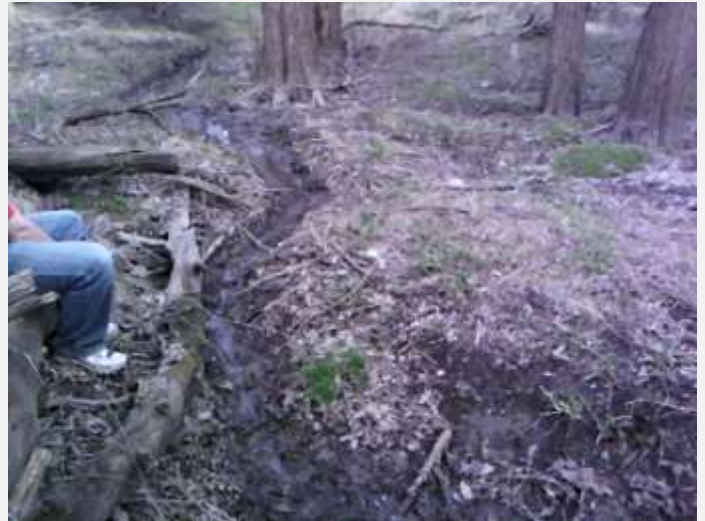
Woody debris jam major.

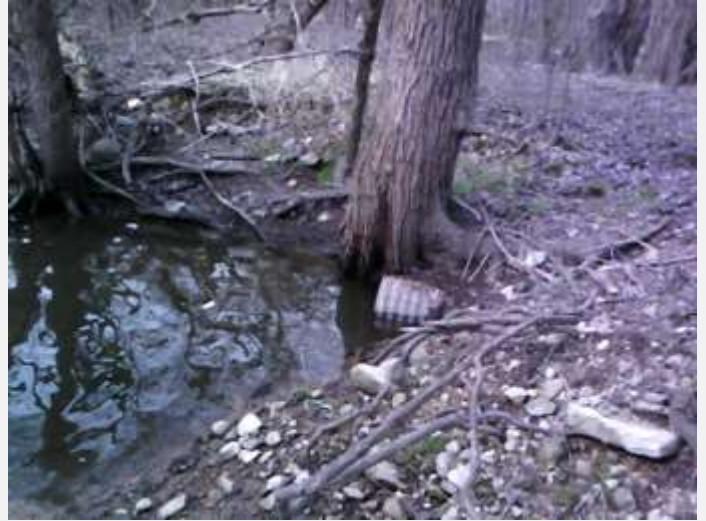
Stormwater outlet & ditch; major woody debris jam.

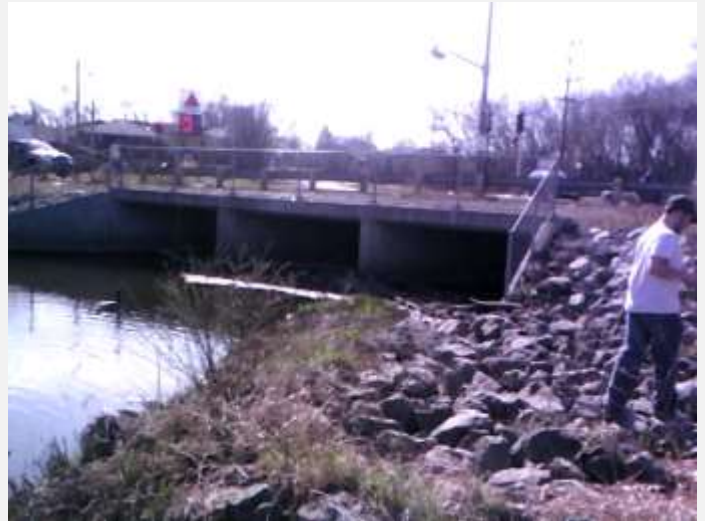
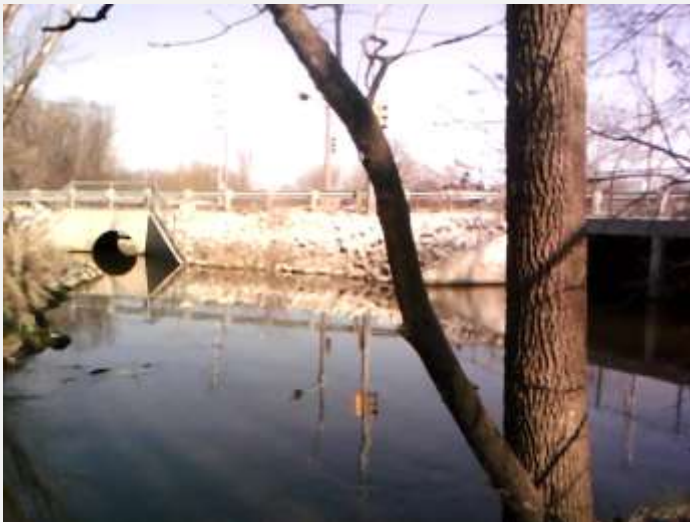
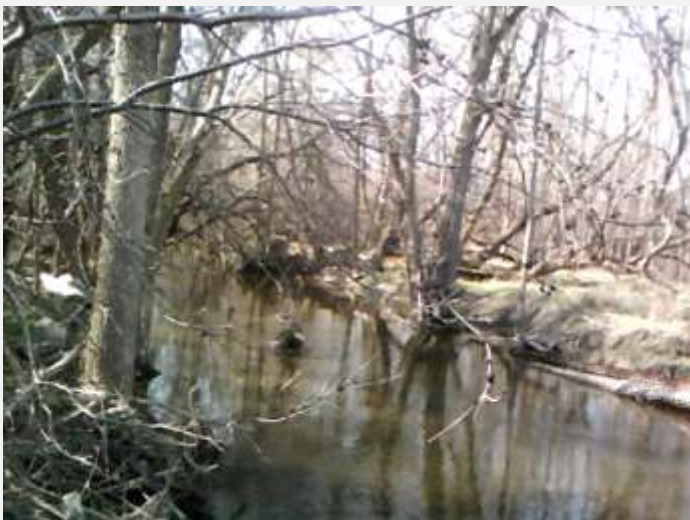
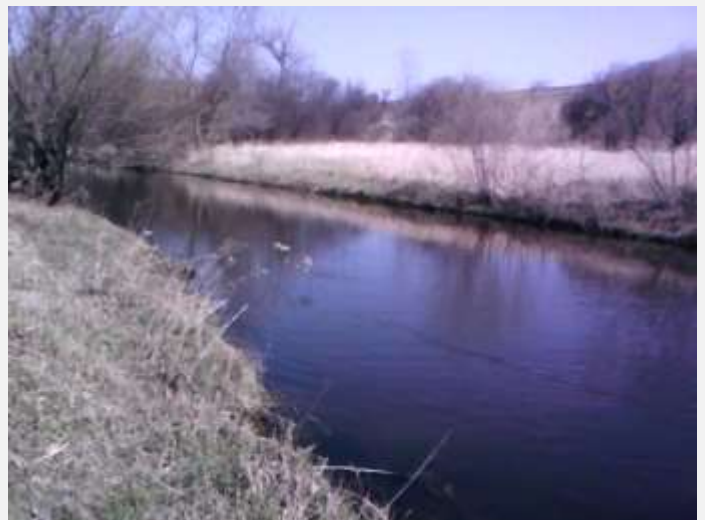
Debris jam blocking openings of bridge; rectangular concrete structure; another culvert nearby outlet.

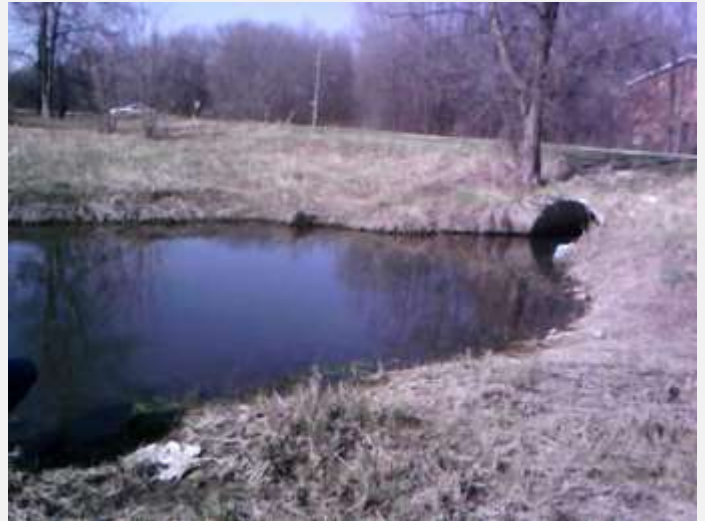
Stormwater outlet & ditch.
