## Menomonee Fish Passage Barrier Survey

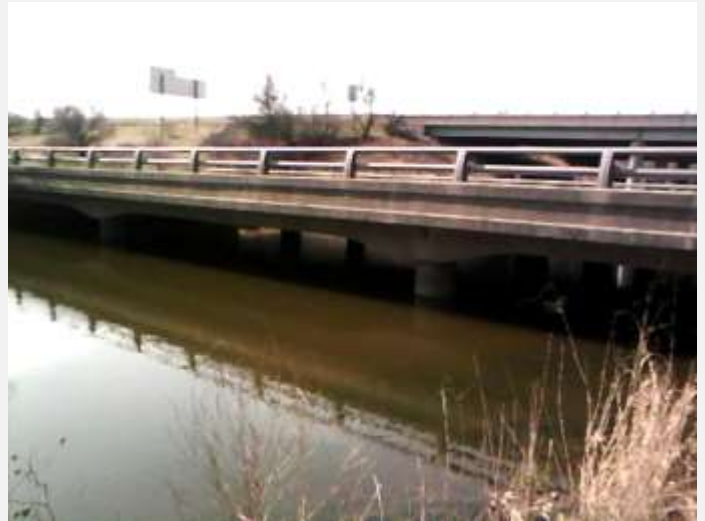
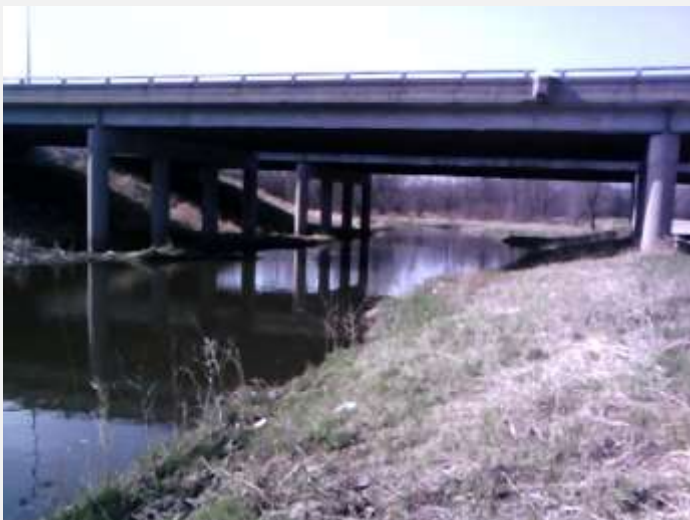
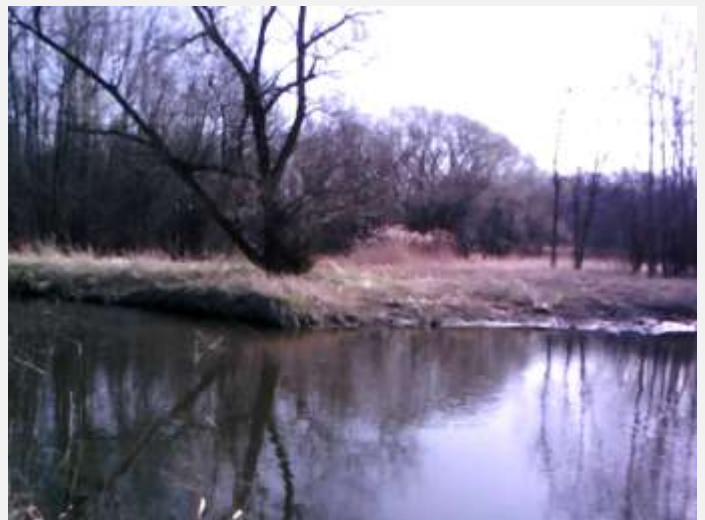
Low bridge with two sections of pilons. Storm water culvert nearby.

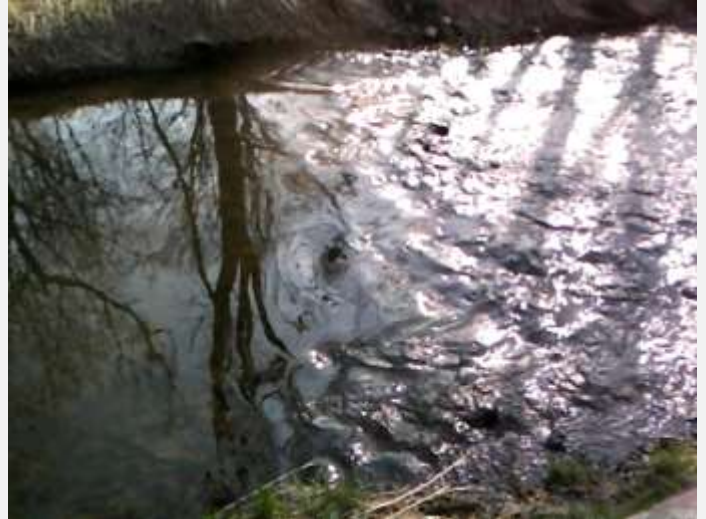
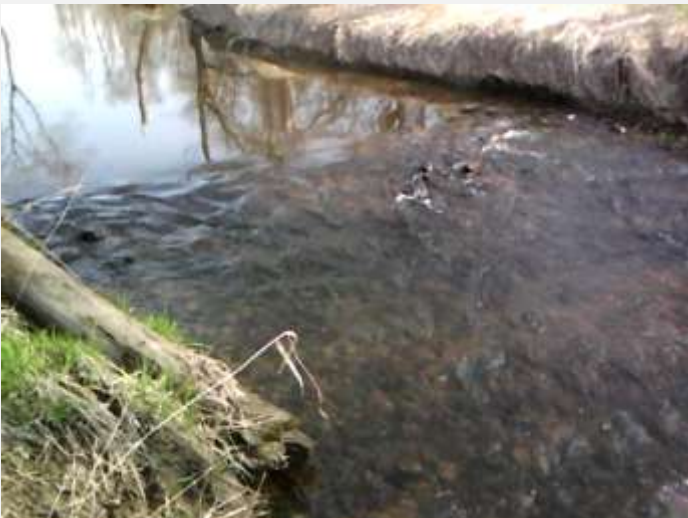
Small drop in elevation from bedrock.

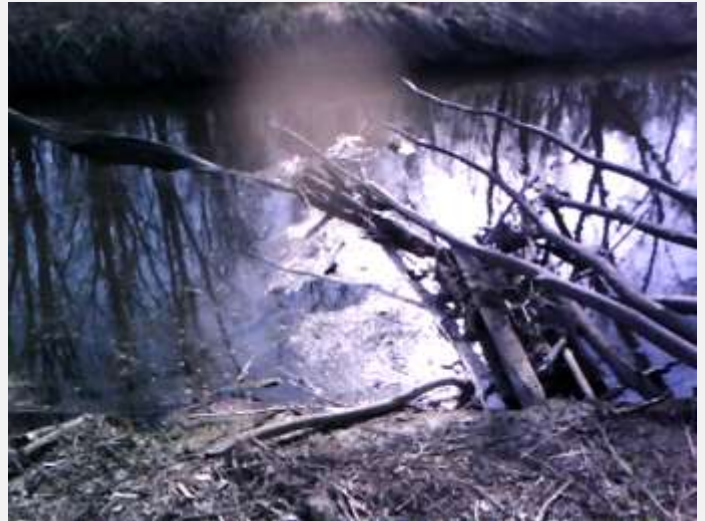
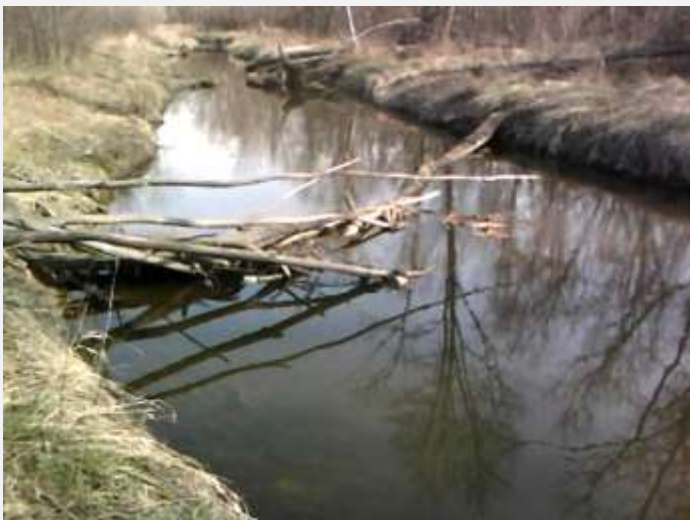
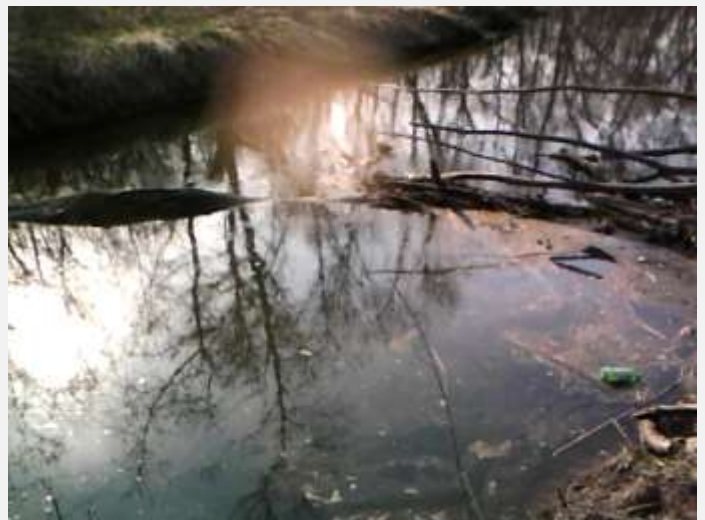
Minor debris jam.

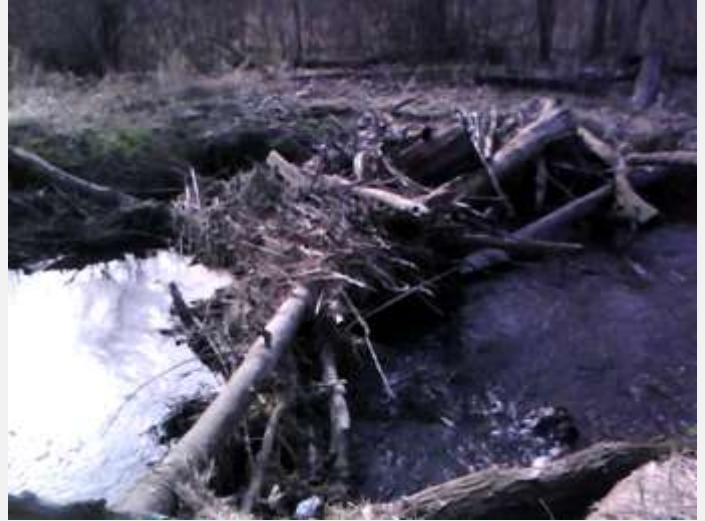
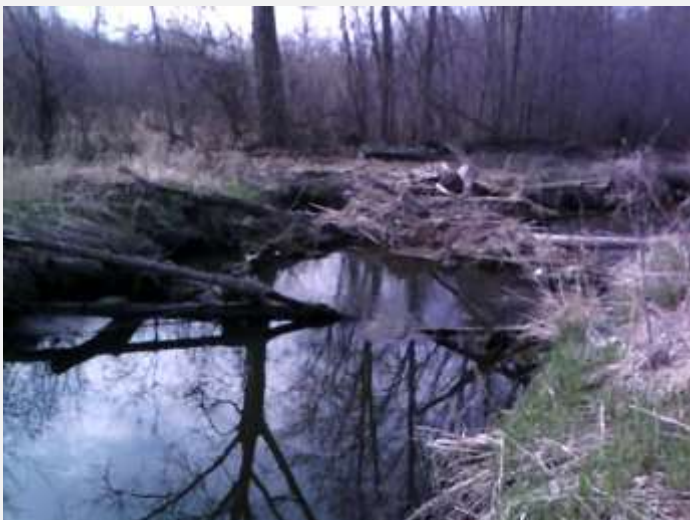
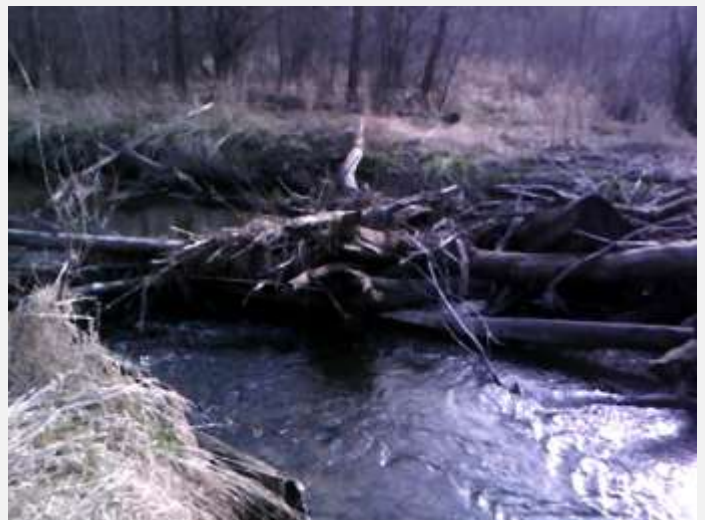
Major debris jam; change in water elevation; possible beaver.

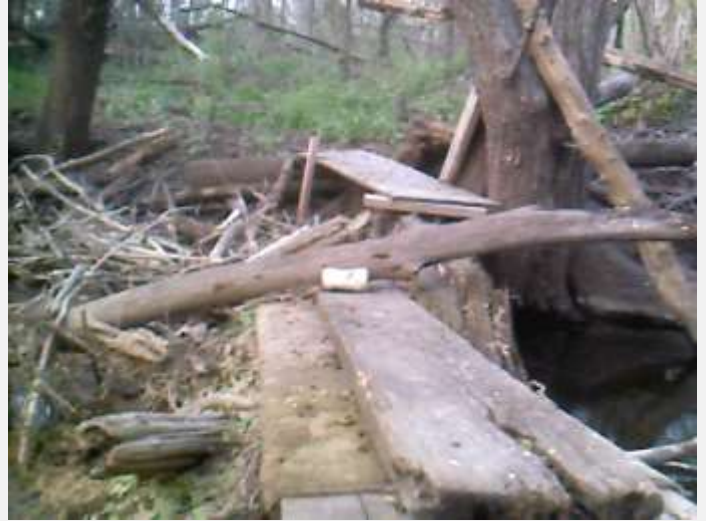
Foot bridge dirt & tree stacked with planks on top.

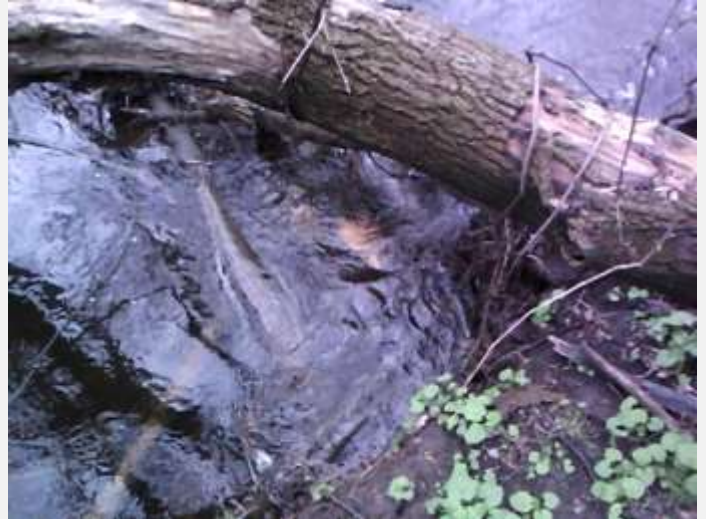
Several fallen trees & maybe garbage trapped.

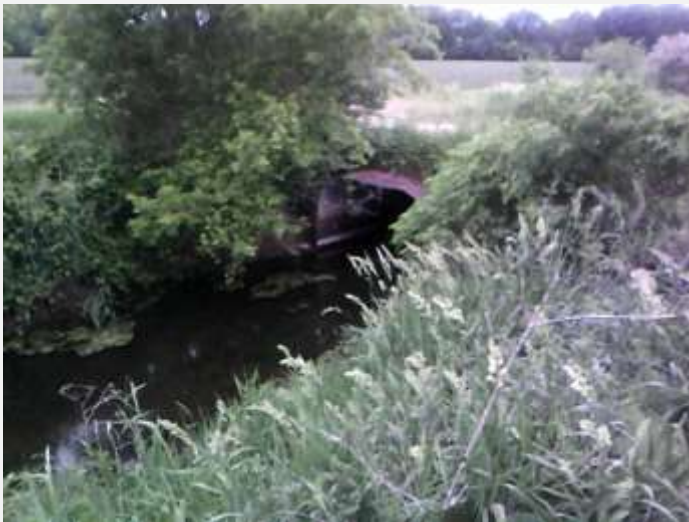
[Photo Outlet](#)

Rusty metal culvert.

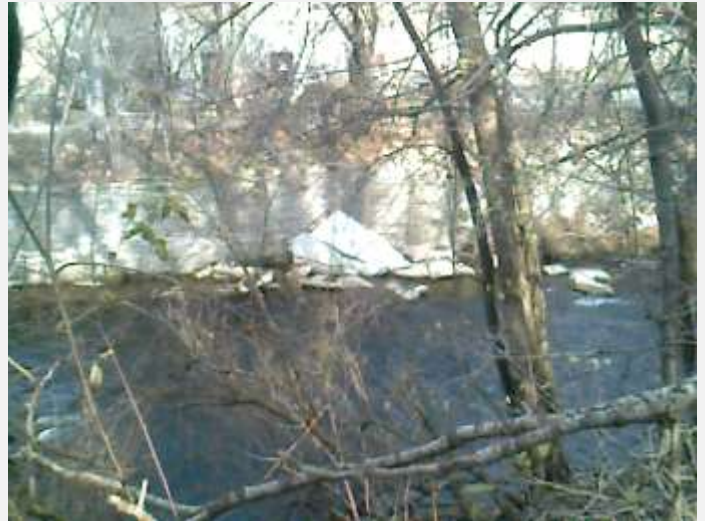
Construction debris in river. May be a problem in low water.

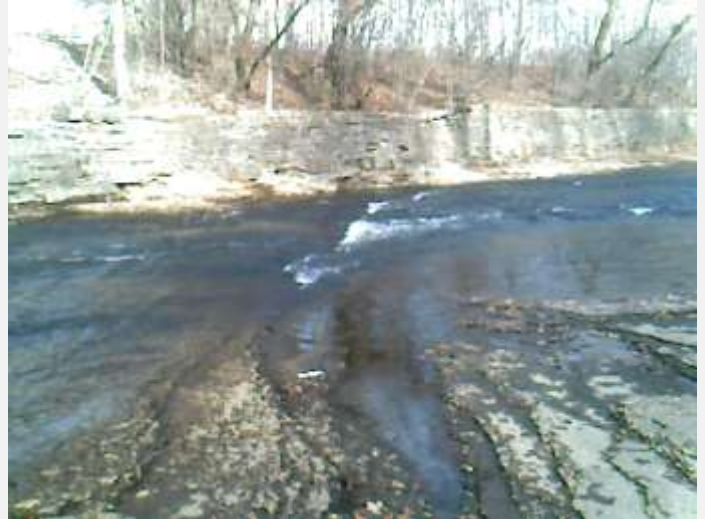
Natural bedrock drop.

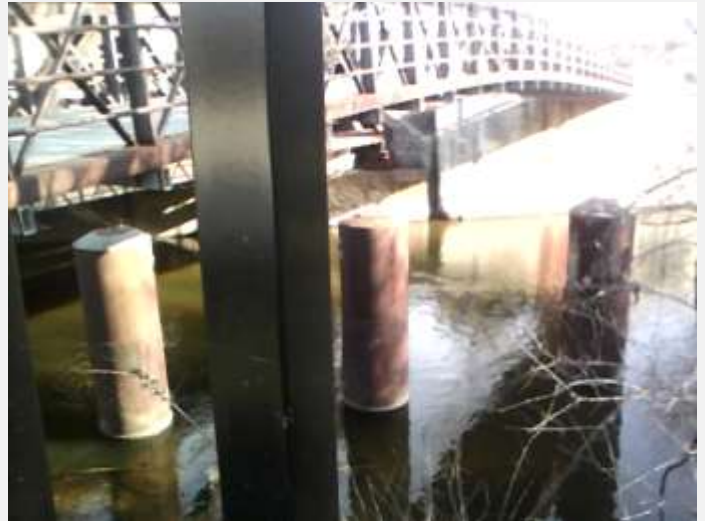
3 Remnant bridge supports in river, no impediment.

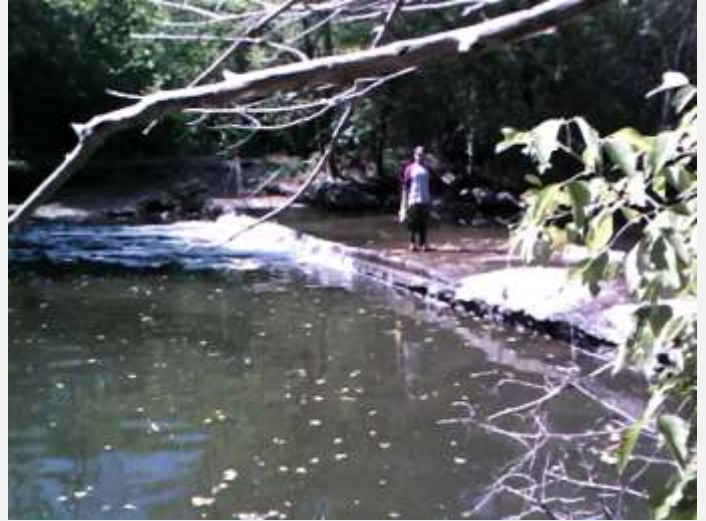
Old stone ford/road spans river.

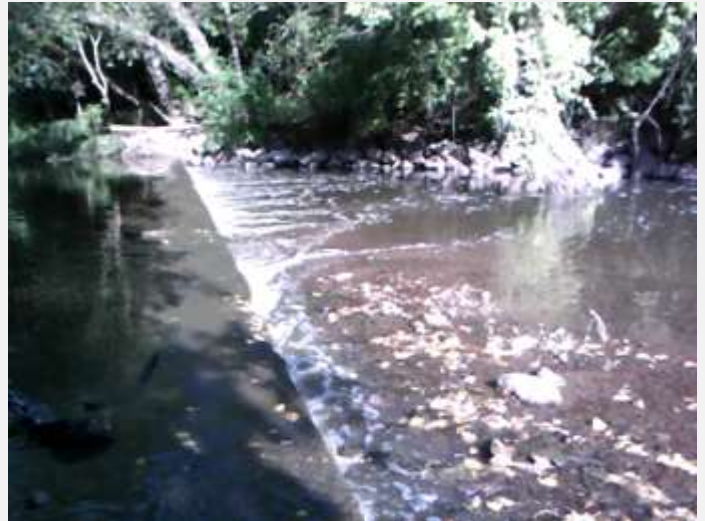
Concrete sewer box; diagonal to bank; exceeded tape length.  
Water depth range 1.2, 2.5, 3.6.

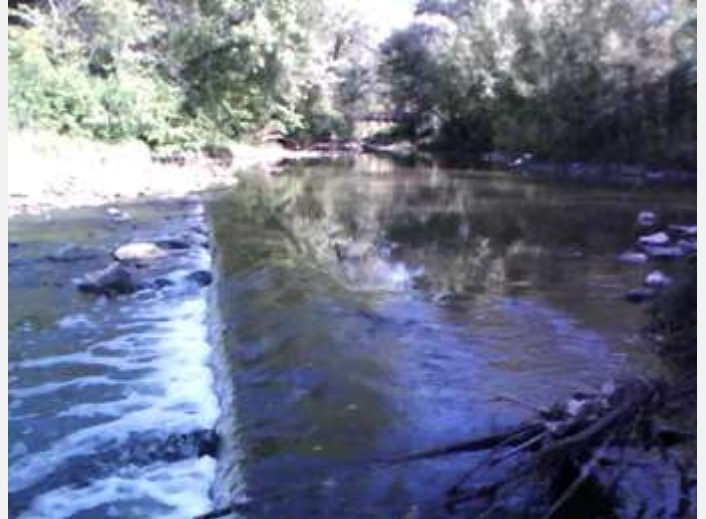
Diagonal to stream bank, concrete sewer box.

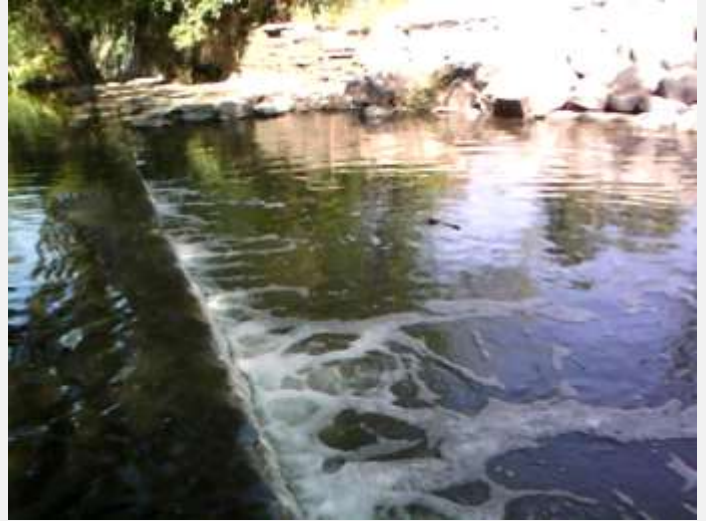
Concrete sewer box spans stream diagonally. Too deep and cold to survey; come back in spring.

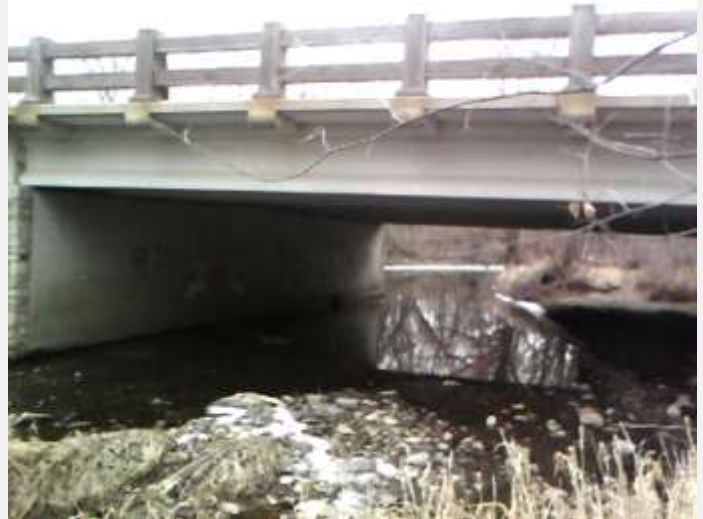
STRUCTURE 1 - 6 staggered concrete slabs spanning the river, 2 channels divided by barrier spanning the bridge. (structure 1) headwater depth = 1.82 / tailwater depth = 1.05. STRUCTURE 2 - headwater depth = 1.44 / tailwater depth = 0.24. very low flow.

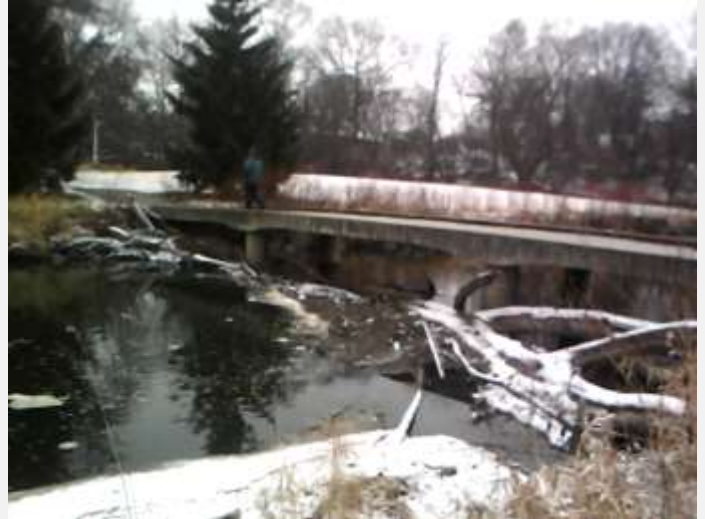
Golf cart bridge causing debris jam.

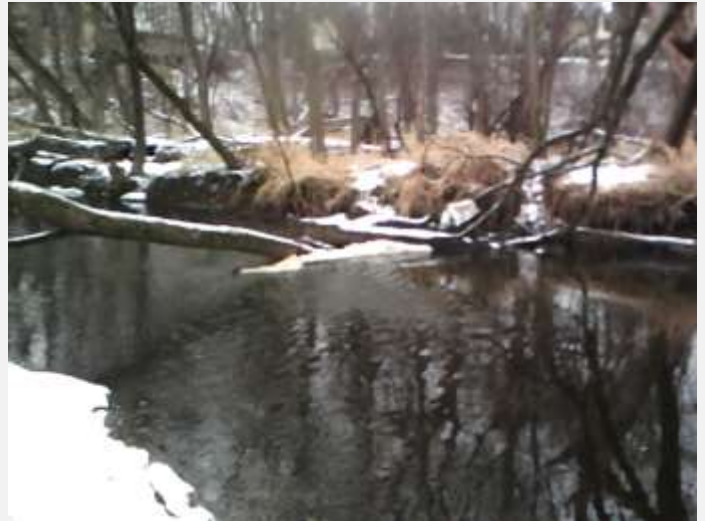
Fallen tree partial block.

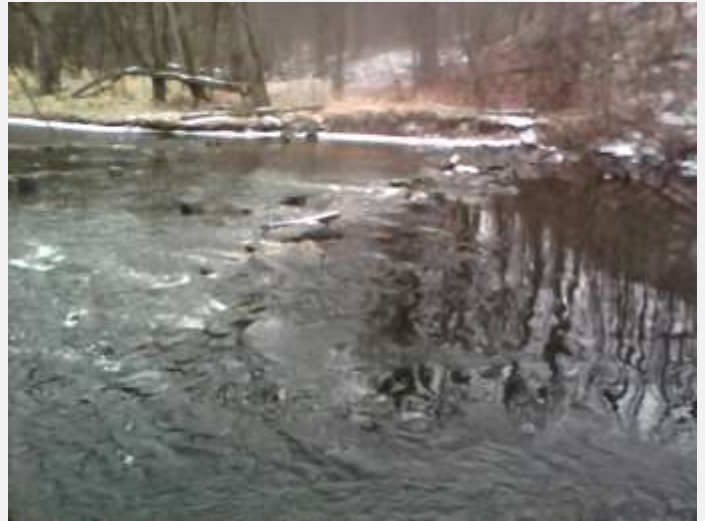
Pile of boulders . Return to survey.

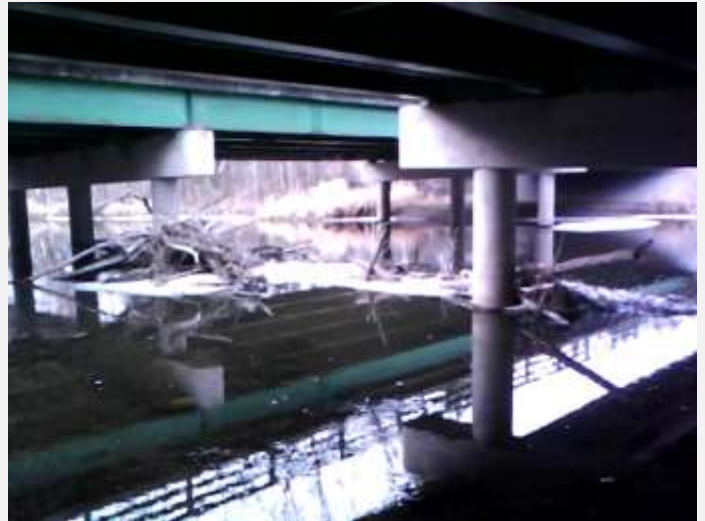
Fallen tree upstream - no impediment. debris jam under bridge.

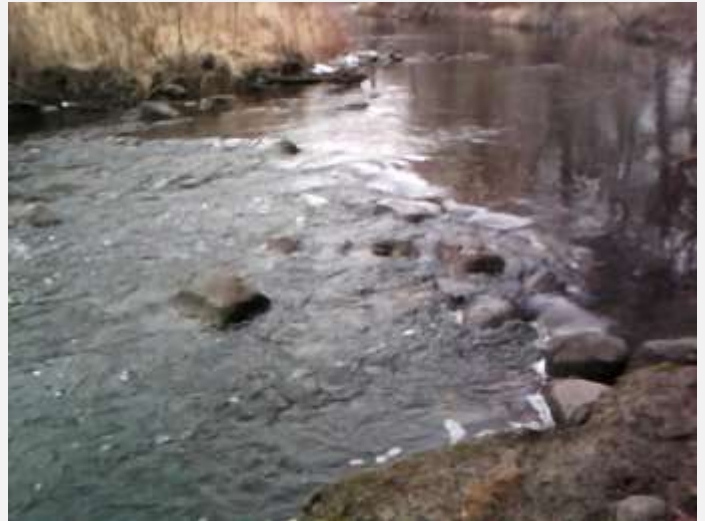
Small natural drop, boulders across stream.

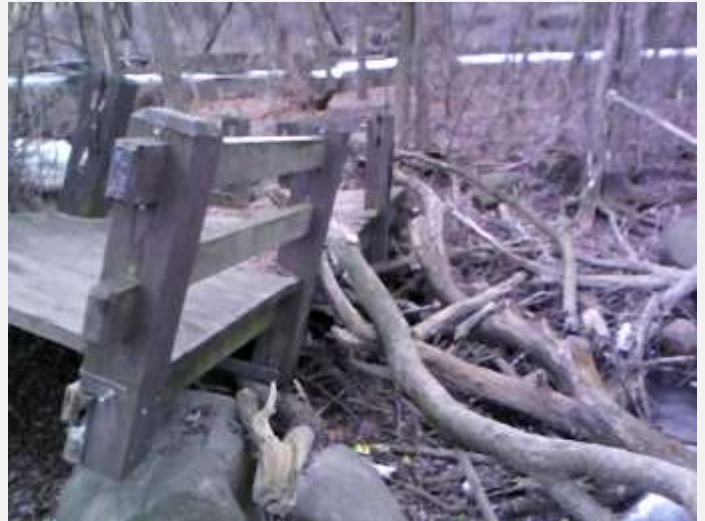
Impoundment w/ dam/bridge; bridge collapsed & causing debris backup.

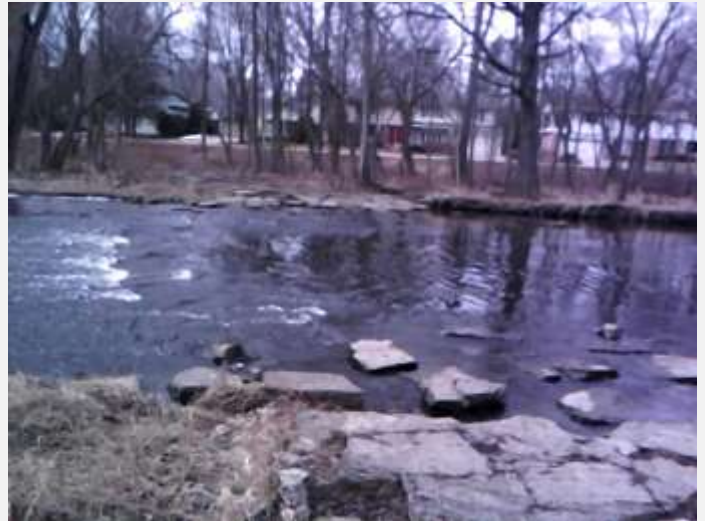
Old stone river crossing.

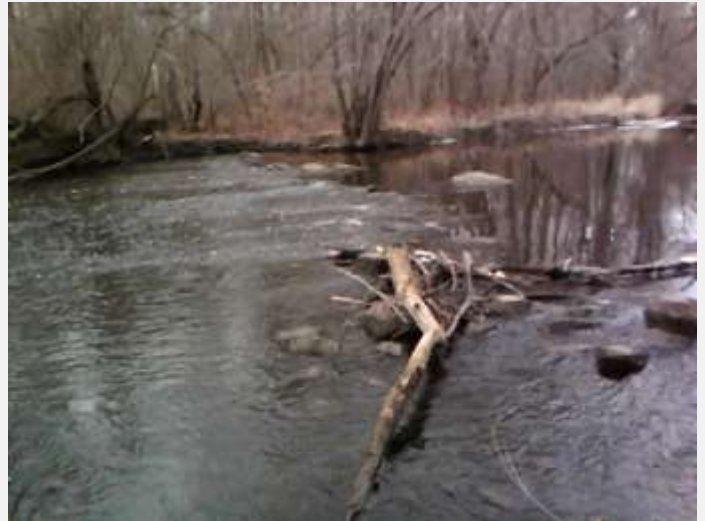
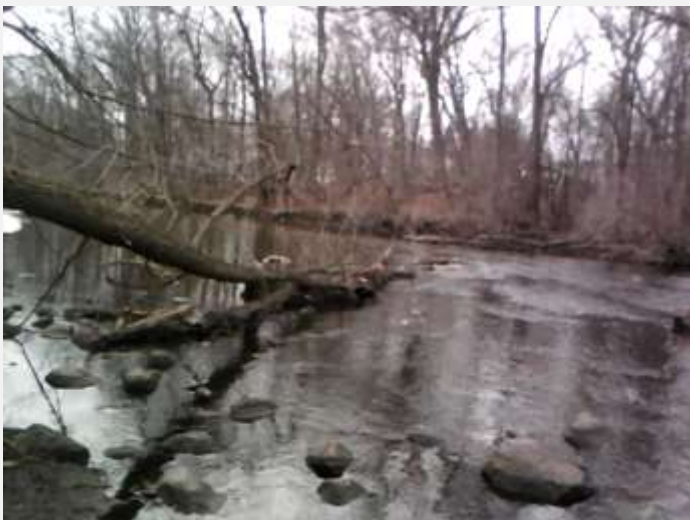
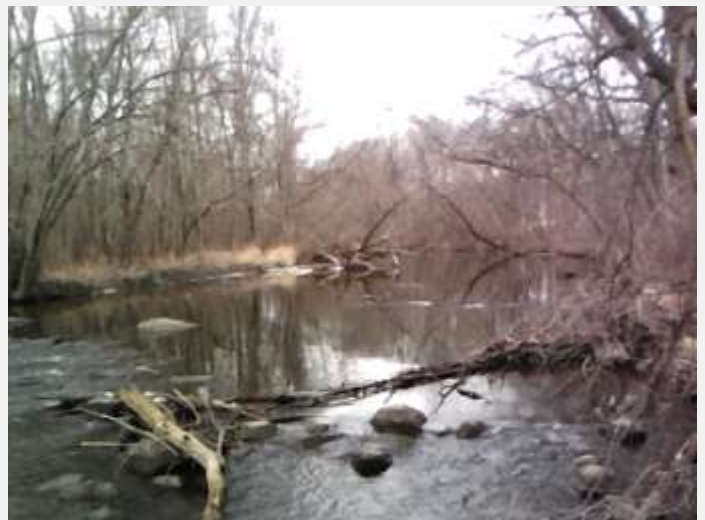
Line of boulders across river and multiple fallen trees.

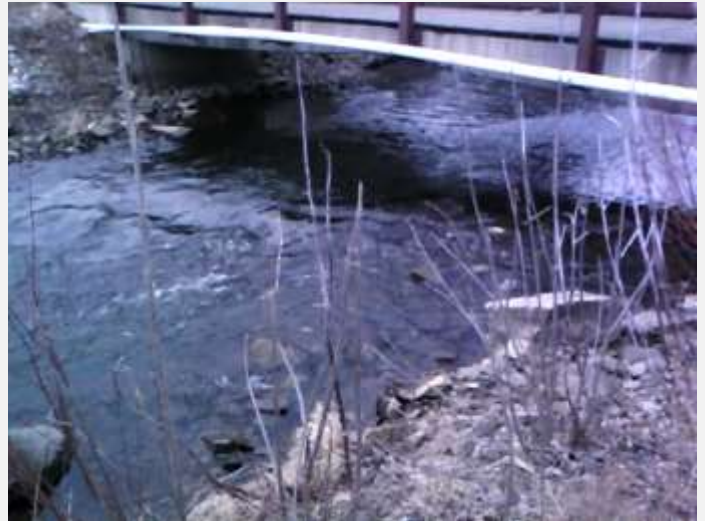
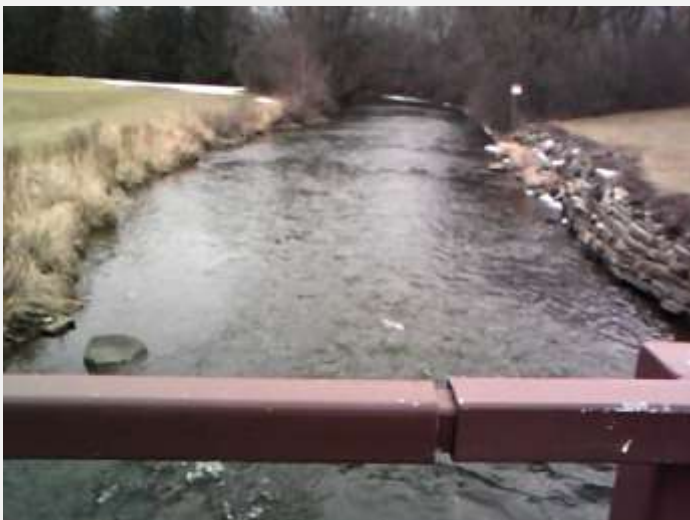
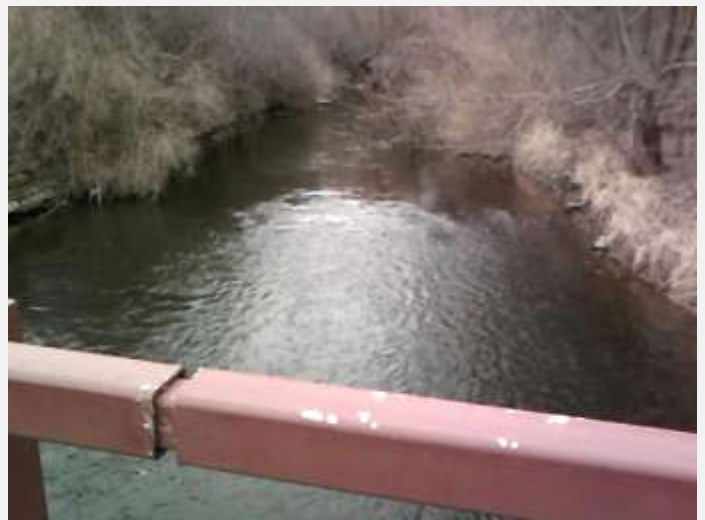
Golf cart bridge. No impediment. Possible weir.

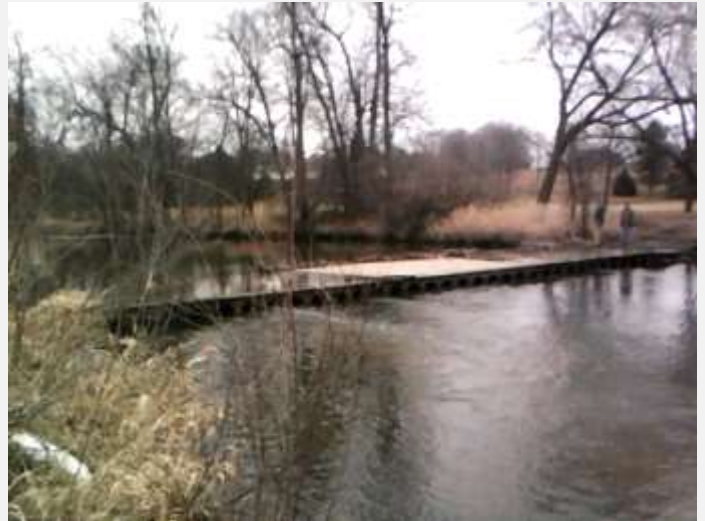
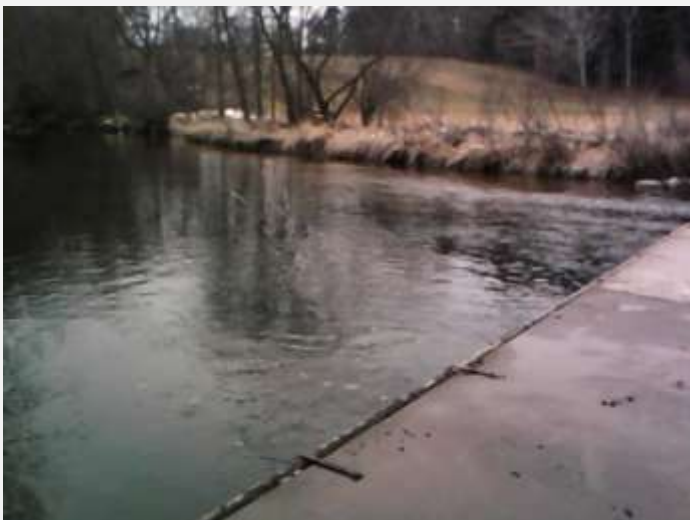
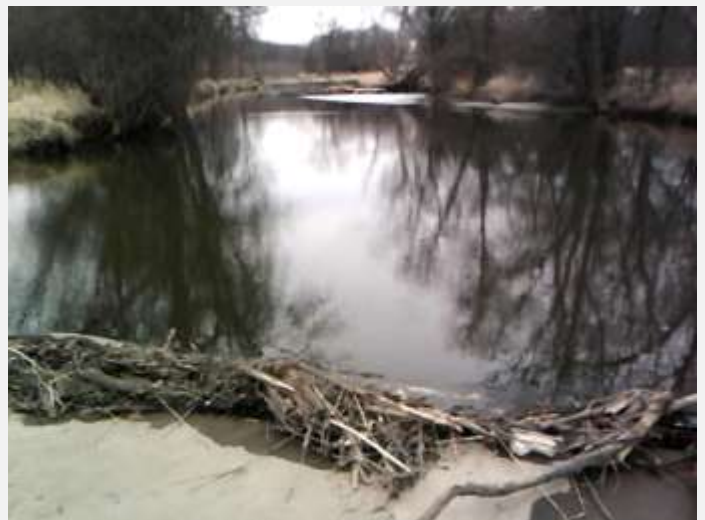
Low water bridge/ debris jam; fallen tree upstream.

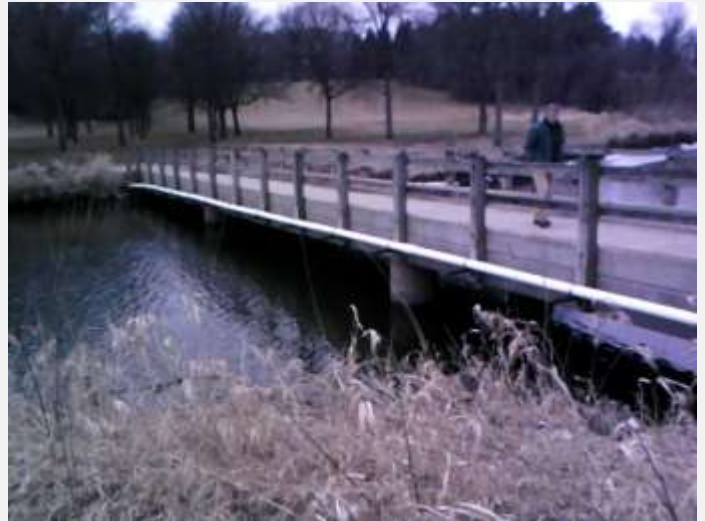
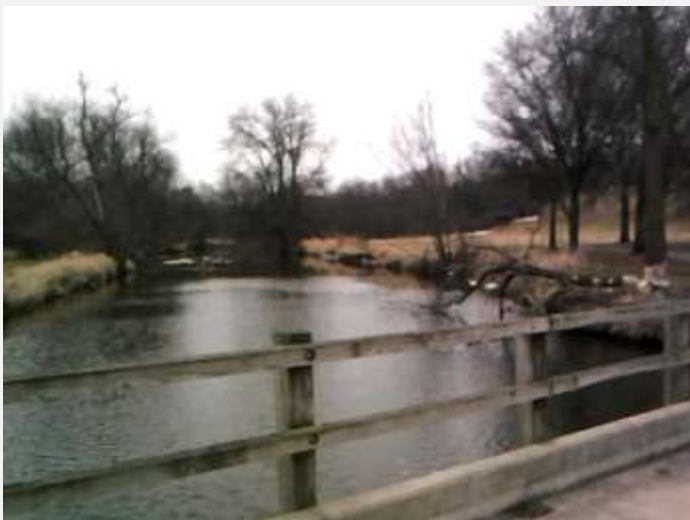
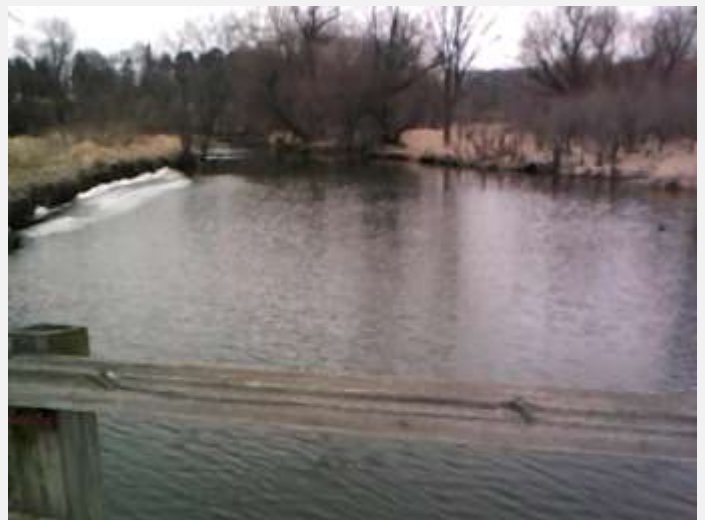
Golf cart bridge, somewhat low. evidence of beavers nearby.

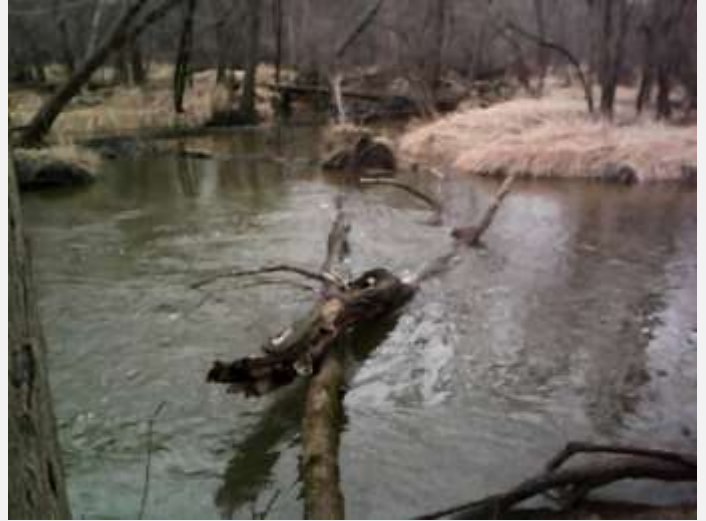
Debris jam braided stream.

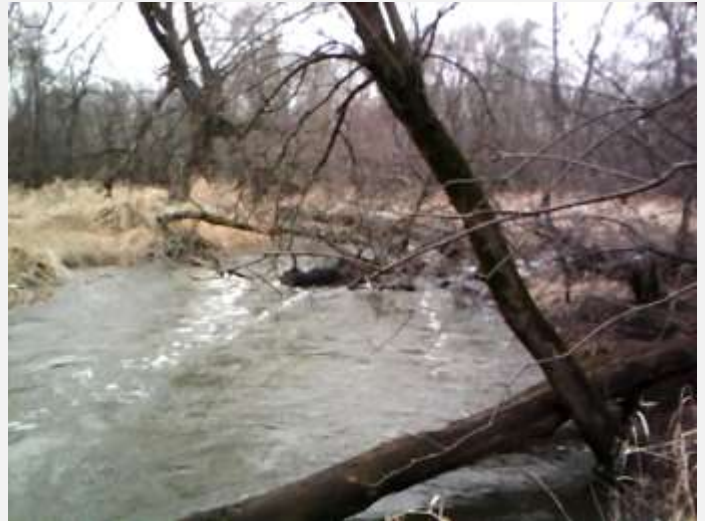
Possible debris jam.

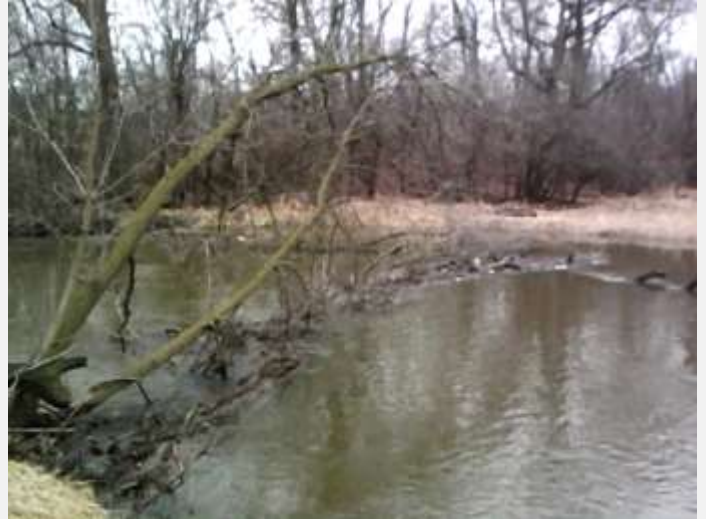
Debris jam; excellent habitat on east bank.

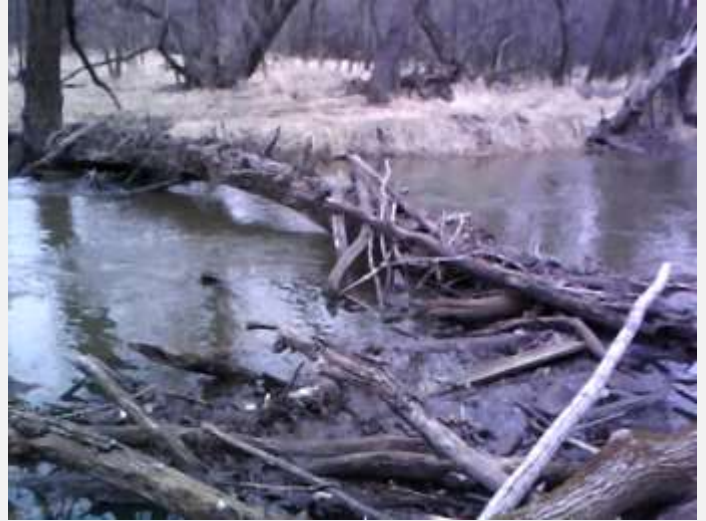
Passable debris jam.

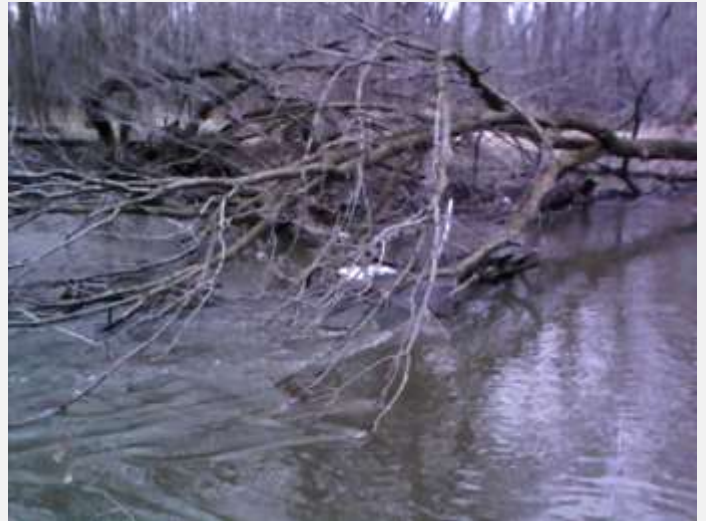
Passable debris jam.

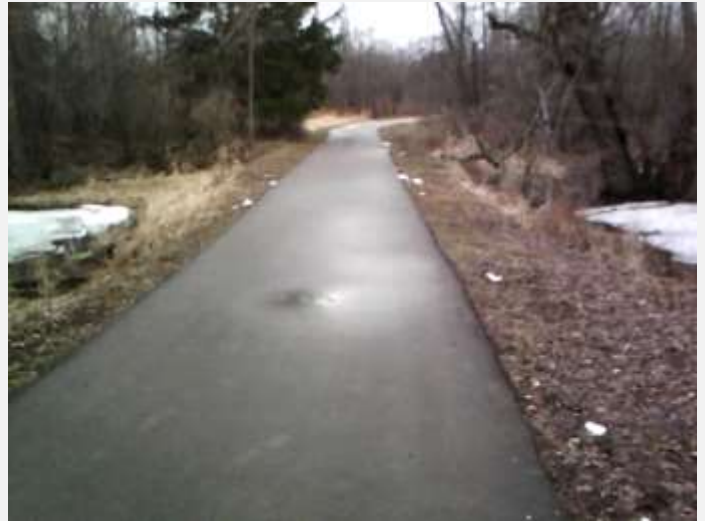
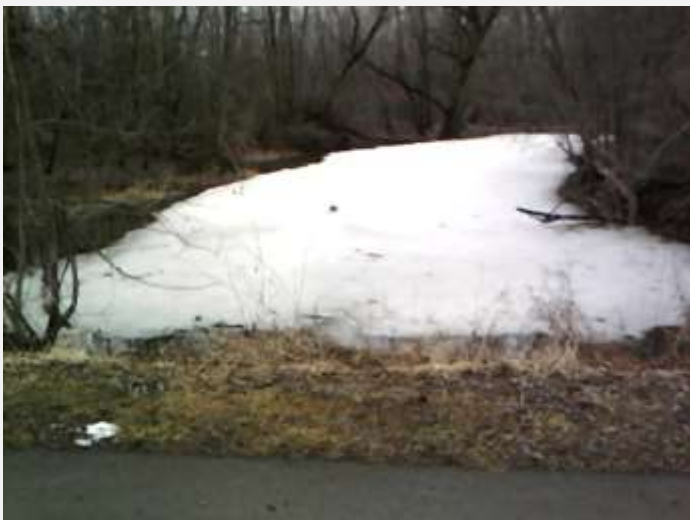
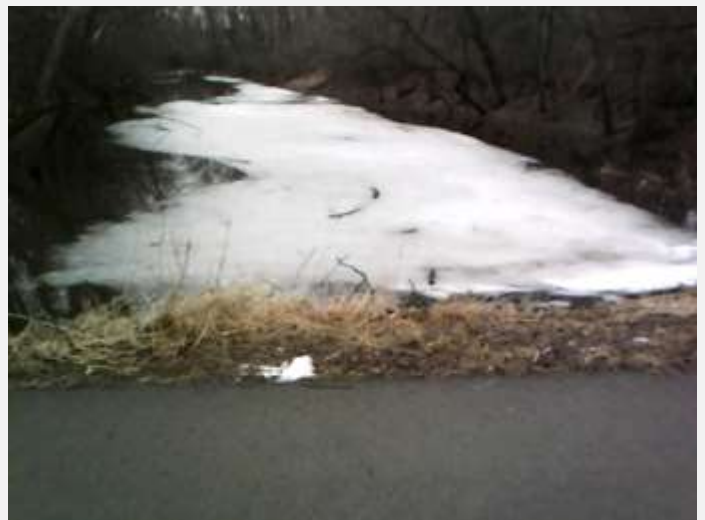
Oxbow off of main channel; buried culvert.

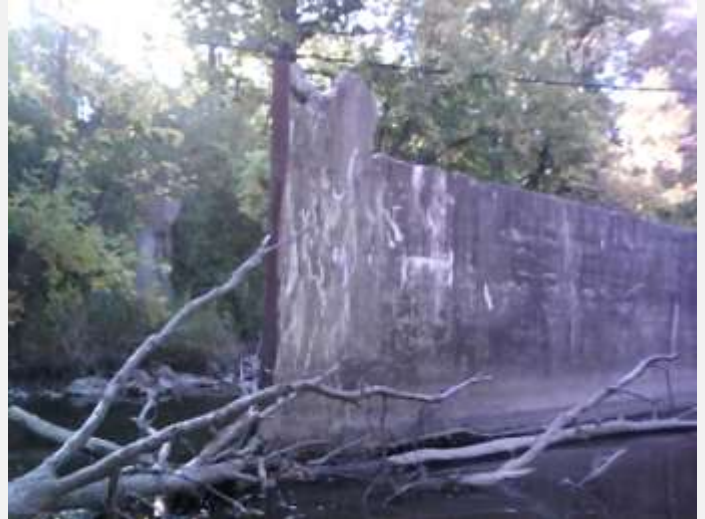
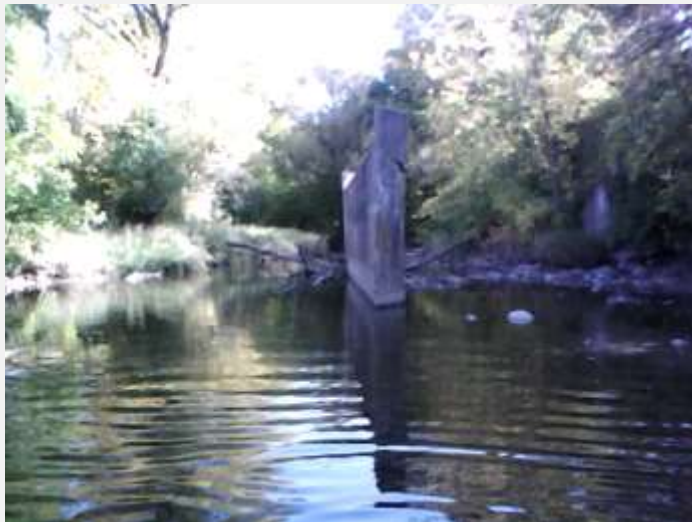
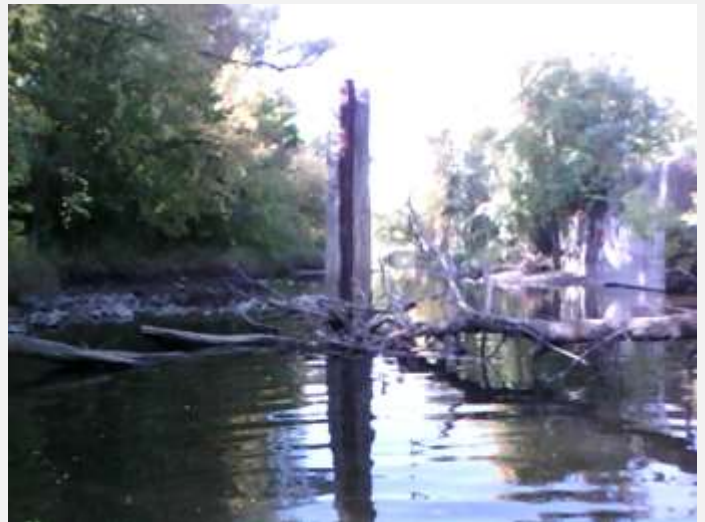
No longer a bridge here; brdige abutment remains in stream.

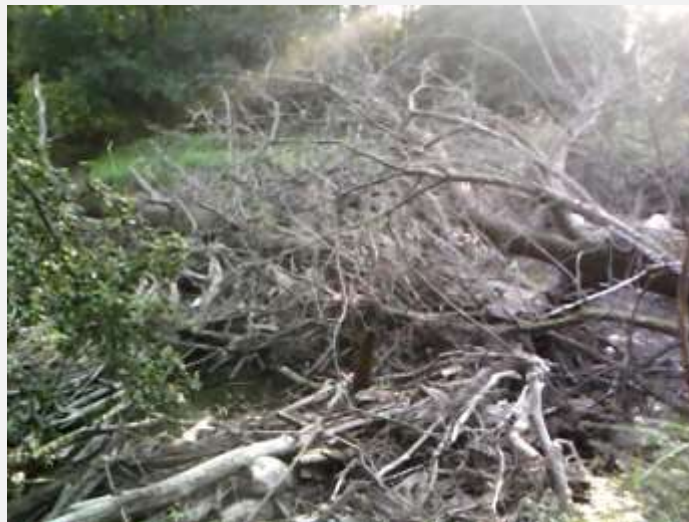
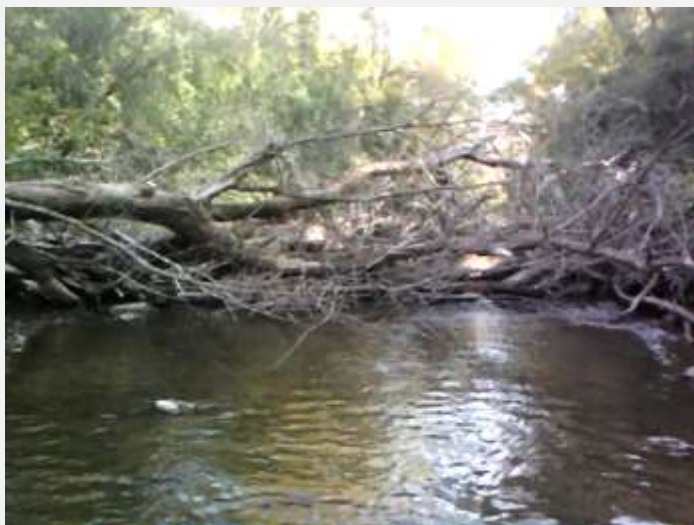
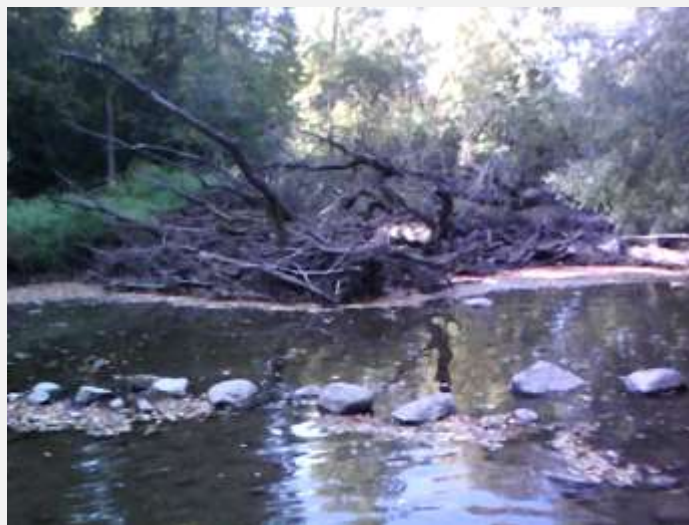
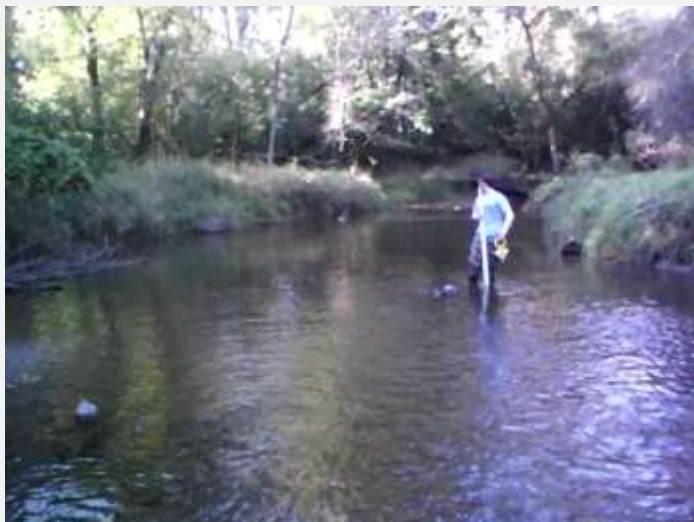
Major debris jam.

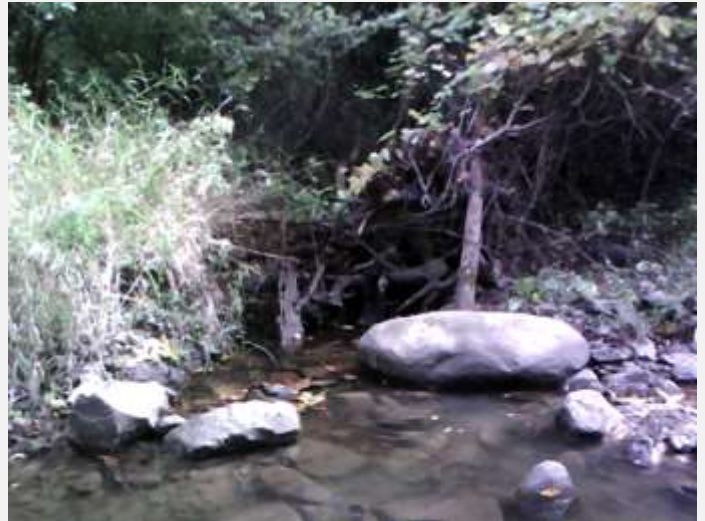
[Photo Outlet](#)

Stormwater outlet & ditch; minor woody debris jam.

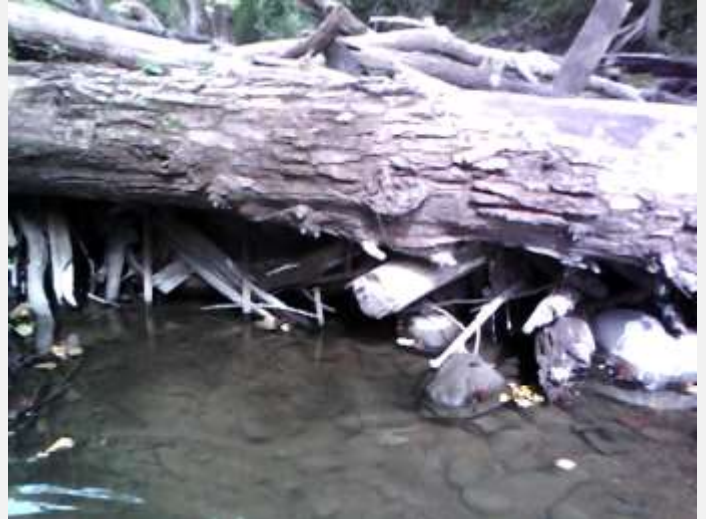
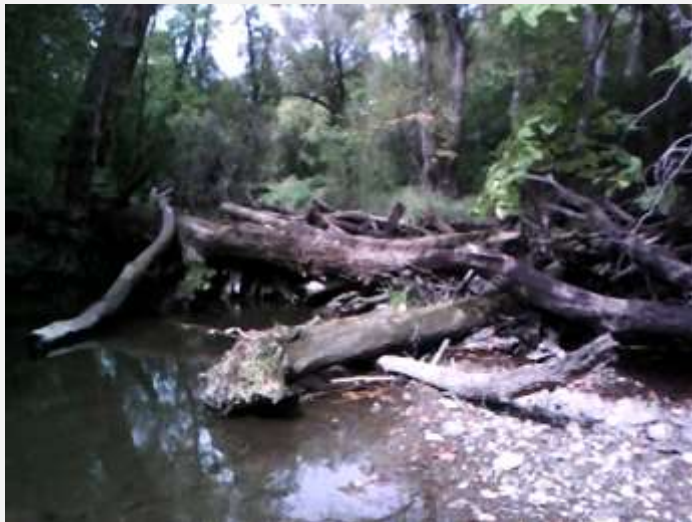
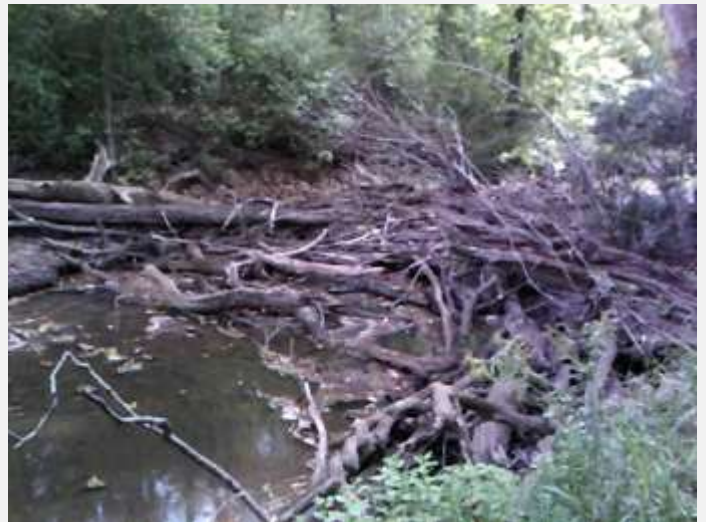
Large debris jam with suspicious rebar lodged in middle.

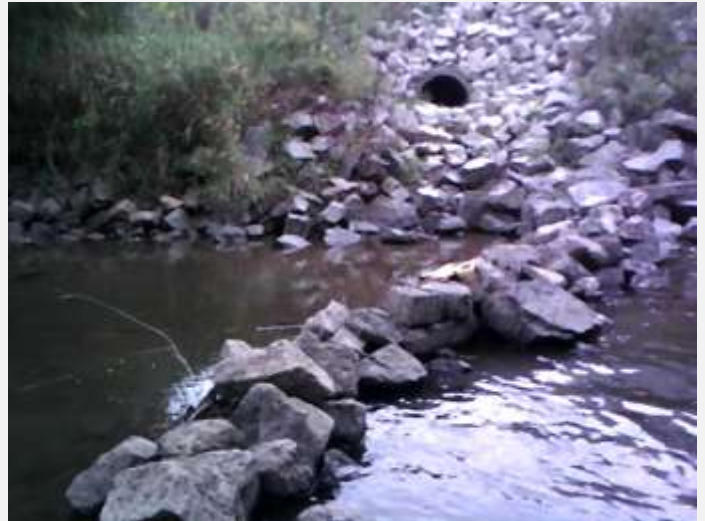
[Photo Outlet](#)

Someone lined up rocks across stream channel next to a storm outfall.
