## Menomonee Fish Passage Barrier Survey

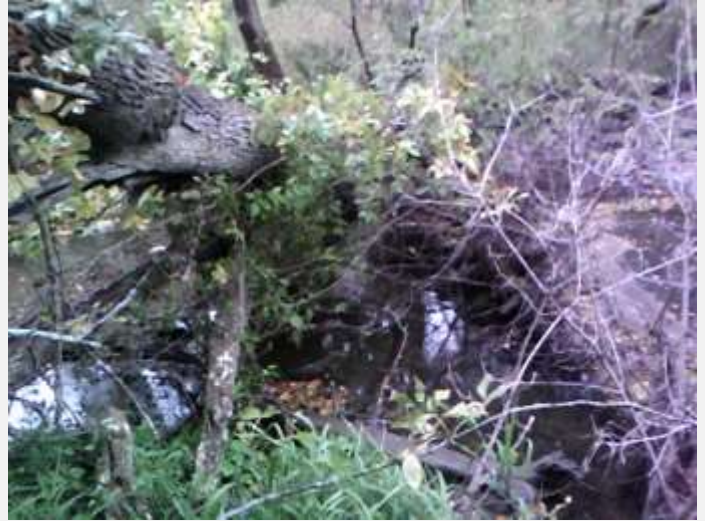
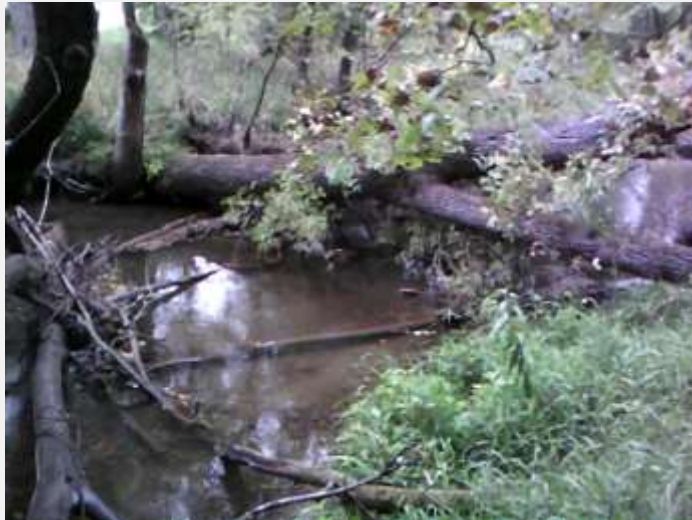
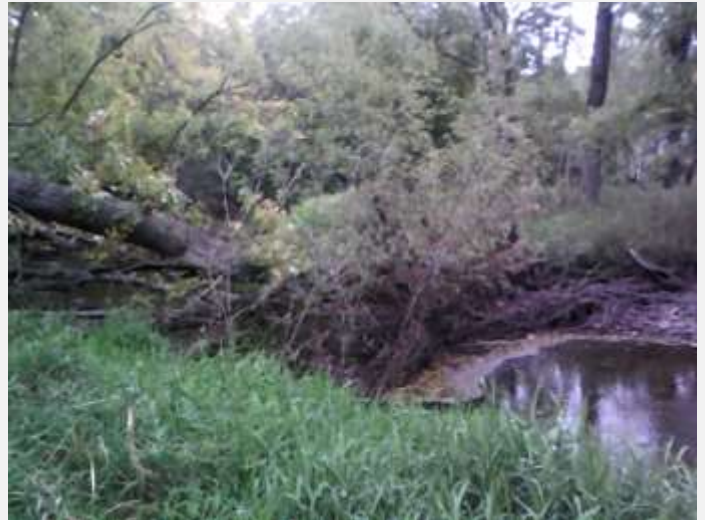
Debris jam partial impediment.

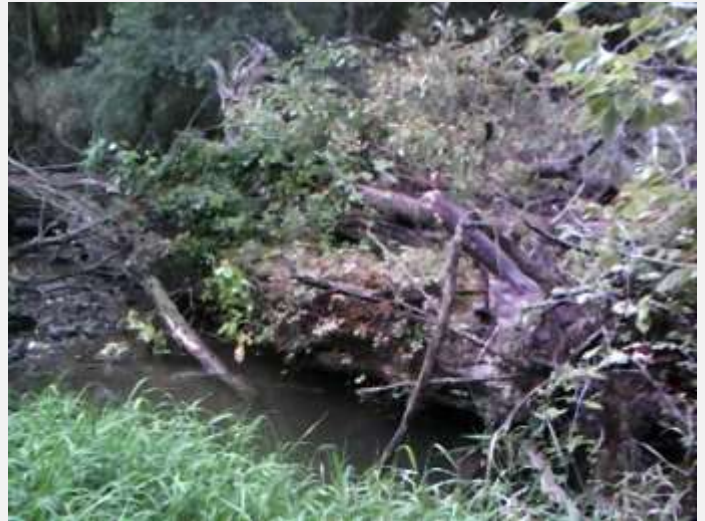
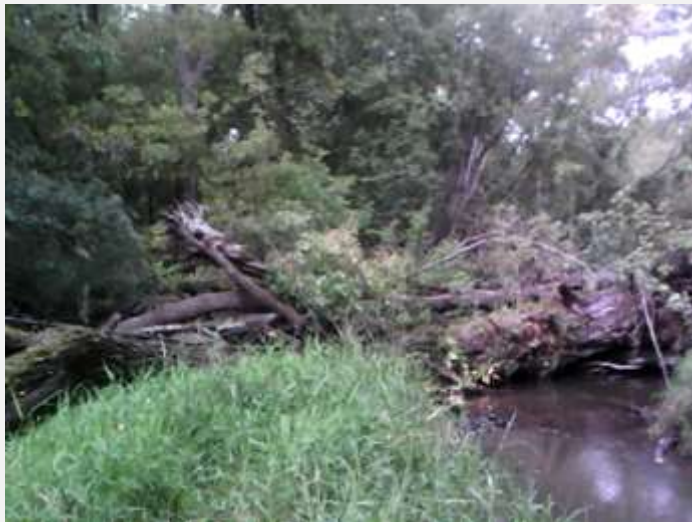
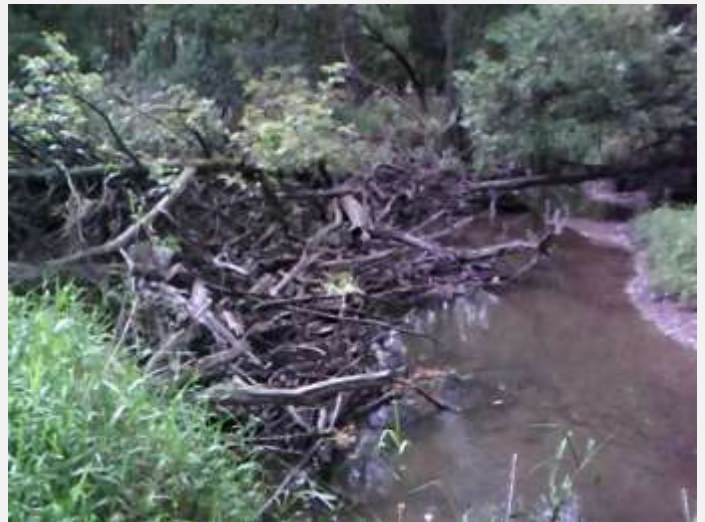
Severe debris jam, high potential for being an impediment.

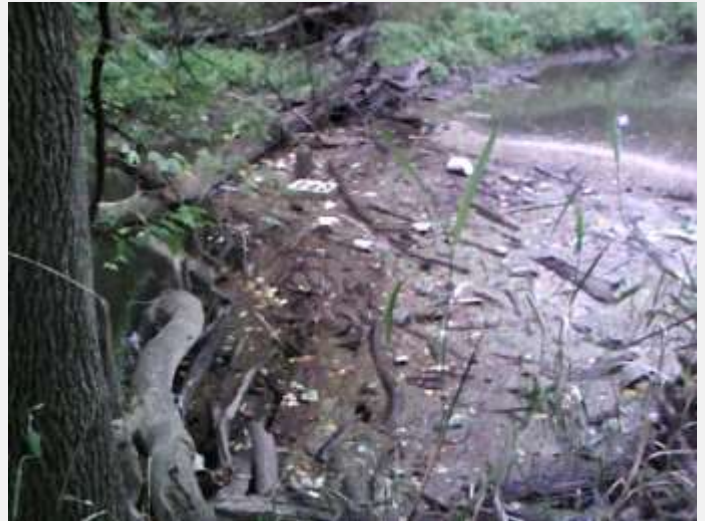
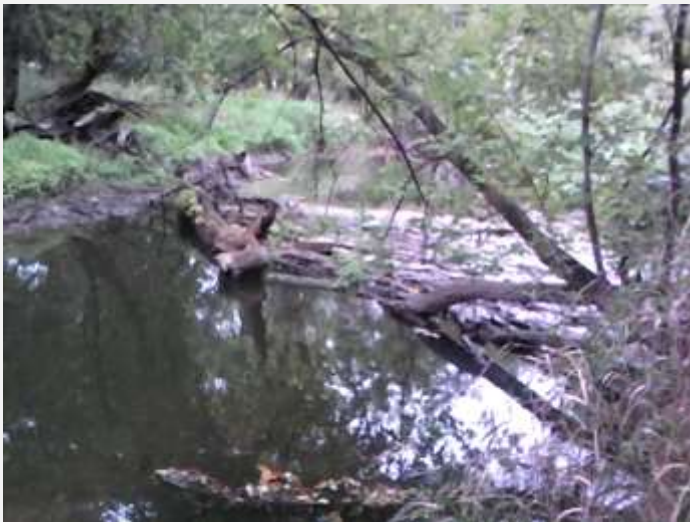
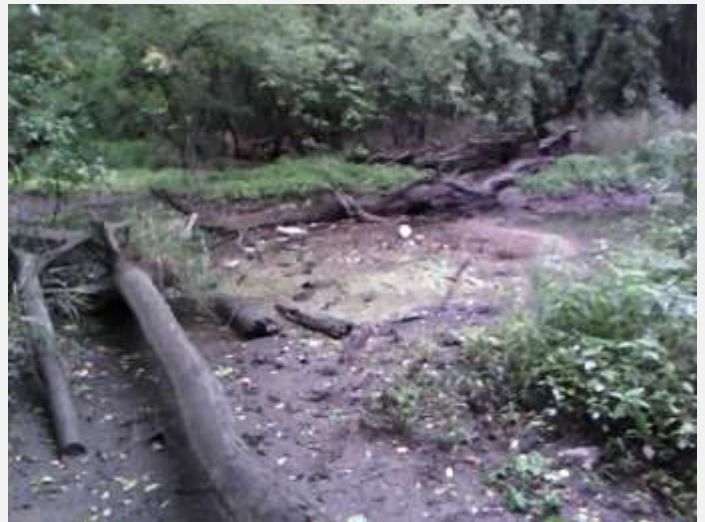
Debris jam causing backup of surface debris.

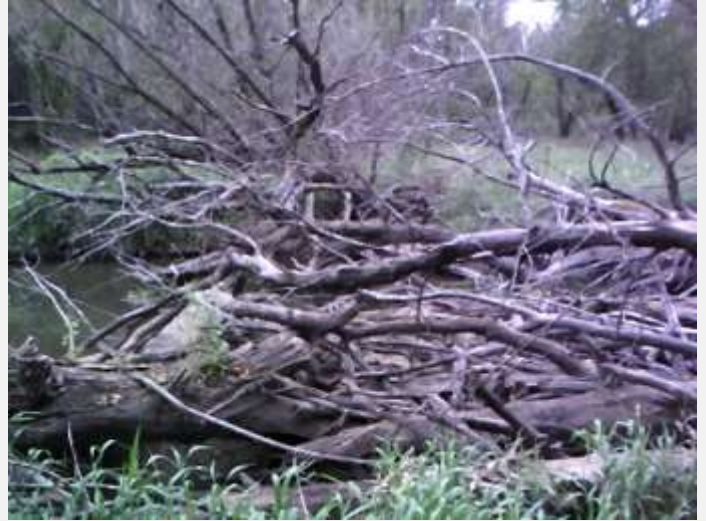
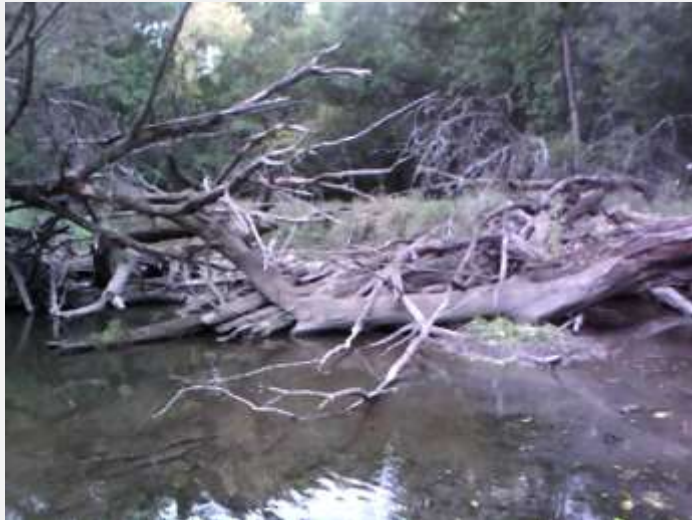
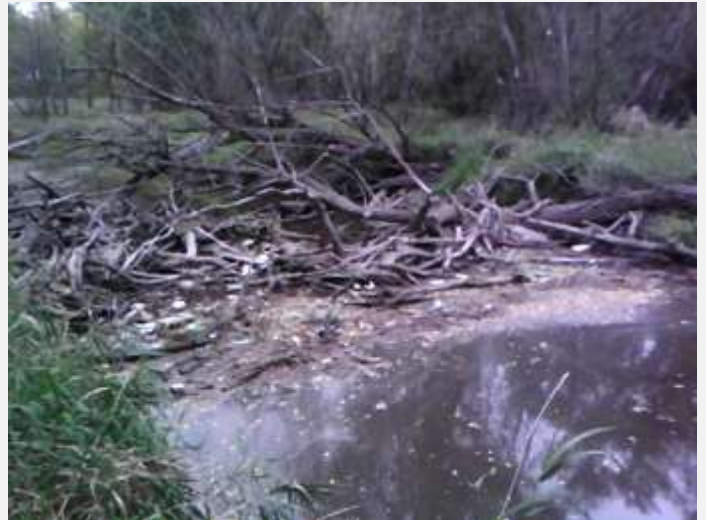
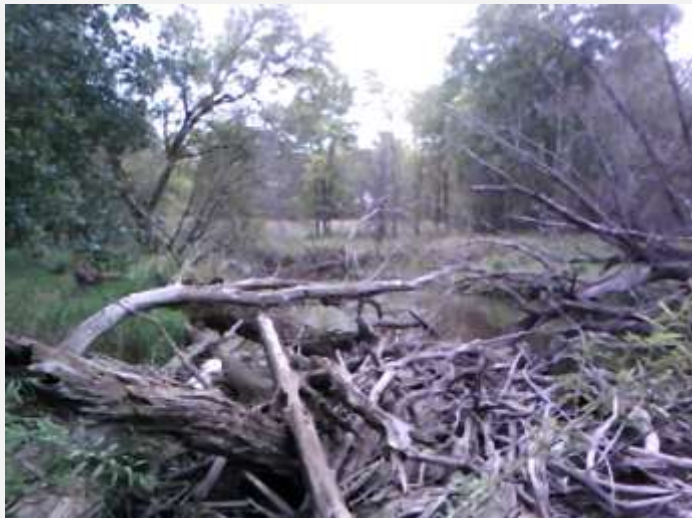
Large debris jam; passable?

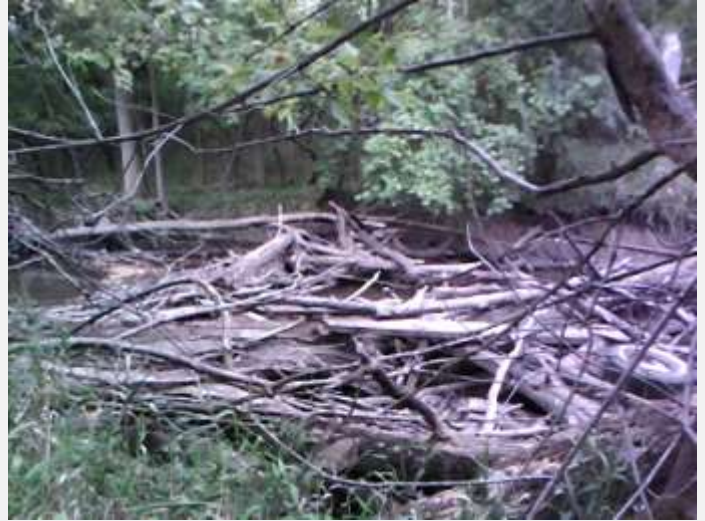
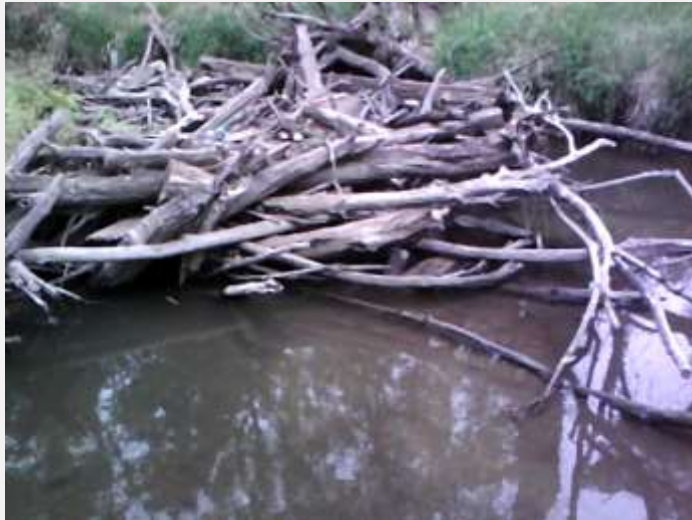
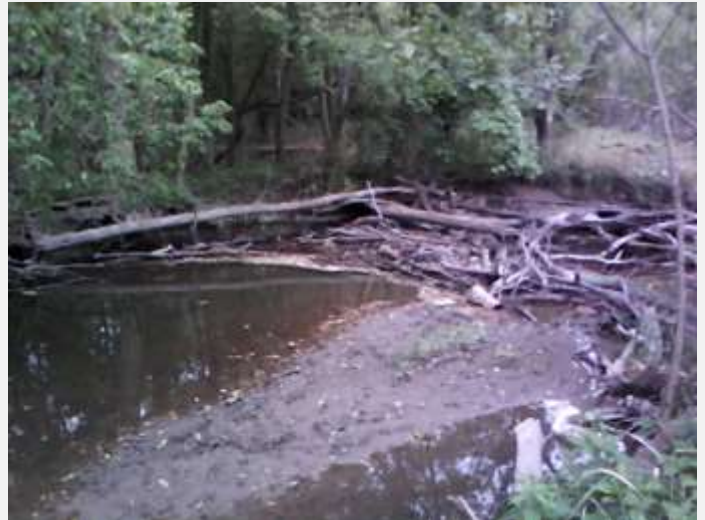
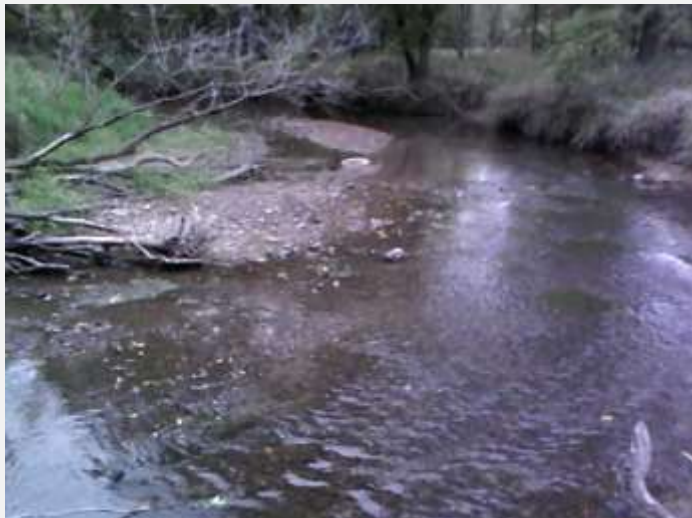
Woody debris jam major.

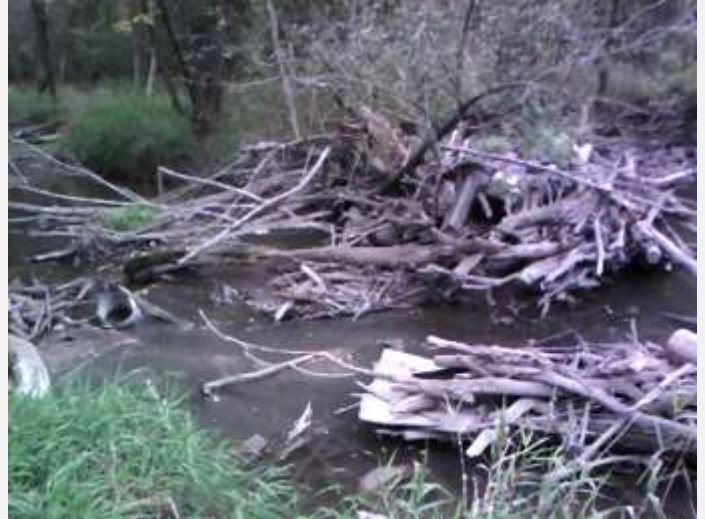
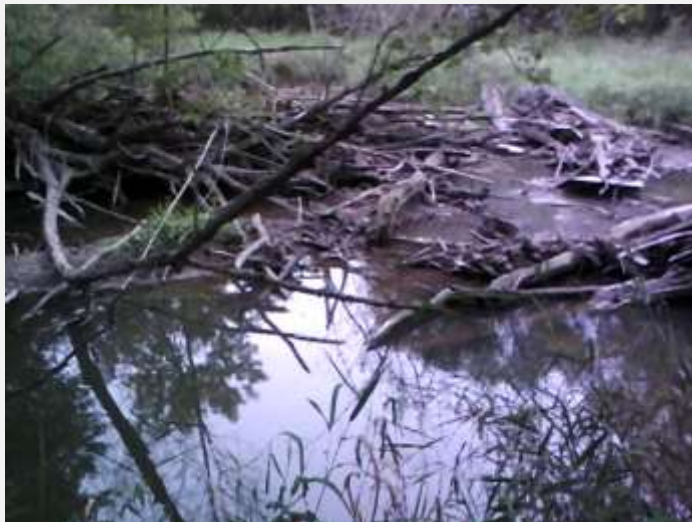
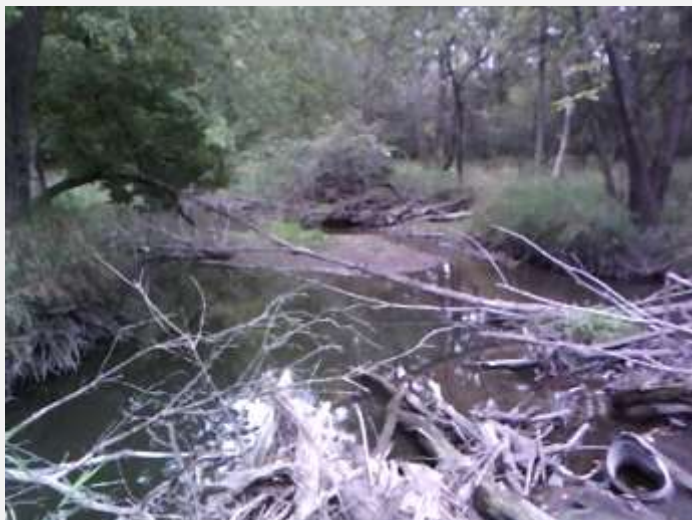
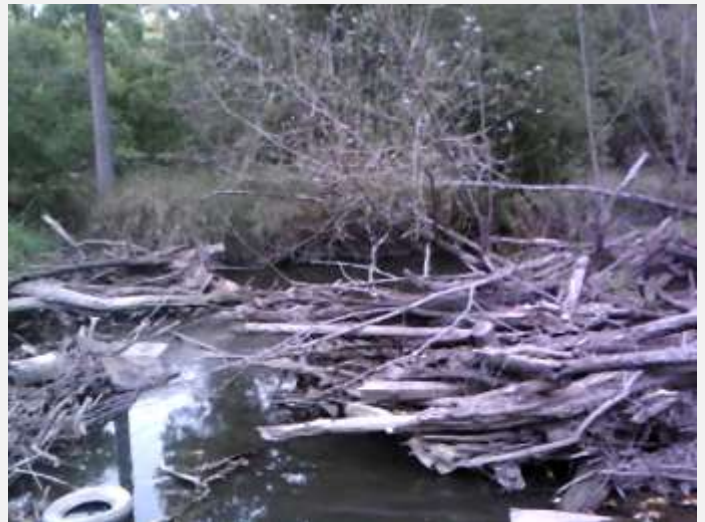
Serious debris jam; still passable.

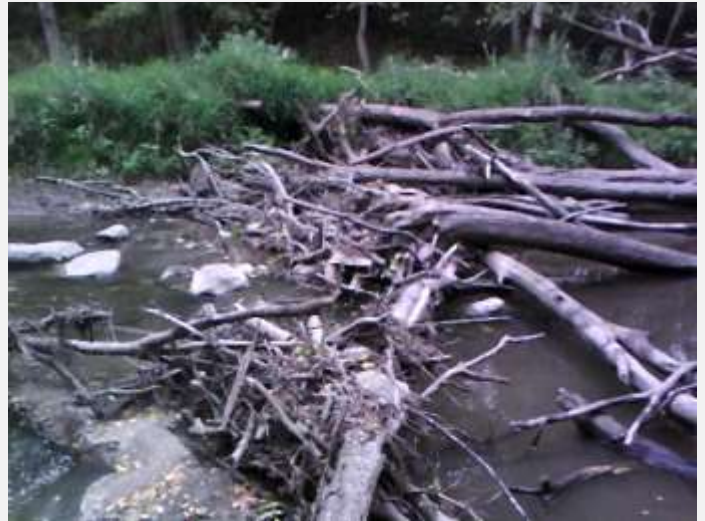
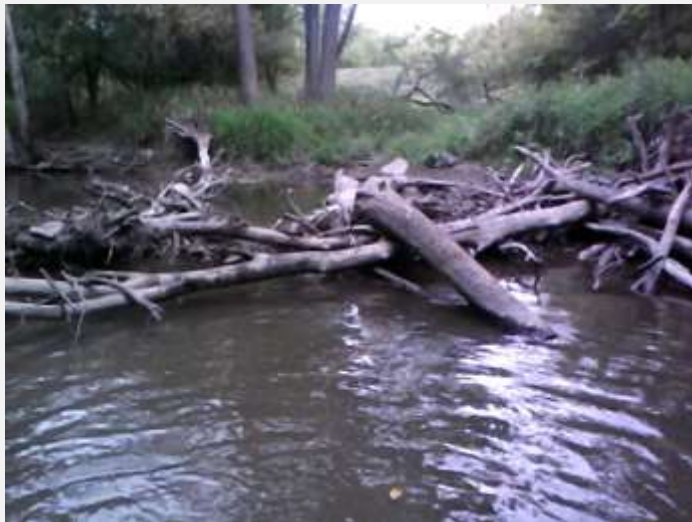
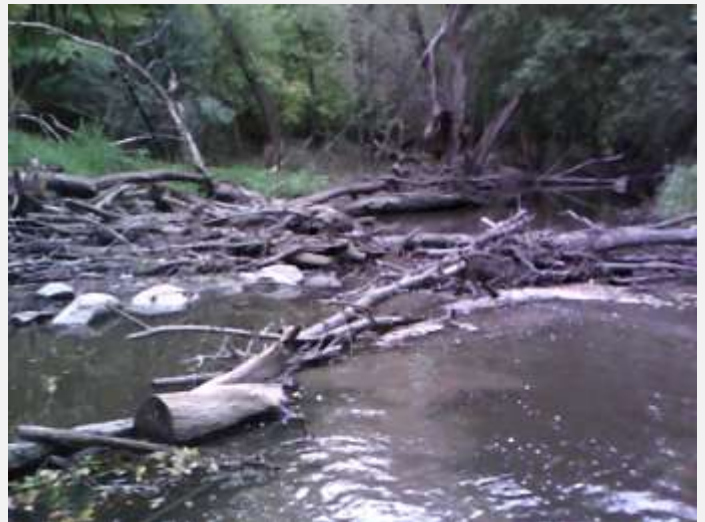
Big debris jam; passable but may become a problem.

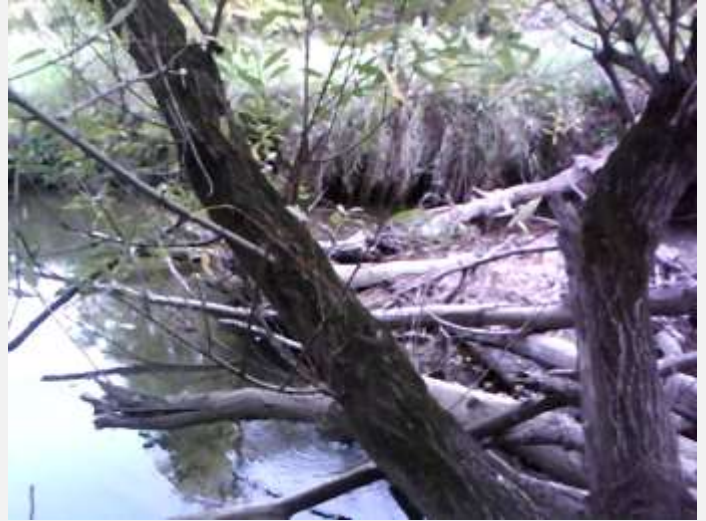
Debris jam; passable now, may become an issue soon.

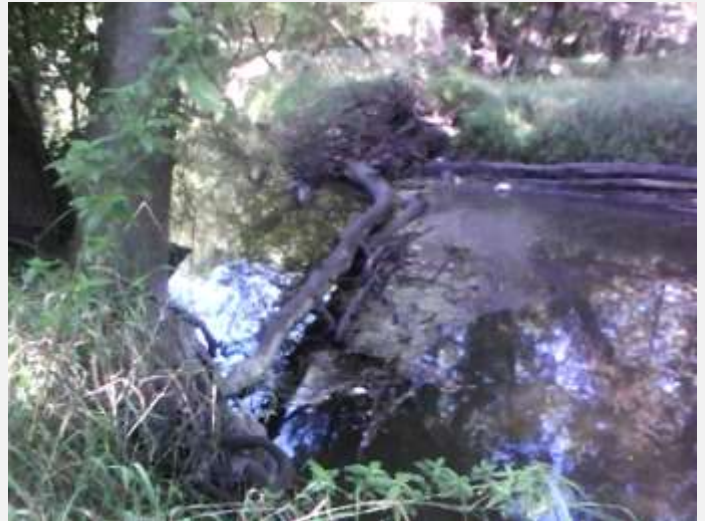
Debris jam spans river, but passable.

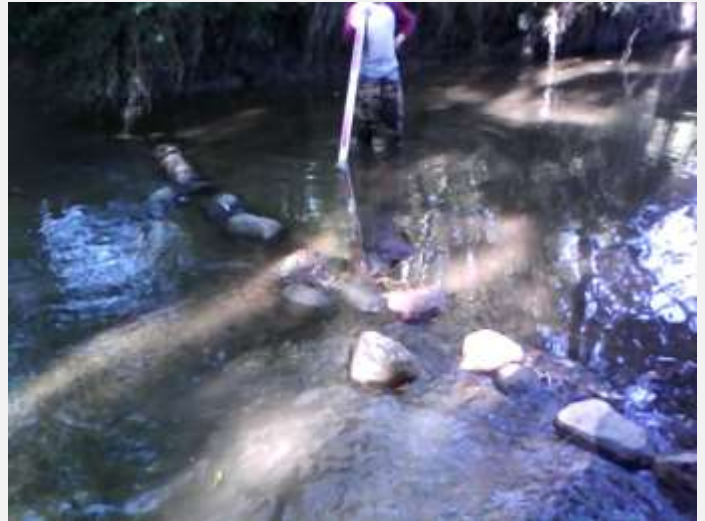
Passable; looks like neighbors built a small rock wall dam here

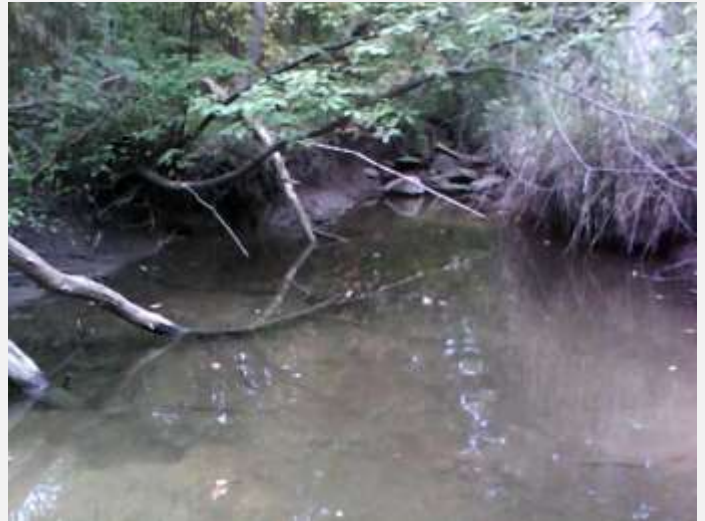
Mouth of storm ditch; has tons of construction rubble in it.

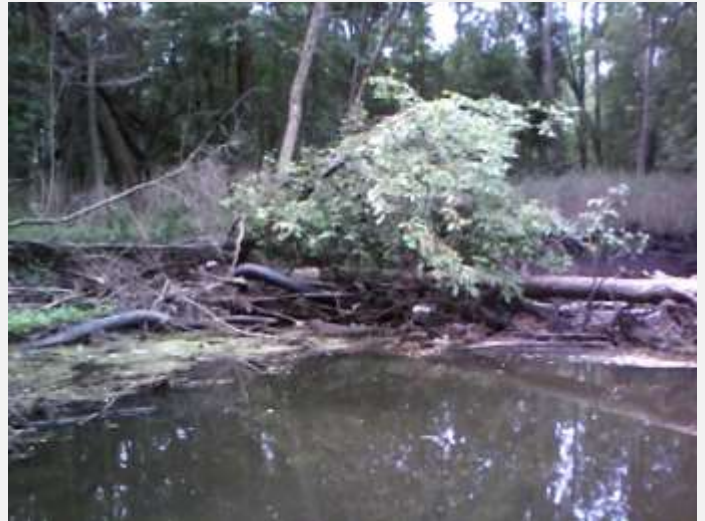
Debris jam; lots of garbage, should be cleaned up.

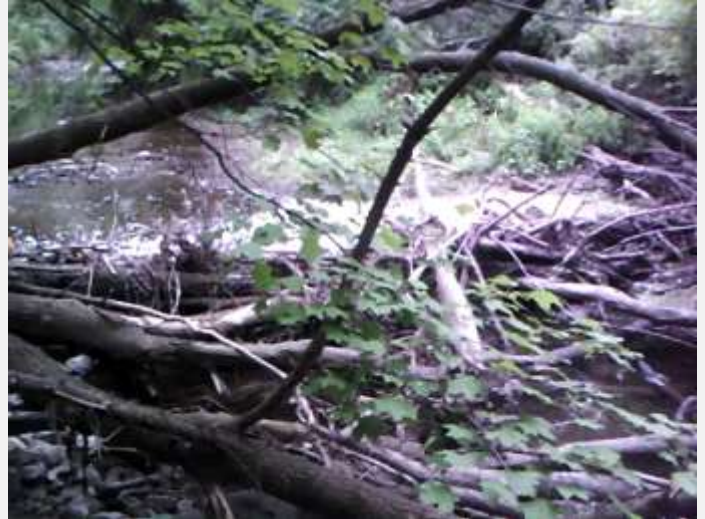
Fairly large debris jam; seems passable, but not sure. Lots of schmutz built up behind downed trees Flaggging delineating wetlands on streambank; Bonestro name on them.

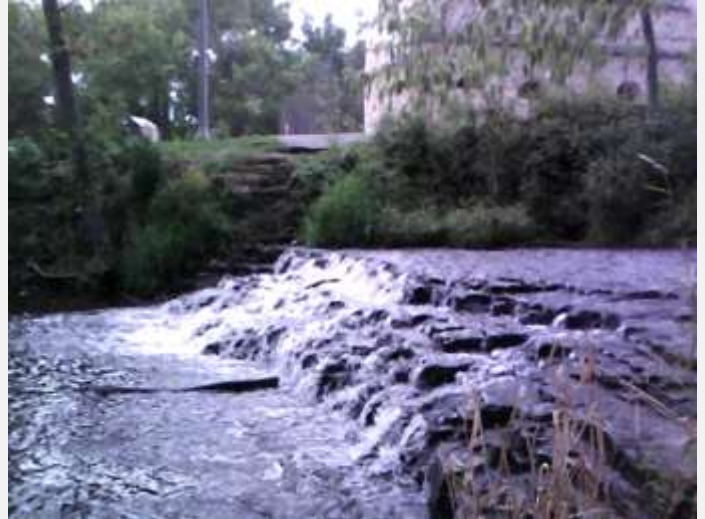
Fairly large natural drop.

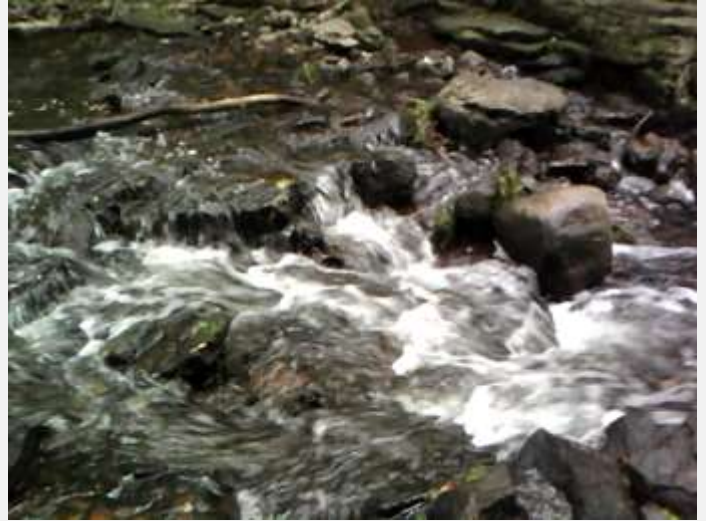
2 to 3 ft falls; probably passable.

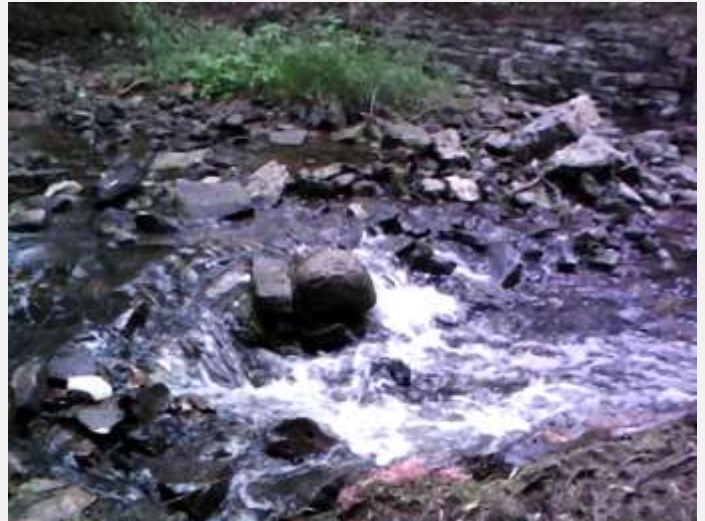
Small (1 ft in low water) natural falls; appears passable.

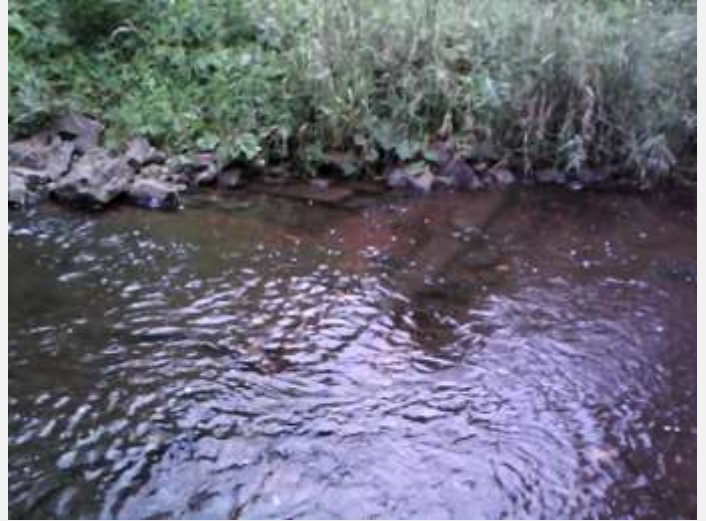
8 in diameter pipe spanning creek bed running parallel with overhead power lines.

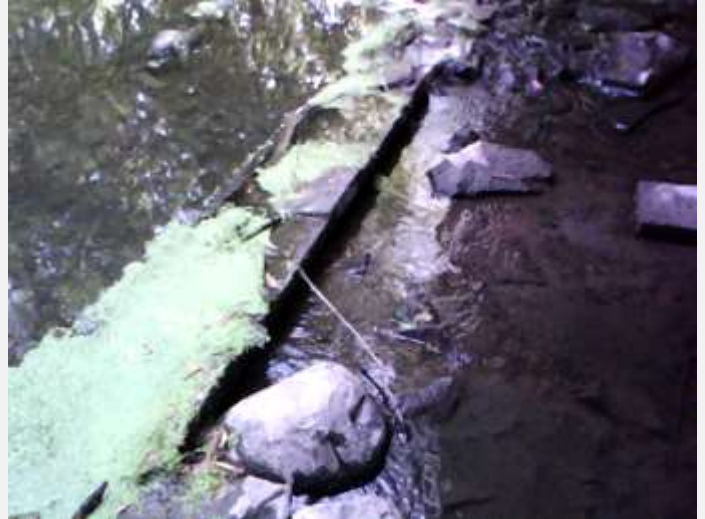
Rocks across entire width of outlet; low water impediment.  
Small drop structure upstream; 0.6 ft high, 0.38 ft tailwater in low water.

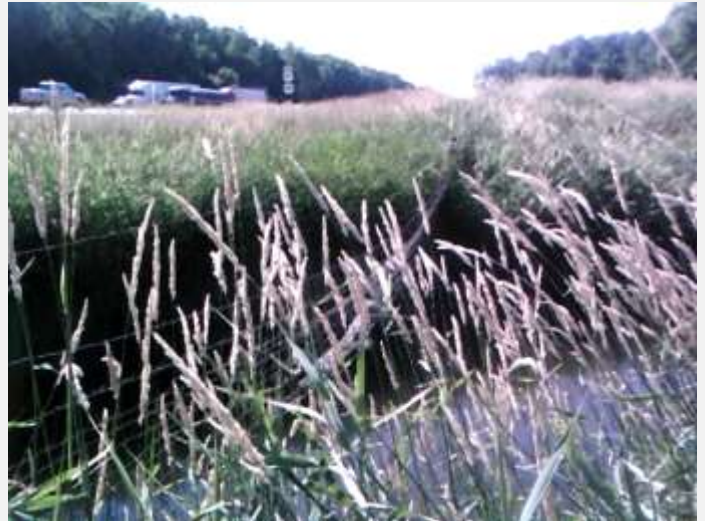
Barbed wire fence spanning river.

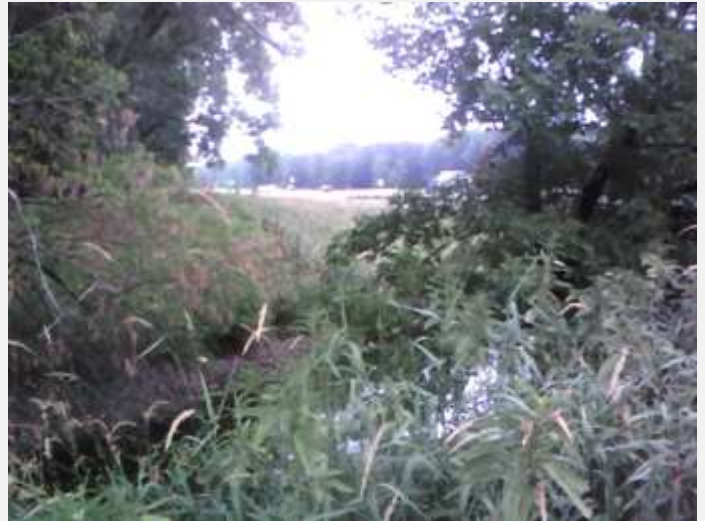
Barbed wire fence crossing the stream.

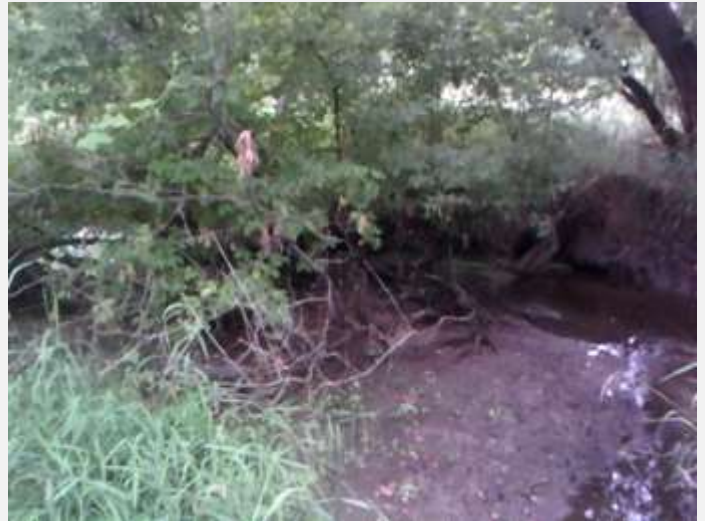
Debris jam (fairly major) spanning river.

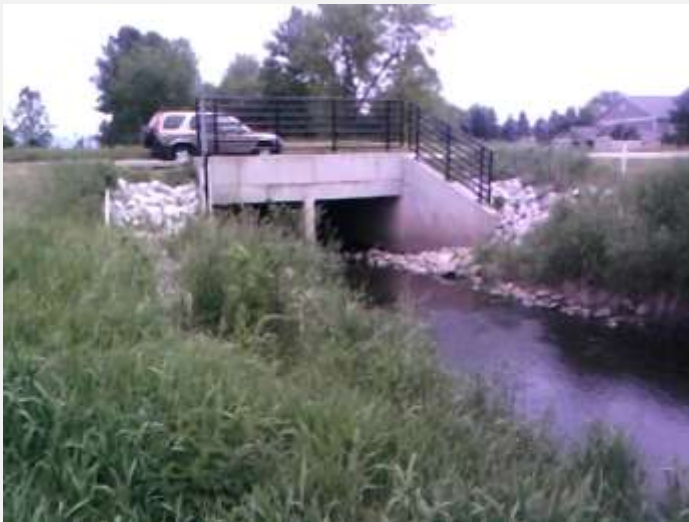
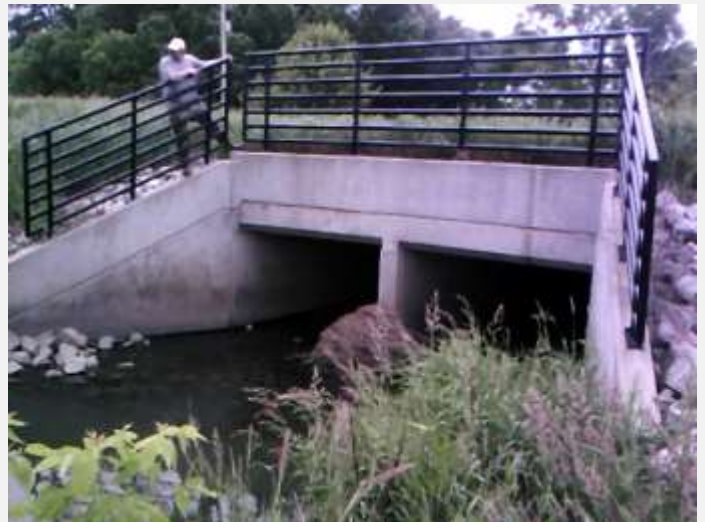
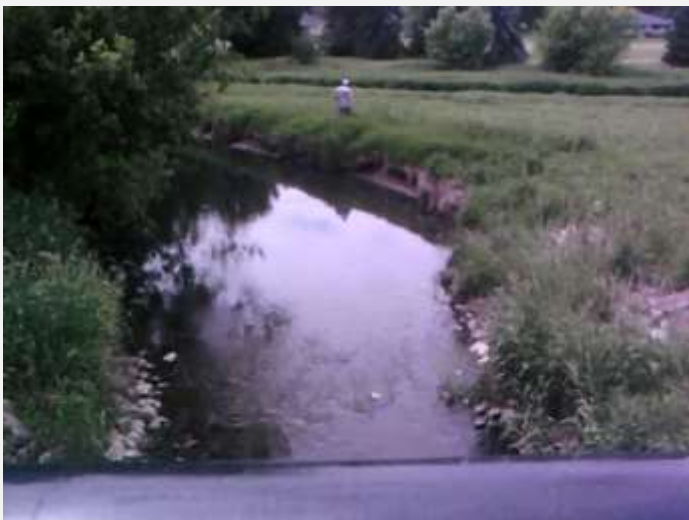
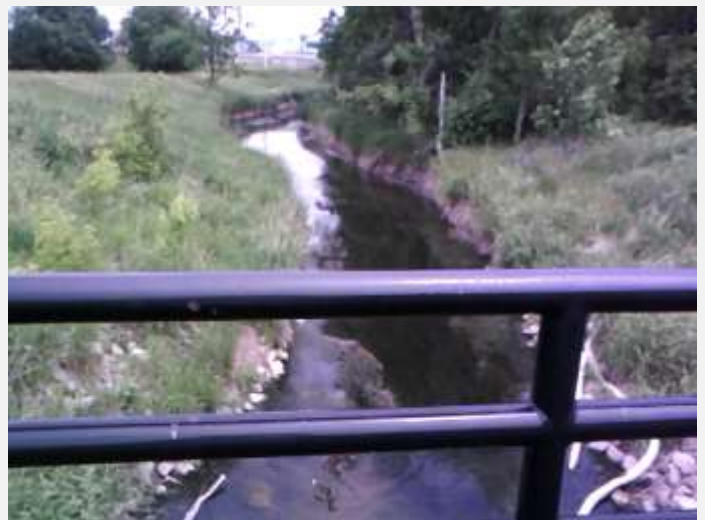
Site ID 1721-26 Strea Nor-X-Way Channel Road Fond du Lac Ave Dat 6/14/2012  
Alt ID NXWSB75 Type Rocky Debris Jam Major Pass 0.5 Pass Method Obstruction  
Habitat NA Scour Pool Yes Upstream Pond: No

Shape Square or rec Drop  
Condition Good Material Concrete  
Drop Slope 0 Plugged 100  
Length 86 Width 8 Height 6

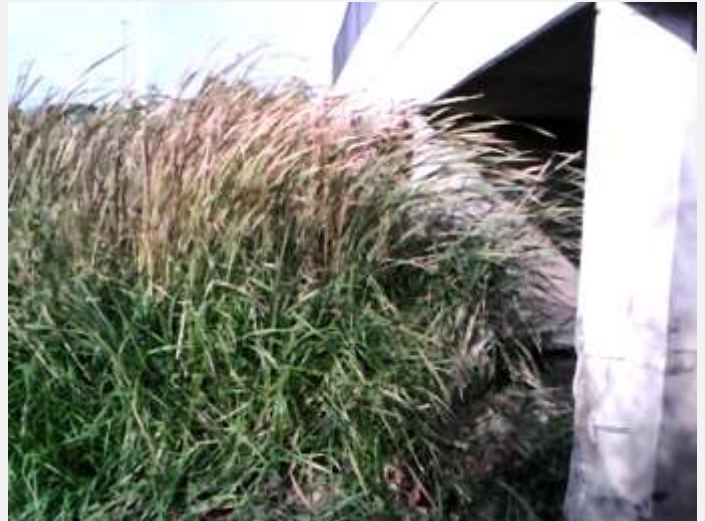
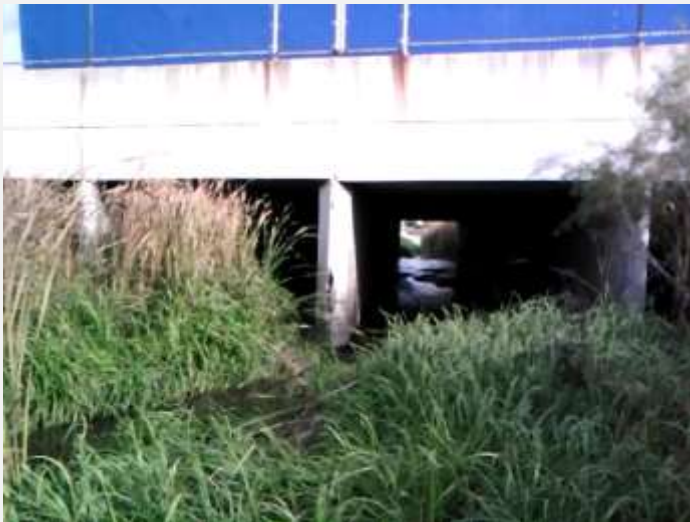
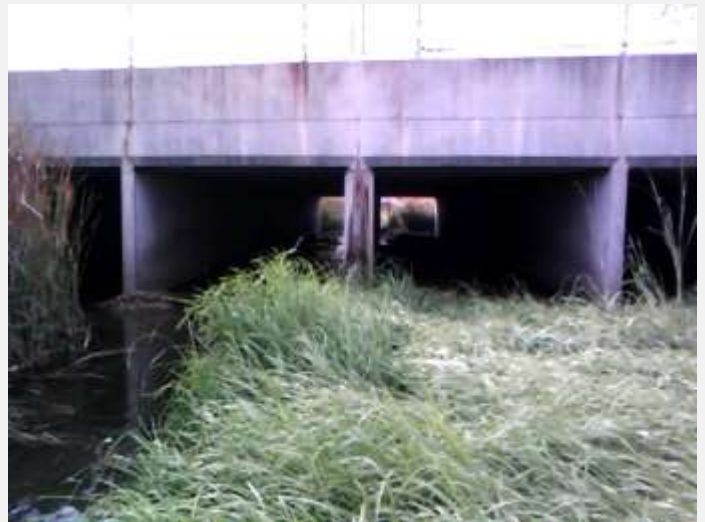
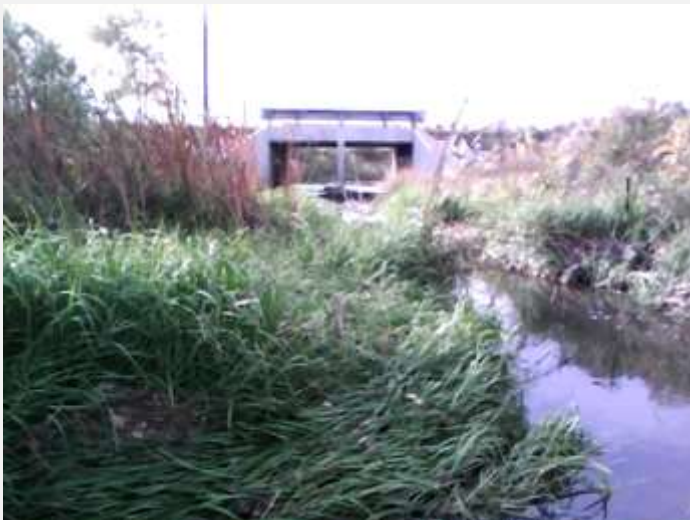
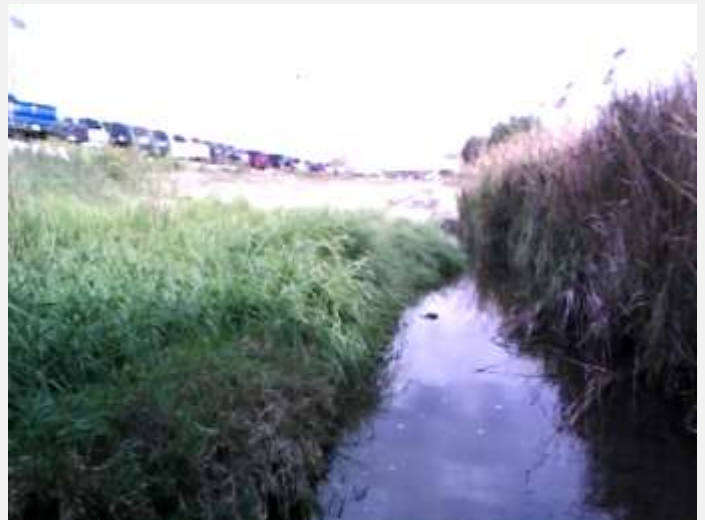
Quadruple culvert. Structures 3 & 4 blocked 50% at outfall. Structure 3 is main channel. Too many culverts. Structure 4 data on data sheet.

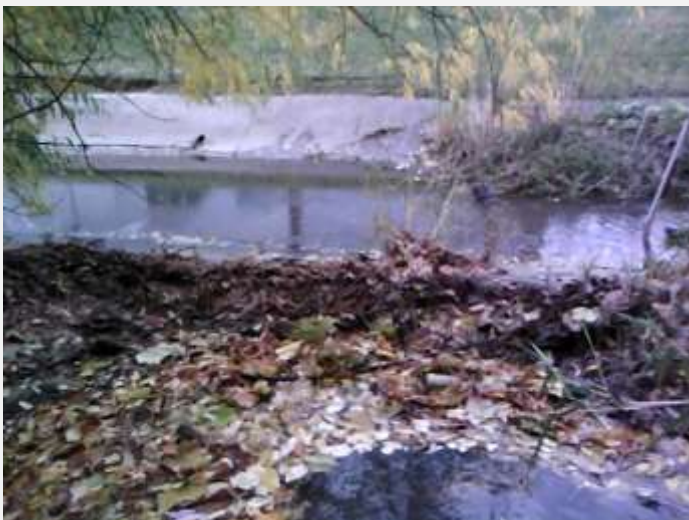
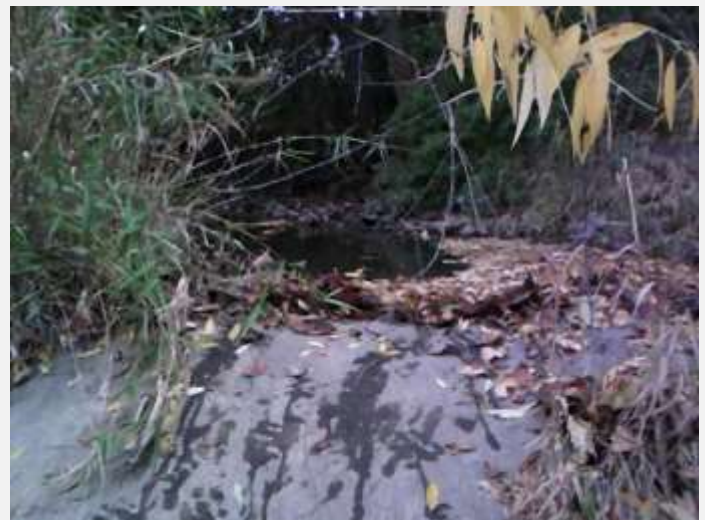
Concrete stormwater channel completely cuts off stream at a right angle, then stream becomes channelized concrete from here downstream. Channel wall about 2 ft high; water backed up behind and leaking through weepholes. Water surface 0.7 ft blw channel.

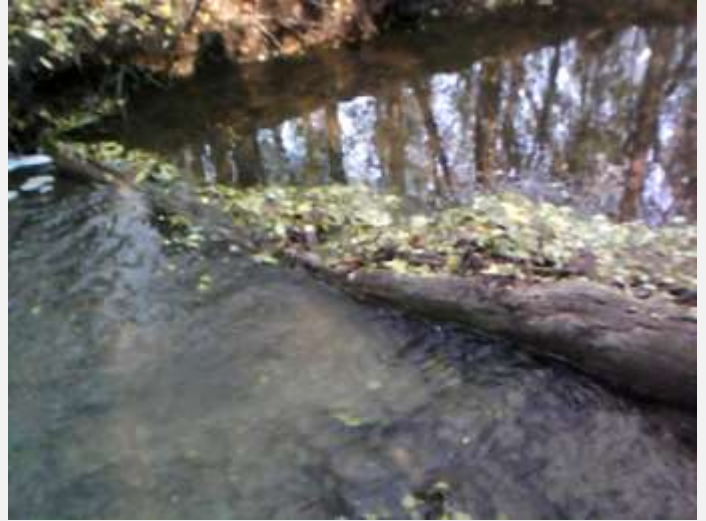
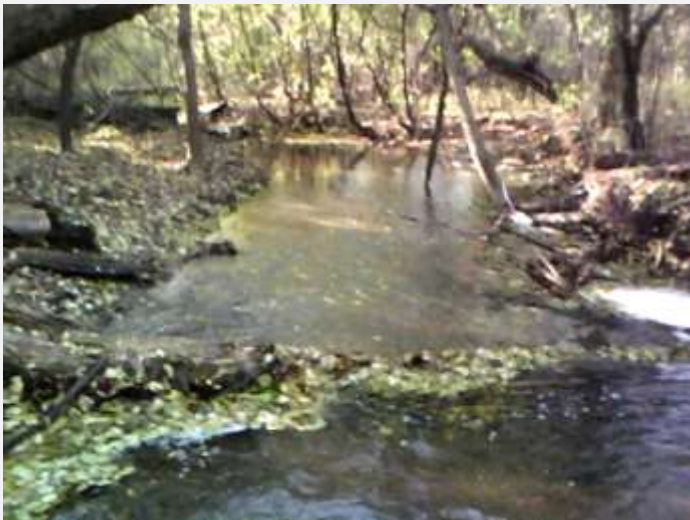
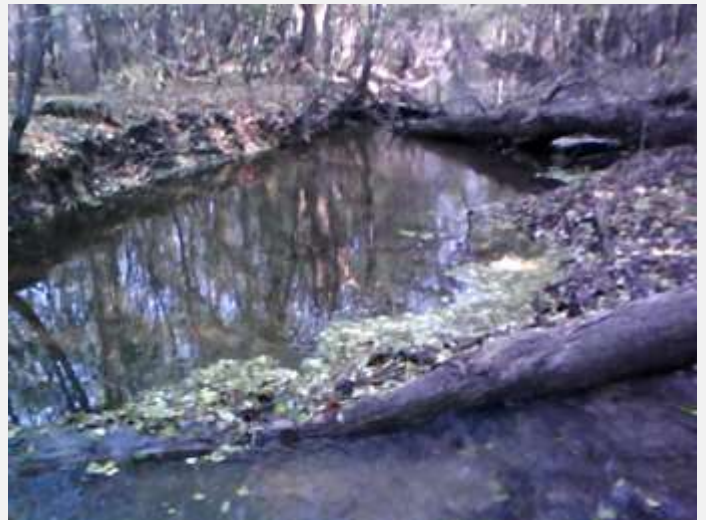
Log spanning stream, medium impediment.

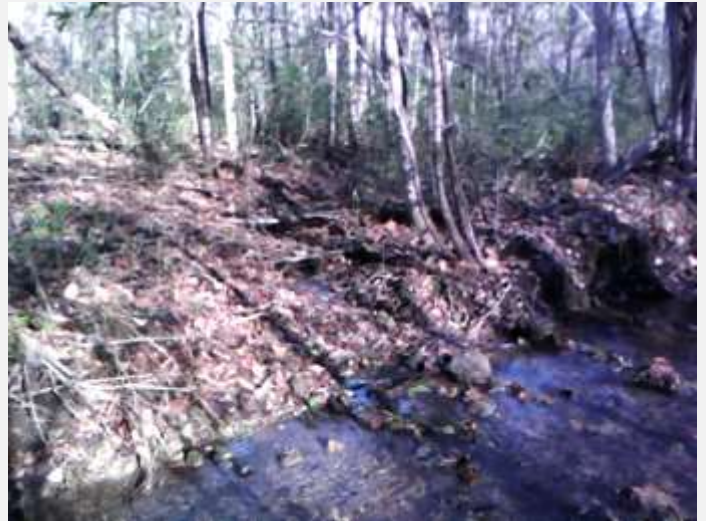
Tributary stream outlet.

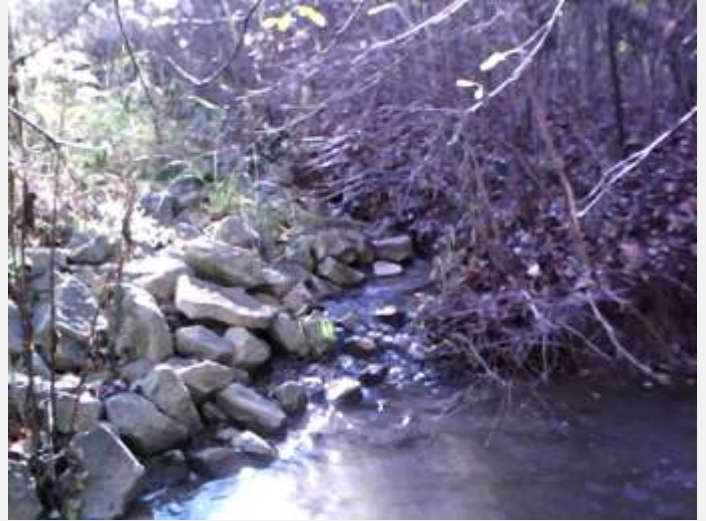
Stormwater outlet & ditch.

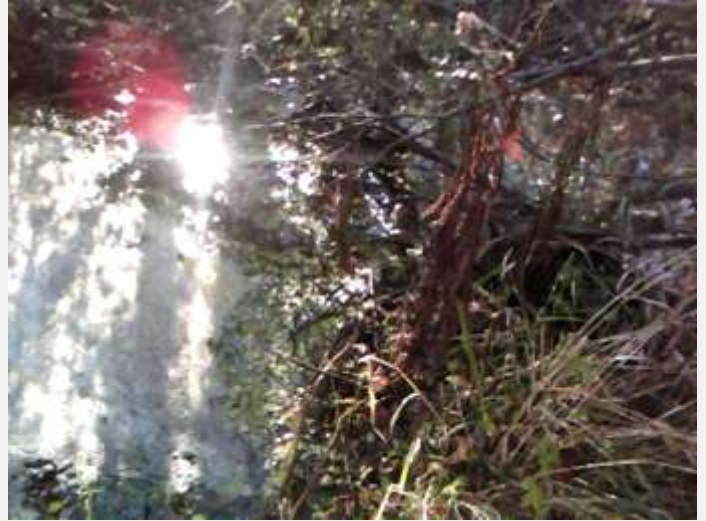
Small debris jam.

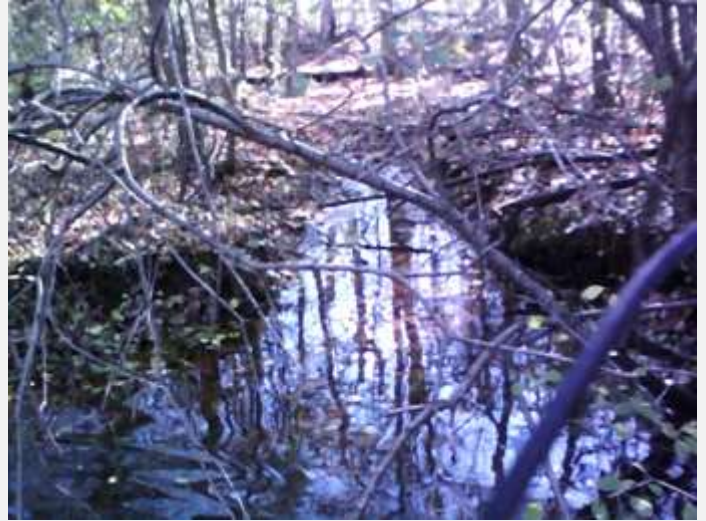
Tributary stream outlet.

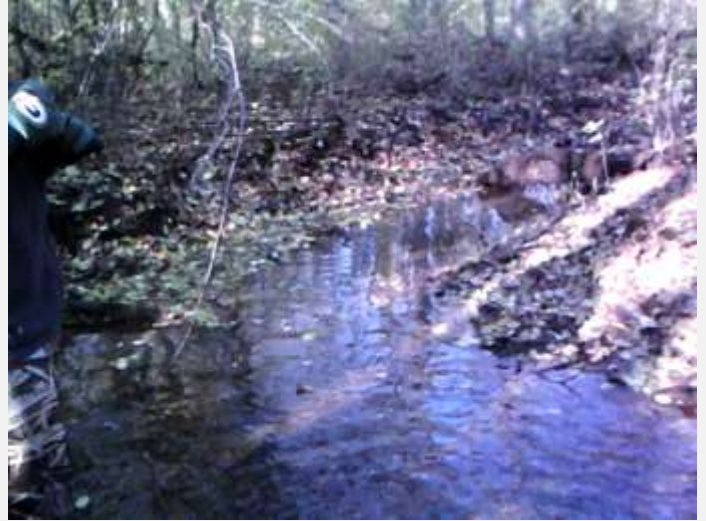
Tributary stream outlet. May connect to wetland.

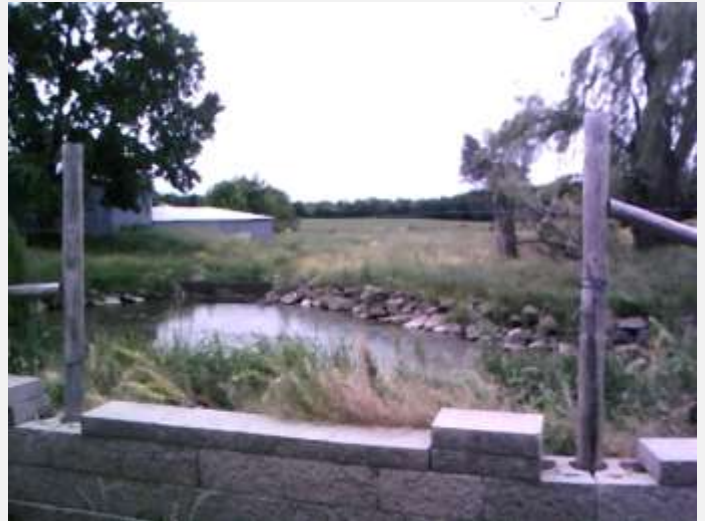
Metal culvert, weir dam at outlet.

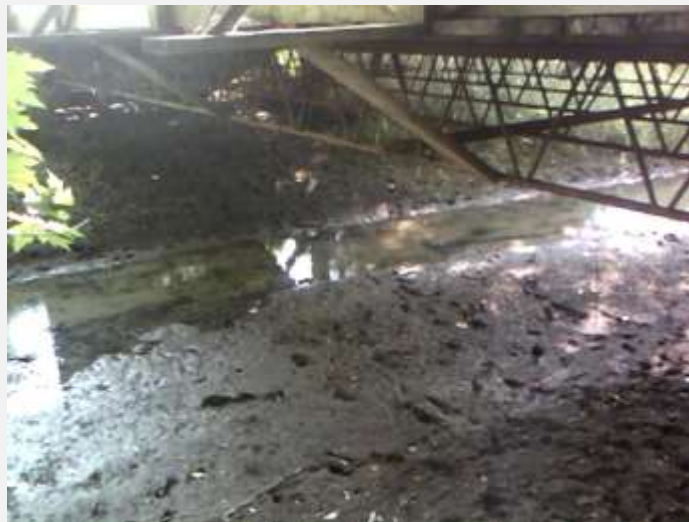
Snowmobile trail bridge.

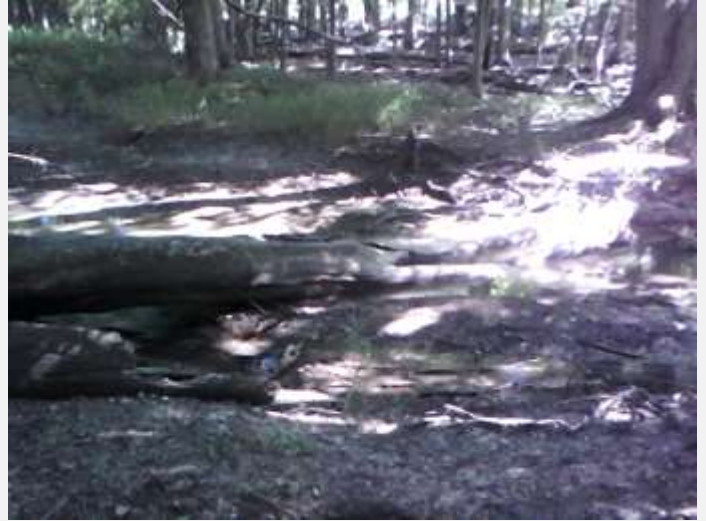
Large tree spanning creek> Definite impairment.

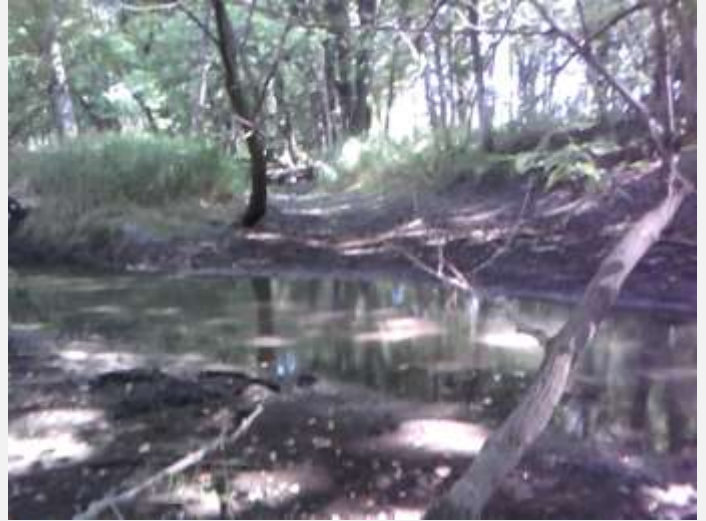
Intermittent stream enters on NE side of stream.

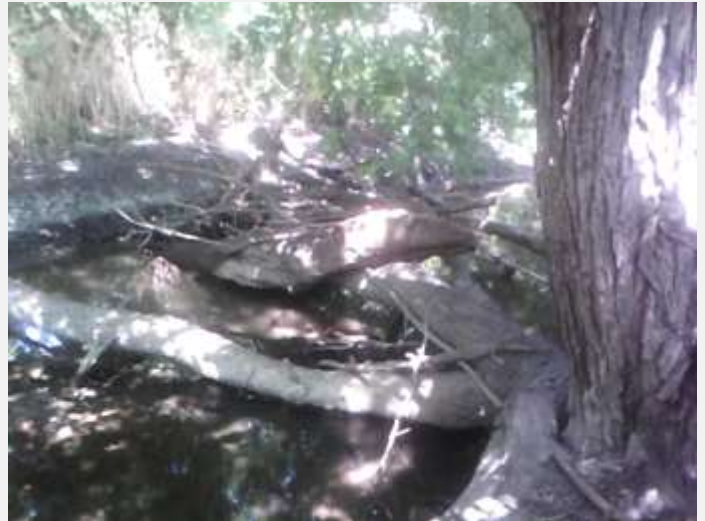
Debris jam (fallen tree ) spanning river.
