## Menomonee Fish Passage Barrier Survey

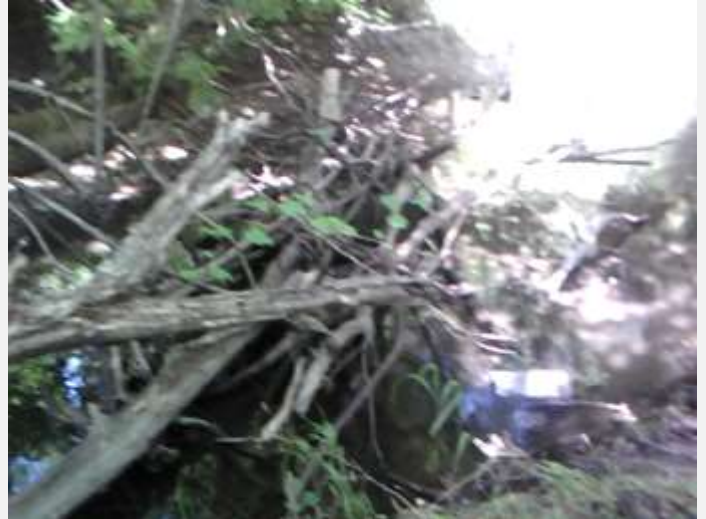
Debris jam spanning river, probable impediment.

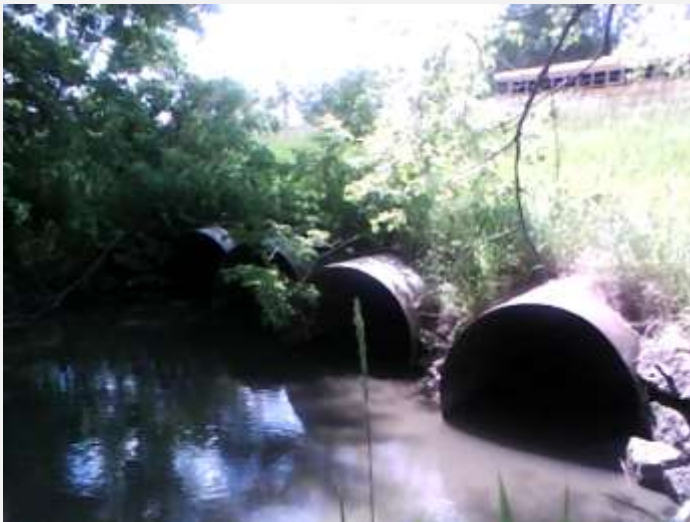
[Photo Outlet](#)

See paper records for structure 4 measurements. Poorly constructed wingwall at inlet -loose rock , major silt deposition at culvert outlets.

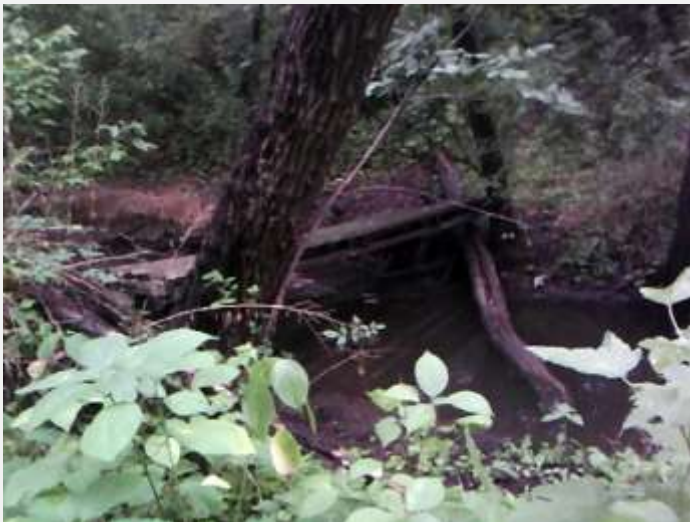
[Photo Inlet](#)

Makeshift footbridge potential cause of blockage.

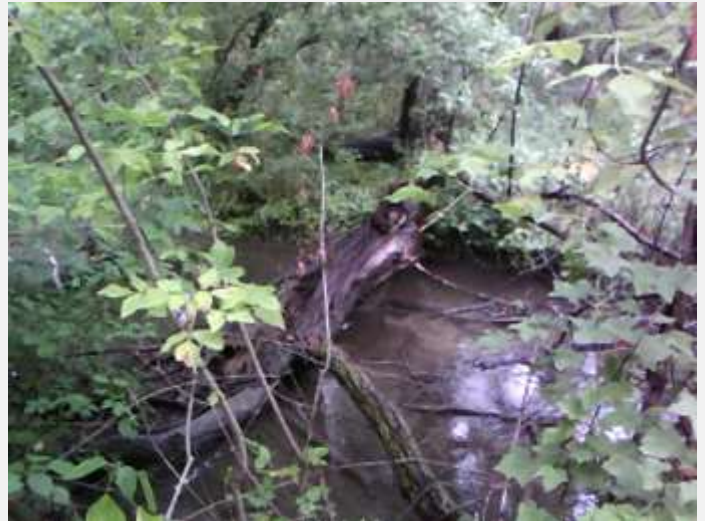
2 somewhat problem trees across river.

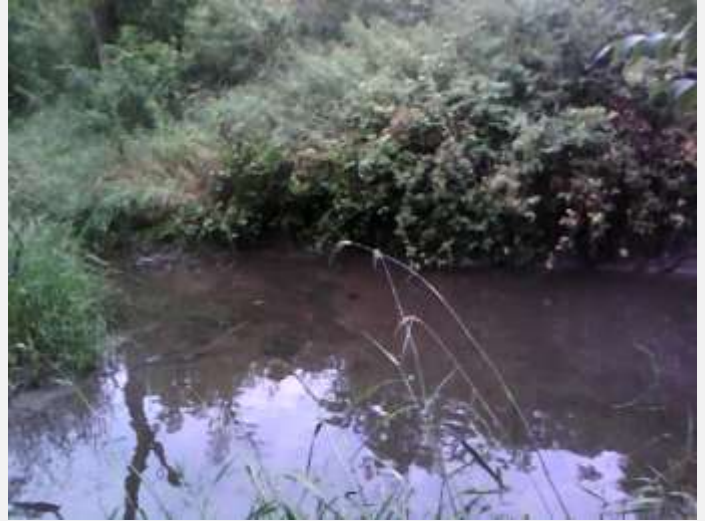
Tributary stream outlet; blocked by debris jam.

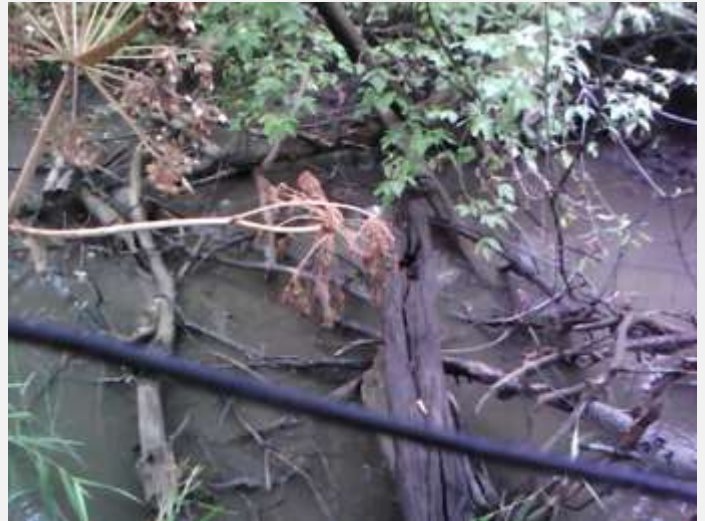
Medium debris jam; passable.

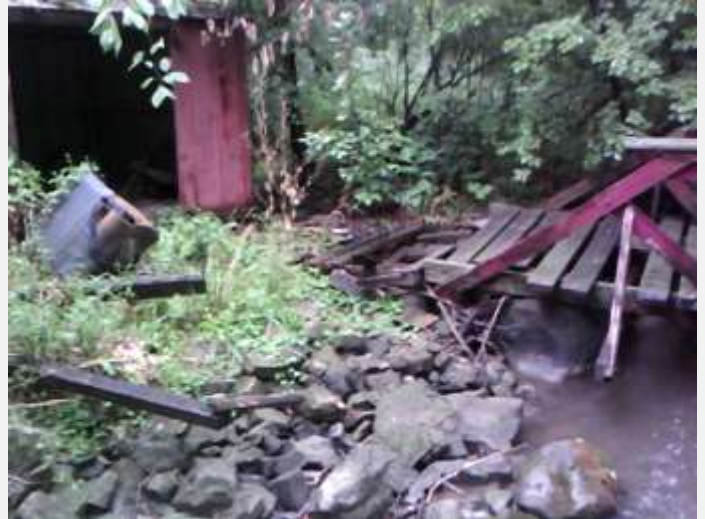
Private bridge crumbling over creek; Garbage strewn about.

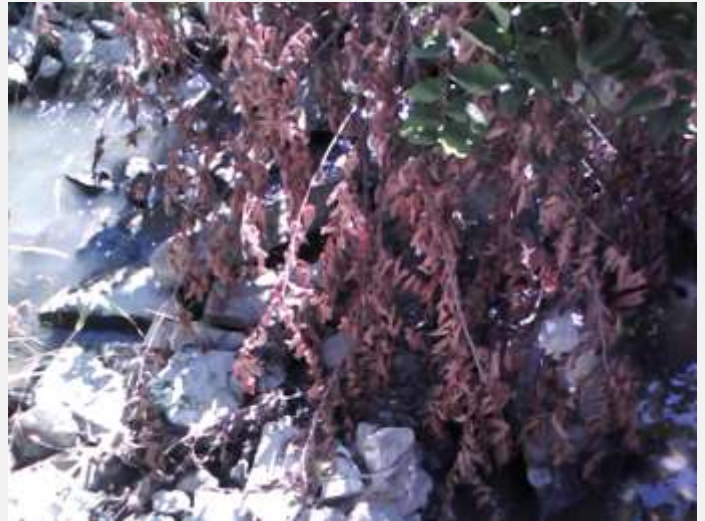
Free span bridge, no blockage. Small rock pile spanning creek just dwnstrm of bridge is an impairment. Also rocks upstream of bridge.

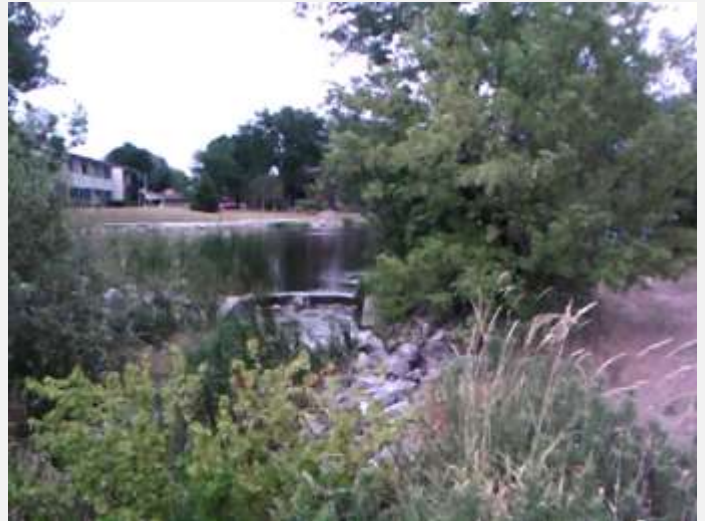
[Photo Outlet](#)

Potential spawning habitat, series of connected ponds in Germantown; Square concrete culvert (blocked), drop structure also at outlet of pond (stream not on unit's map).

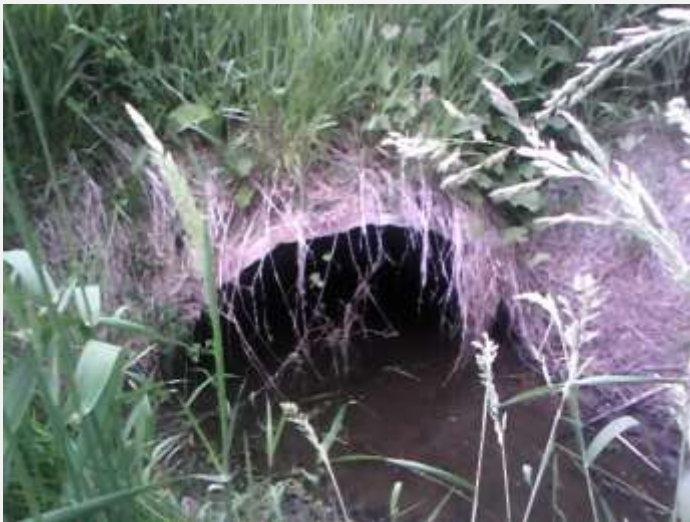
Photo Outlet

Above dam trib to Menomonee, Germantown; rusty metal culvert.

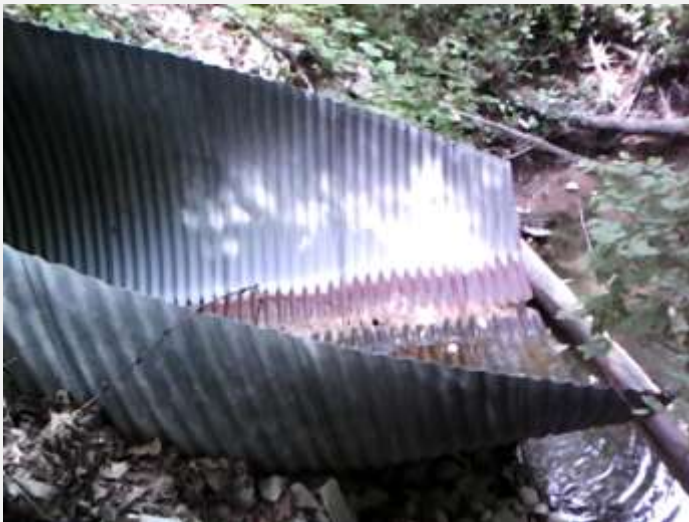
[Photo Outlet](#)

Perched culvert at outlet, upstream plugged, impediments inside culvert, at least two full blockages downstream, evidence of rusting (some holes), severe erosion of road at inlet, deep scour pool before blockages.
